## VEHICLE INSPECTION REPORT

**DU23FRJ**

### Volkswagen Crafter CR35 2.0 TDI 140PS

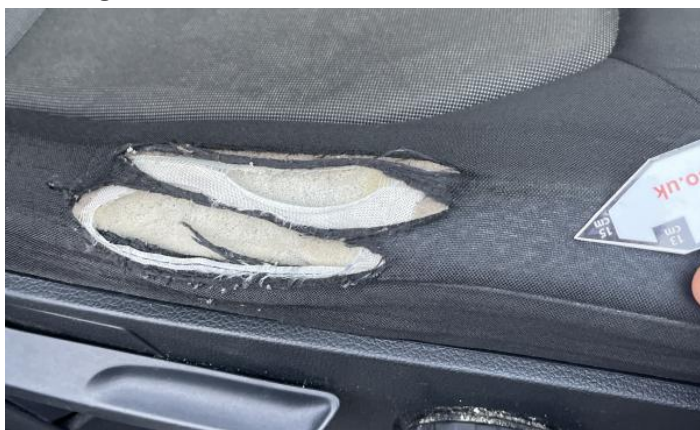
1: Seat Base Cover of  
Torn  
Over 3mm

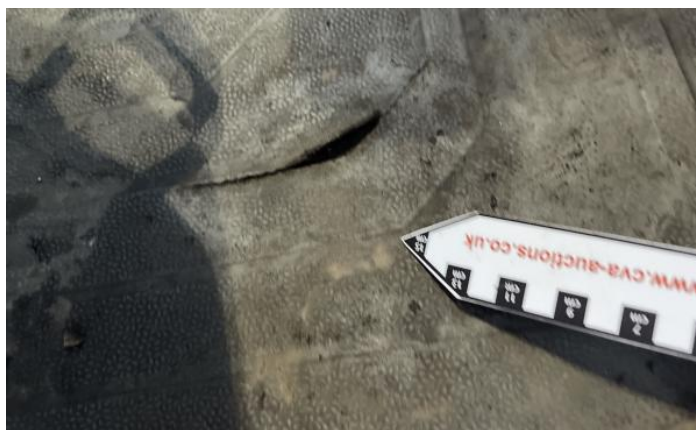
2: Carpets Front  
Torn  
Over 10mm

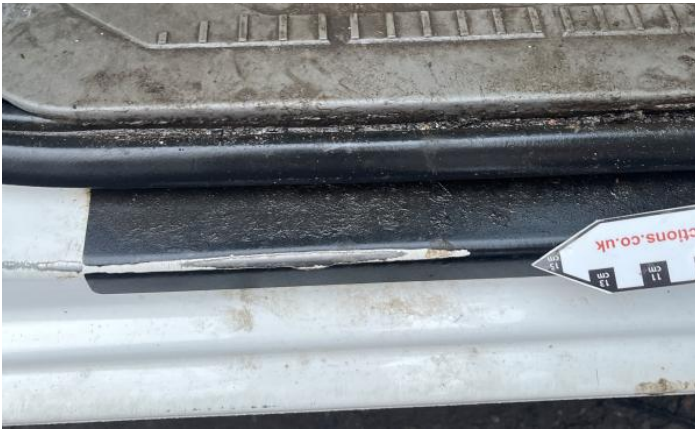
3: Sill os  
Scratched  
Over 25mm Thru Paint

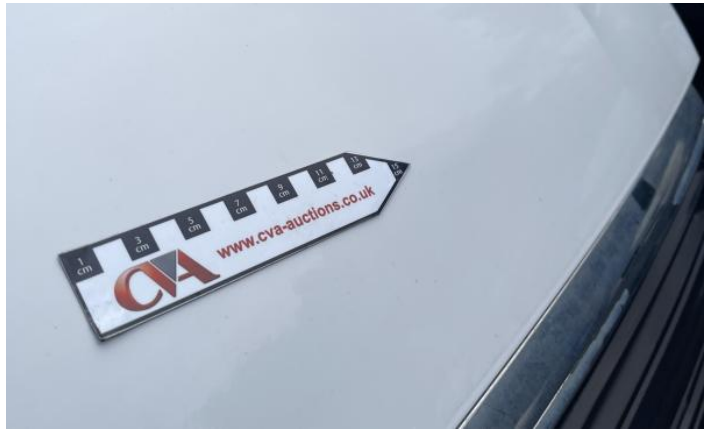
4: Bonnet  
Dented  
Over 30mm

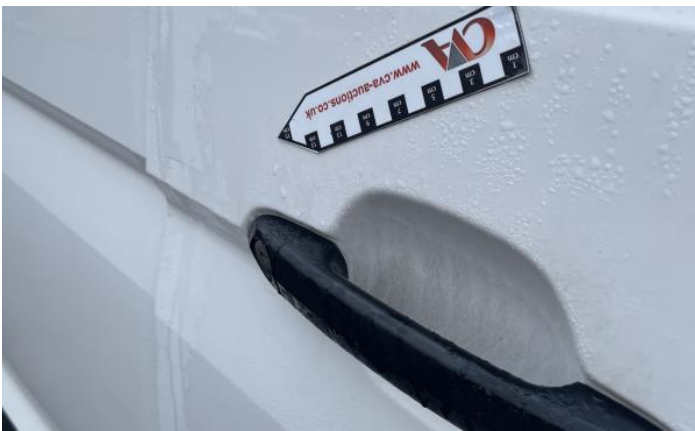
5: Door osf  
Dented  
Over 2 UpTo 10mm

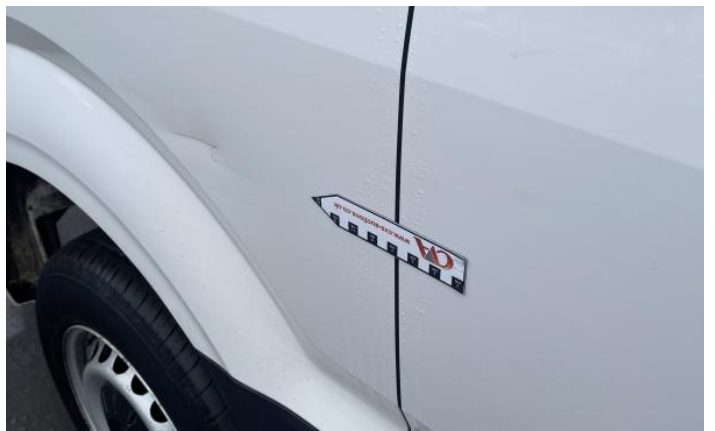
6: Qtr Panel osr  
Dented  
Over 30mm

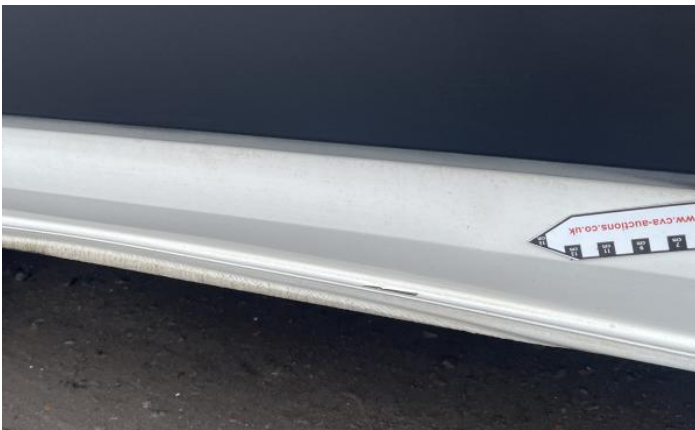
7: Sill os  
Dented  
With Paint Damage

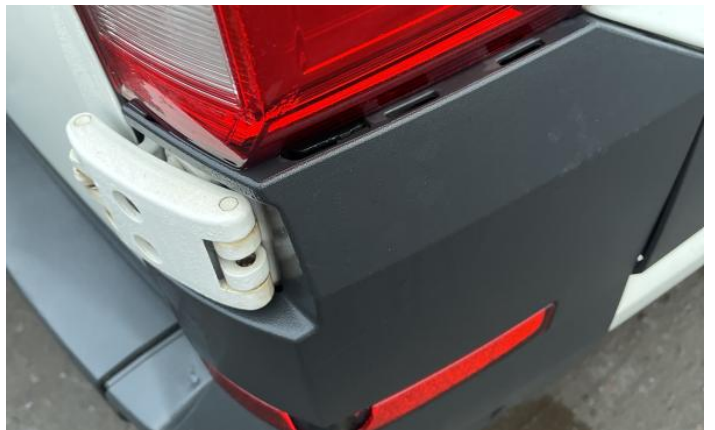
8: Bumper Rear Moulding  
Broken  
Replace

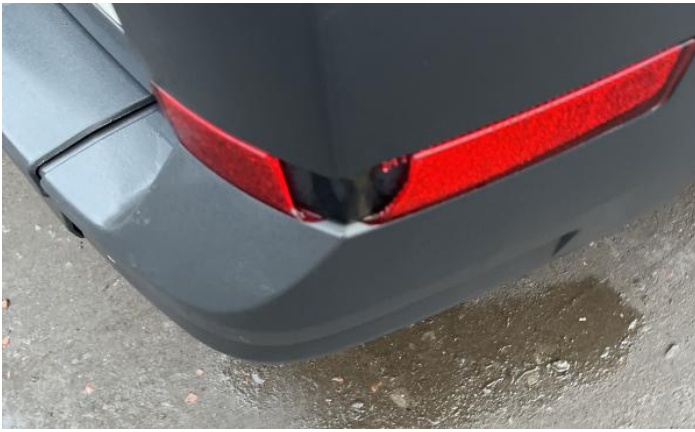
9: Fog Lamp osr  
Broken  
Replace

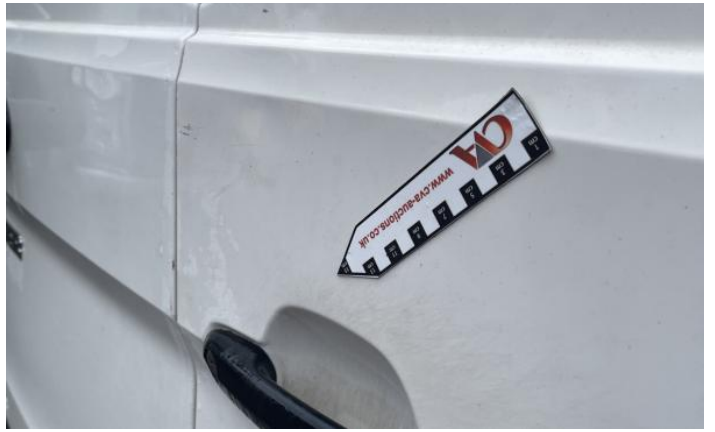
10: Tailgate  
Dented  
With Paint Damage

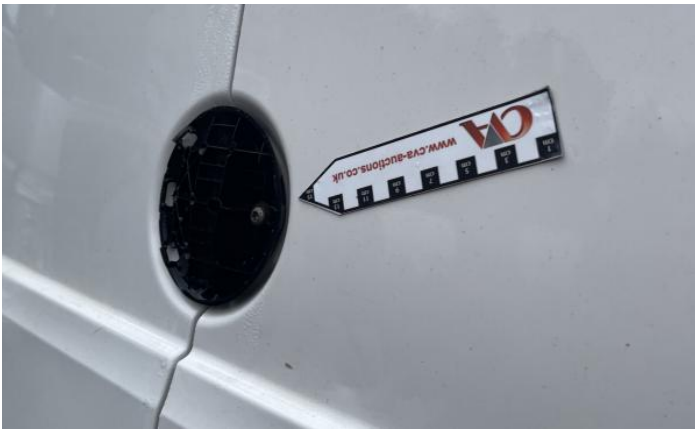
11: Badgedecal Rear  
Broken  
Replace

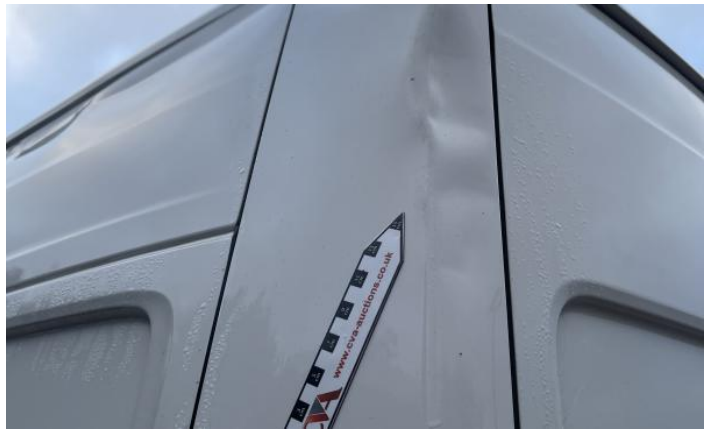
12: D Post ns  
Dented  
With Paint Damage

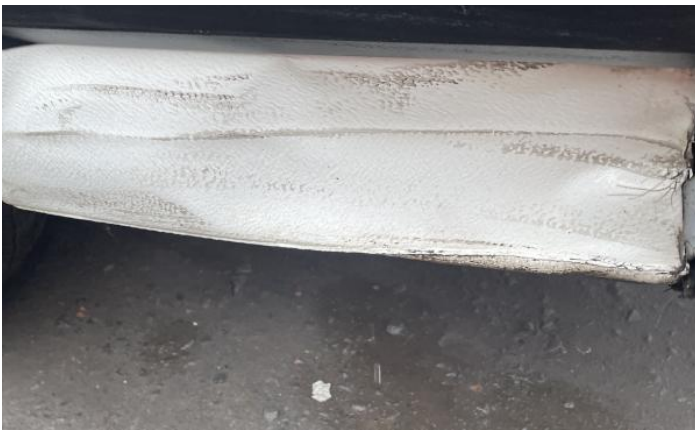
13: Qtr Panel nsr  
Dented  
Over 30mm

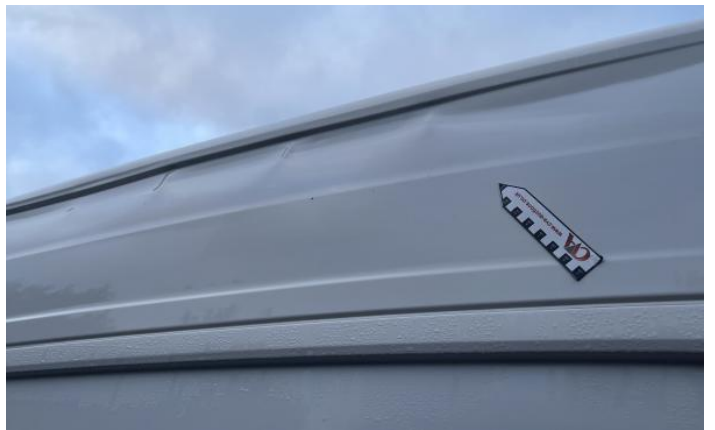
14: Qtr Panel nsr  
Dented  
With Paint Damage

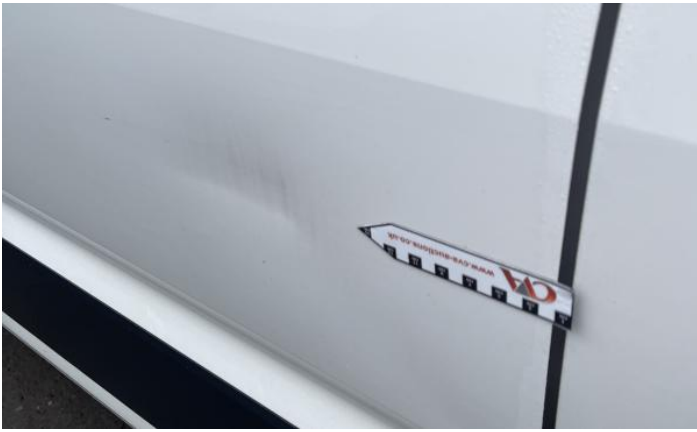
15: Door nsr  
Dented  
With Paint Damage

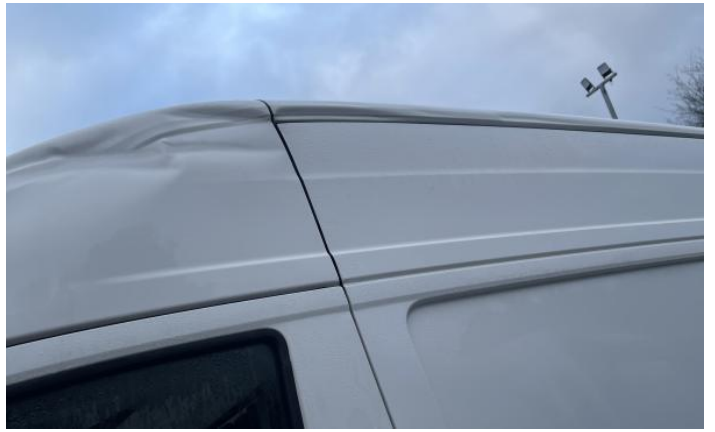
16: Roof  
Dented  
With Paint Damage

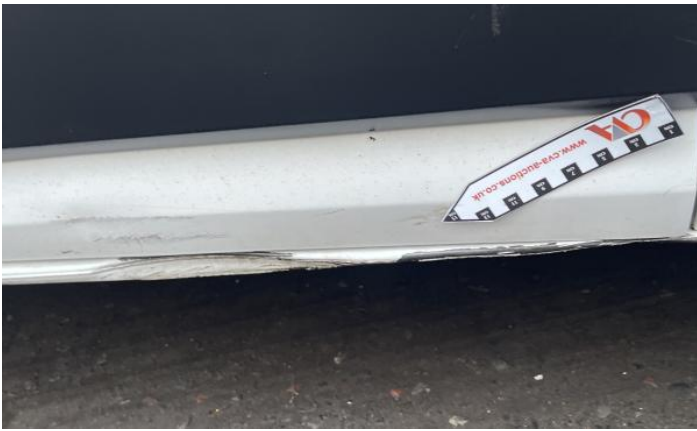
17: Sill ns  
Dented  
With Paint Damage

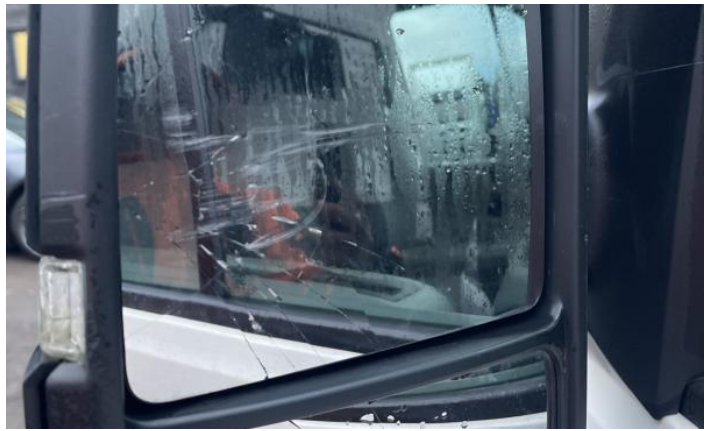
18: Door Mirror Glass ns  
Broken  
Replace

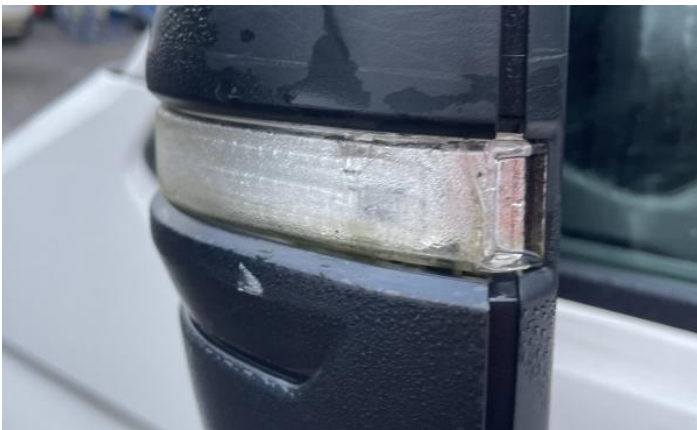
19: Flasher Side Repeater ns  
Broken  
Replace
