# VEHICLE INSPECTION REPORT

**WX21VCE**

## Mercedes-Benz VITO TOURIER 119 CDI

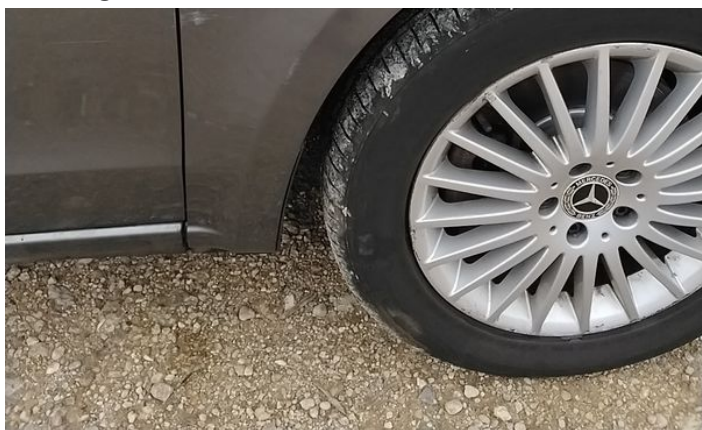
1: Wing of  
Dented  
With Paint Damage

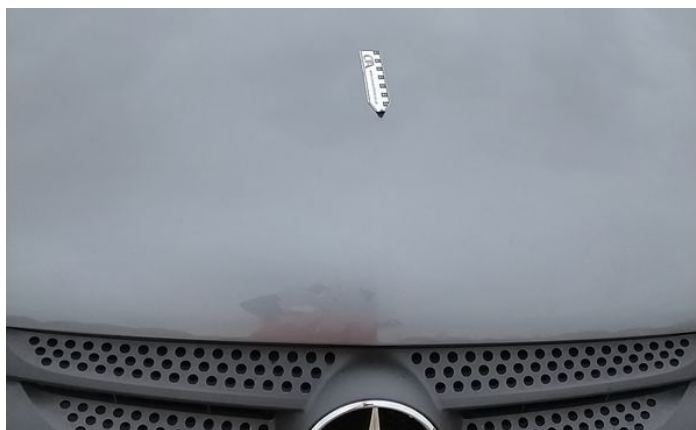
2: Bonnet  
Poor Previous Repair  
Poor Paint

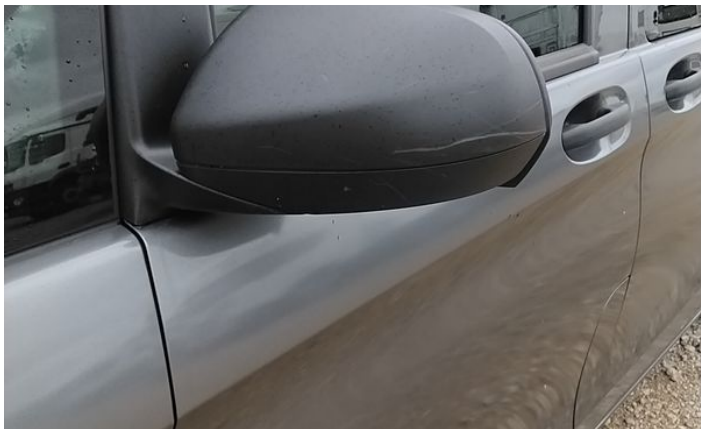
3: Door Mirror Assy nsf  
Scuffed (Unpainted)  
Over 100mm

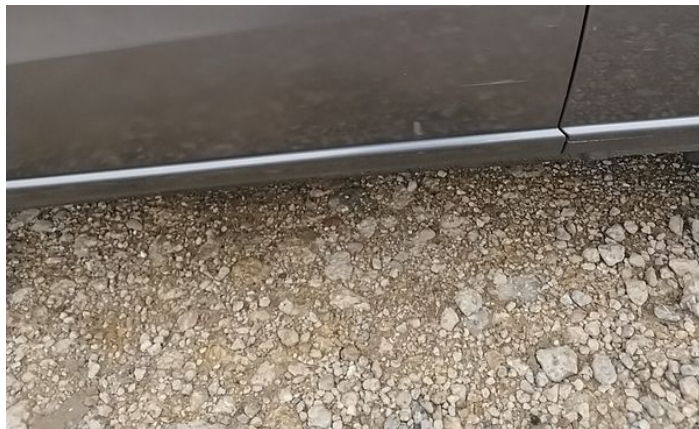
4: Door nsr  
Scratched  
Over 25mm Thru Paint

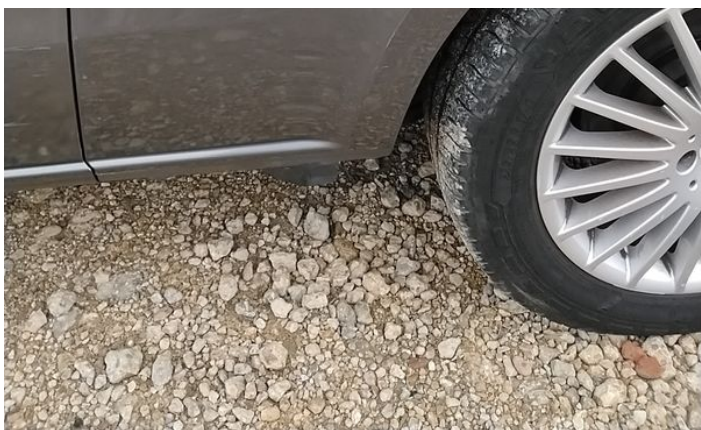
5: Qtr Panel nsr  
Scratched  
Over 25mm Thru Paint

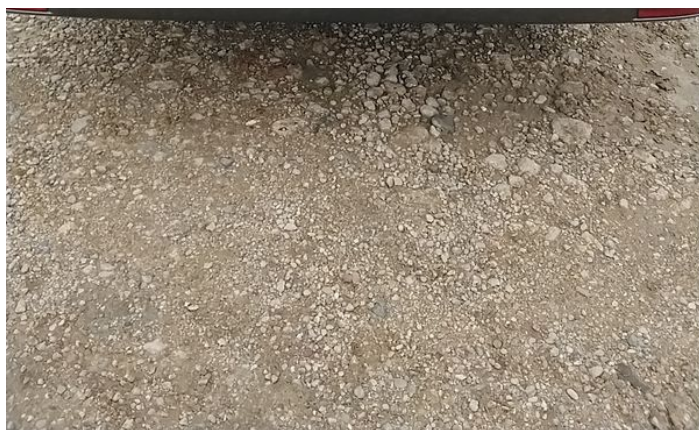
6: Bumper Rear  
Scratched  
25 to 100mm Thru Paint

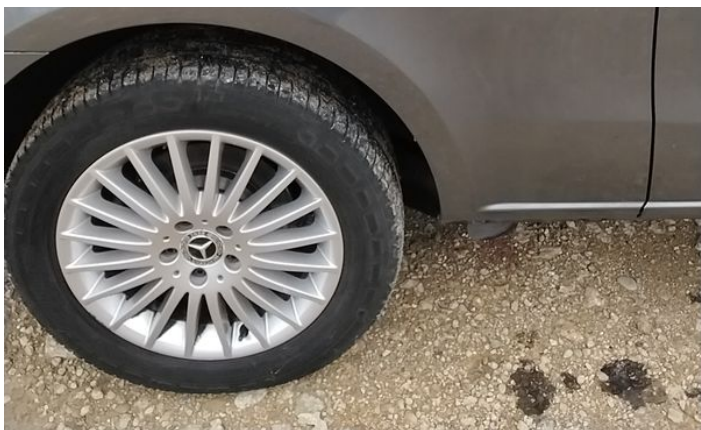
7: Qtr Panel osr  
Scratched  
Over 25mm Not Thru Paint

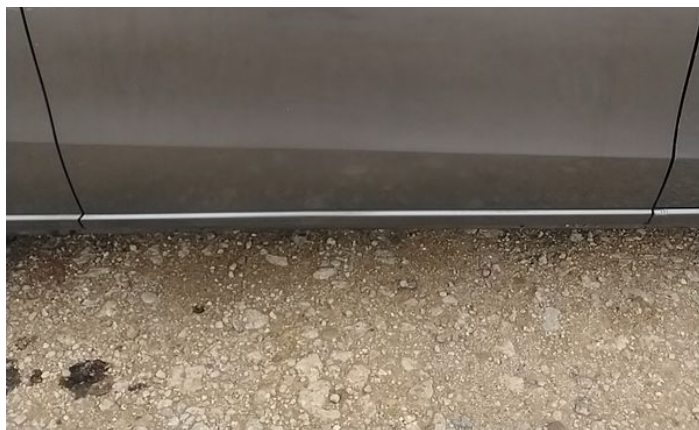
8: Door osr  
Dented  
With Paint Damage

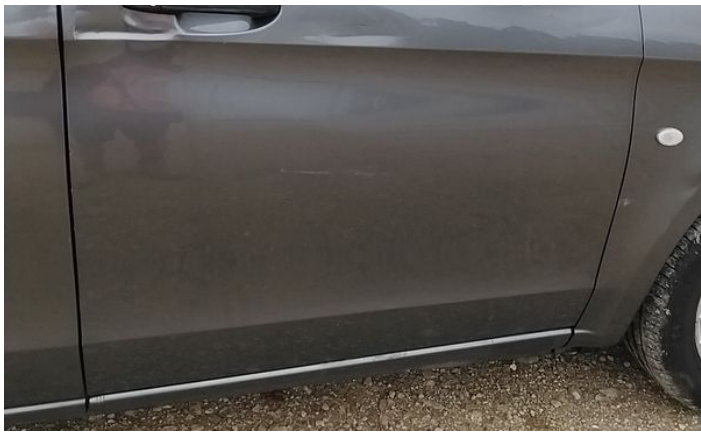
9: Door osf  
Dented  
With Paint Damage

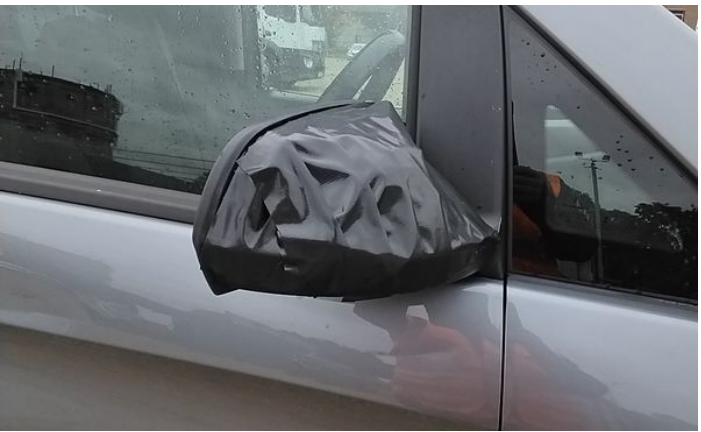
10: Door Mirror Assy osf  
Broken  
Replace
