# VEHICLE INSPECTION REPORT

**DS72NUP**

## Vauxhall Movano 3500 2.2 TURBO 140PS DYNAMIC

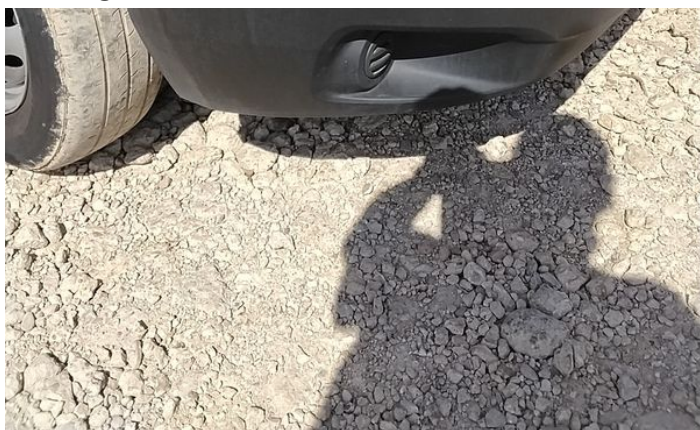
1: Bumper Front Moulding  
Scuffed (Unpainted)  
Over 100mm

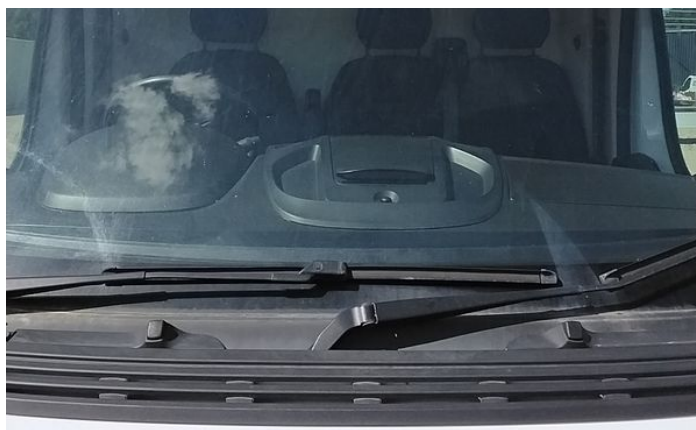
2: Screen Front  
Chipped  
Over 10mm

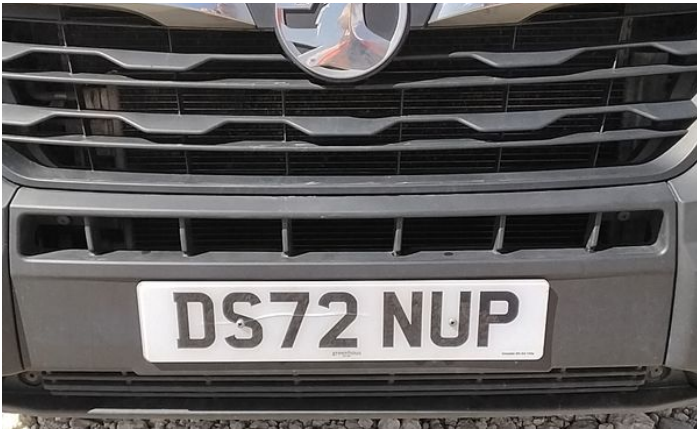
3: Number Plate Front  
Broken  
Replace

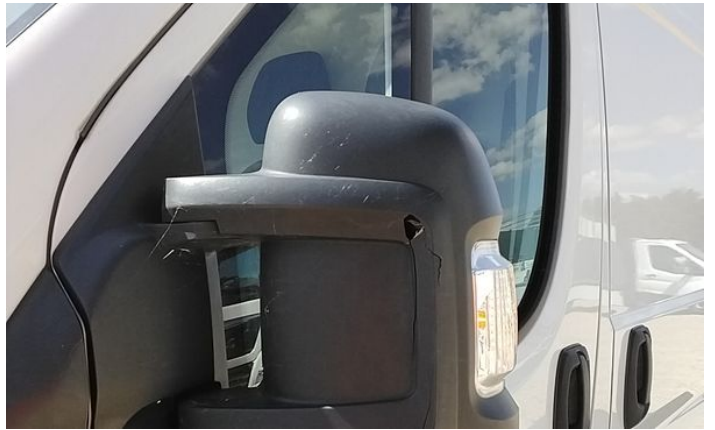
4: Door Mirror Assy nsf  
Broken  
Replace

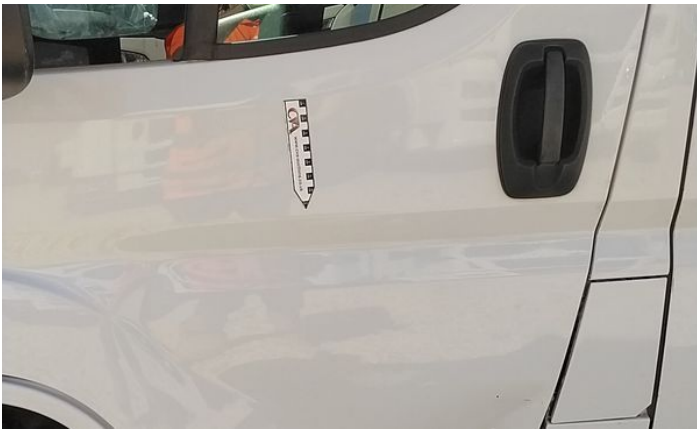
5: Door nsf  
Dented  
Over 30% Of Panel

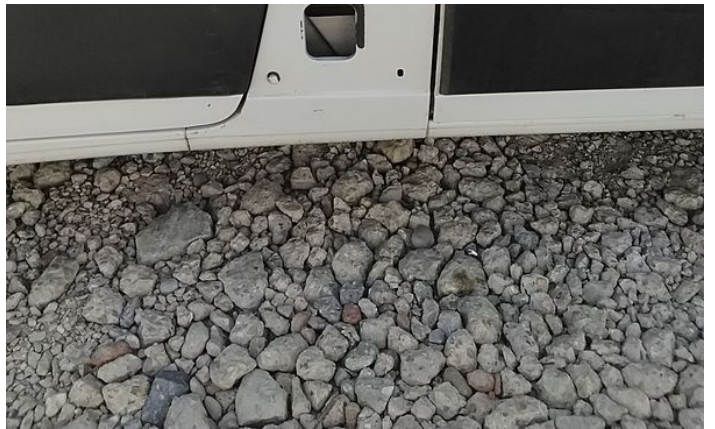
6: Qtr Panel Trim ns  
Missing  
Replace

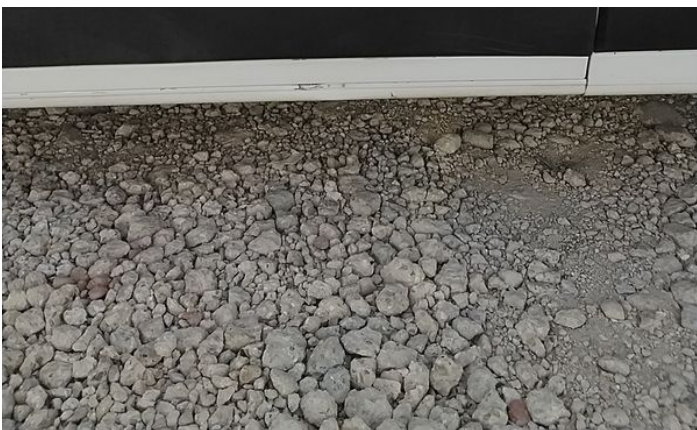
7: Door nsr  
Dented  
With Paint Damage

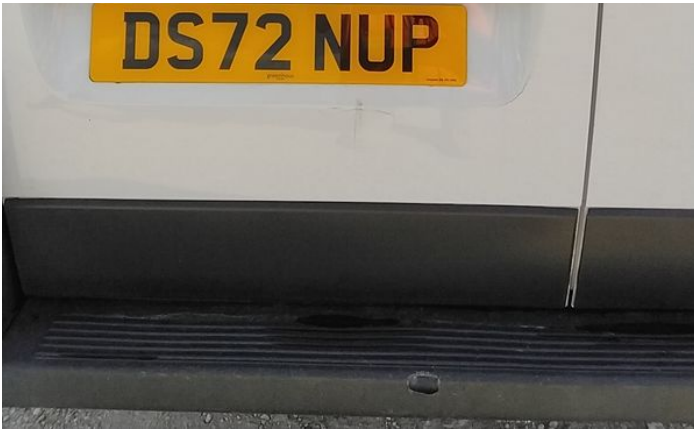
9: Door nsr  
Scratched  
Over 25mm Not Thru Paint

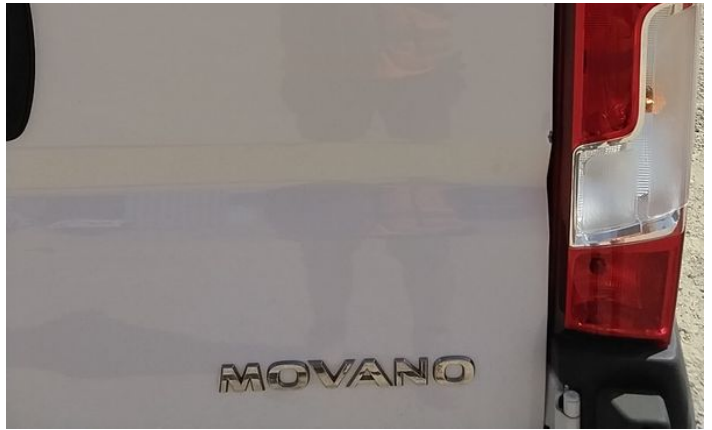
10: Door osr  
Dented  
With Paint Damage

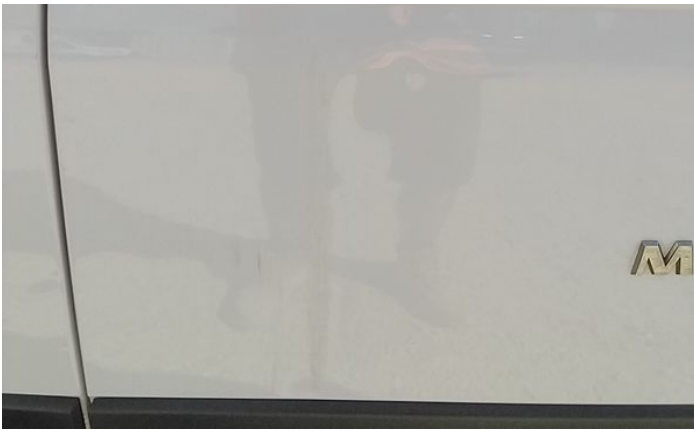
11: Door osr  
Dented  
Between 10mm + 30mm

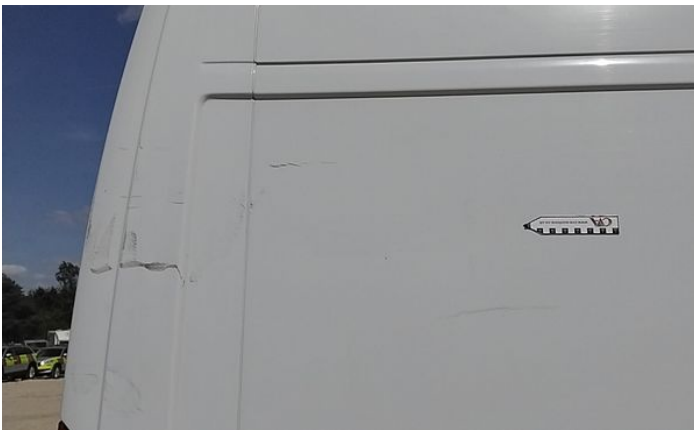
13: Qtr Panel osr  
Scratched  
Over 25mm Not Thru Paint

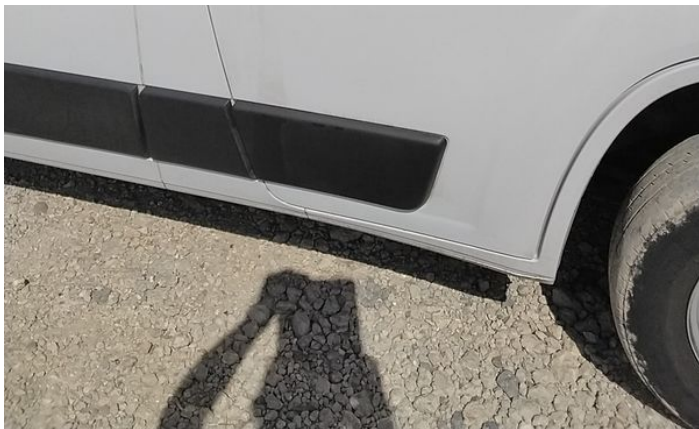
15: Door osf  
Scratched  
Over 25mm Not Thru Paint

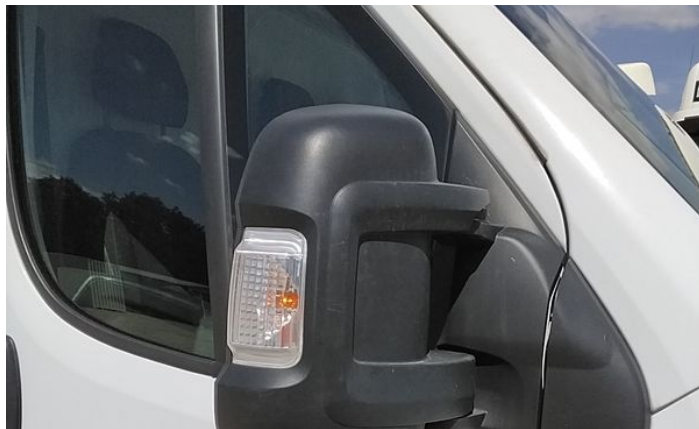
16: Door Mirror Assy osf  
Scuffed (Unpainted)  
UpTo 100mm

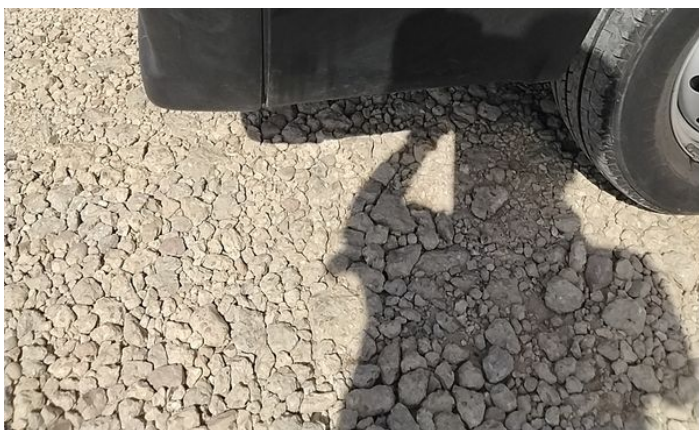
17: Bumper Rear Moulding  
Scuffed (Unpainted)  
Over 100mm
