# VEHICLE INSPECTION REPORT

**WR22TYW**

## Mercedes-Benz Vito Tourer 119 CDI

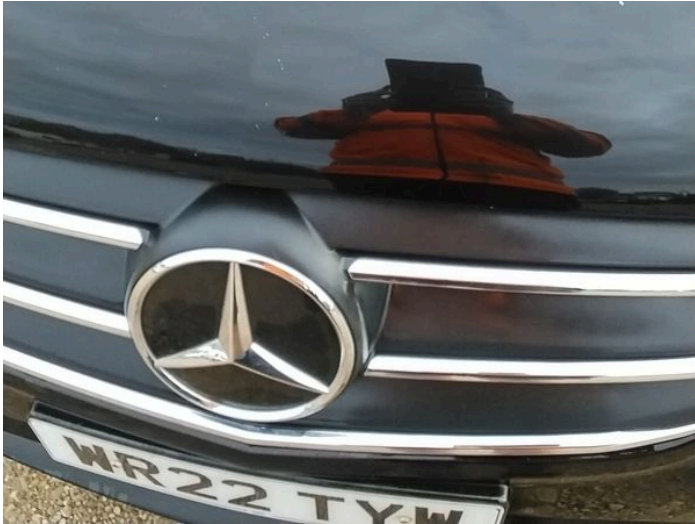
1: Bonnet  
Chipped  
Multiple Chips

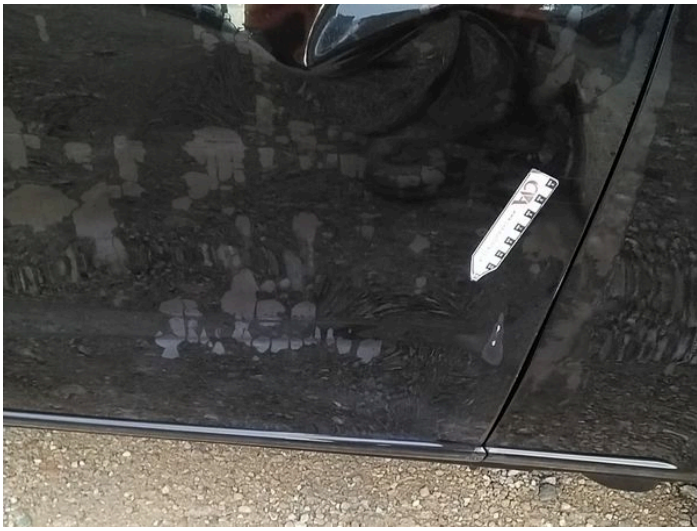
3: Qtr Panel nsr  
Dented  
Over 30mm

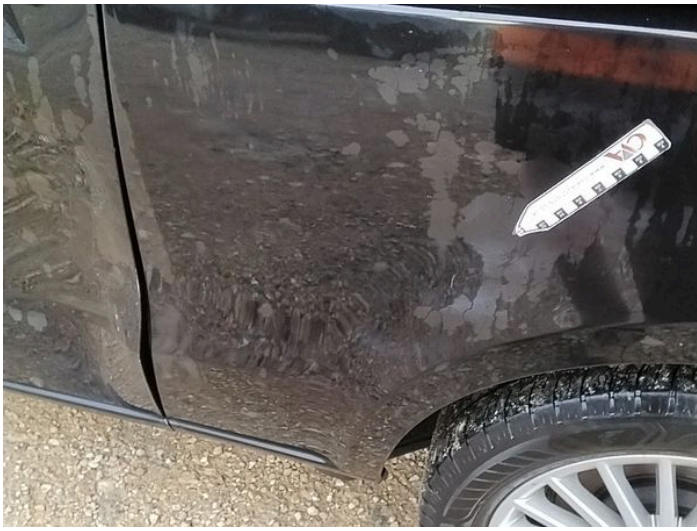
4: Qtr Panel nsr  
Dented  
Over 30mm

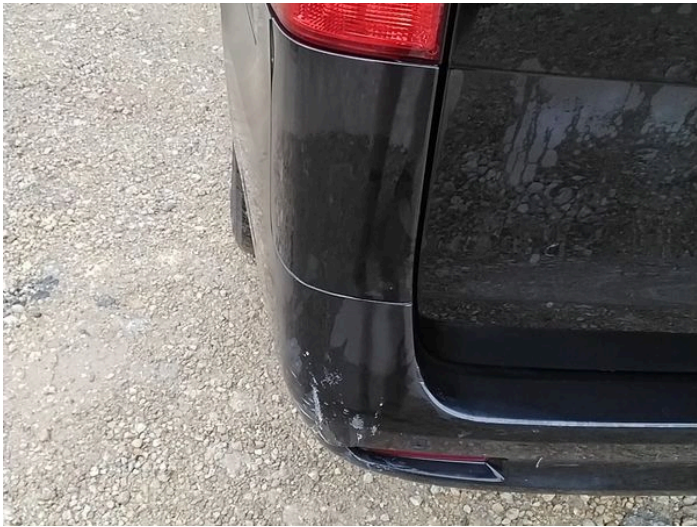
5: Tailgate  
Dented  
With Paint Damage

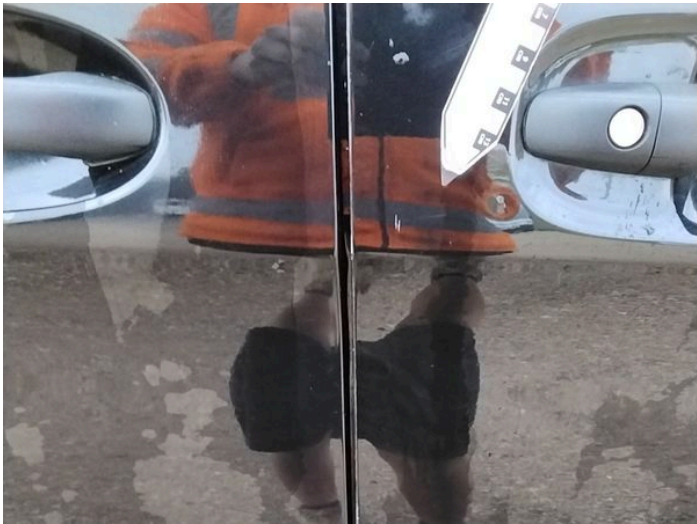
7: Door osf  
Scratched  
UpTo 25mm Thru Paint
