VEHICLE INSPECTION REPORT

Jaguar I-Pace EV400 HSE

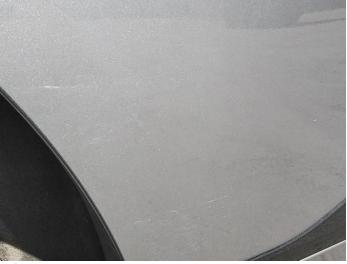
2: Door nsr Scratched Over 25mm Not Thru Paint

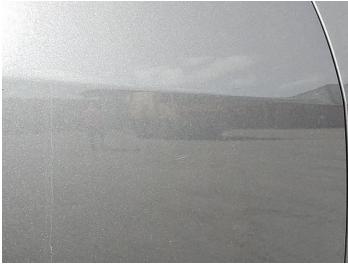
3: Door nsf Scratched UpTo 25mm Not Thru Paint 4: Bumper Front Scratched Over 25mm Not Thru Paint
