## VEHICLE INSPECTION REPORT

**KJ69CBO**

### Mercedes-Benz Vito Tourer 119 CDI L3

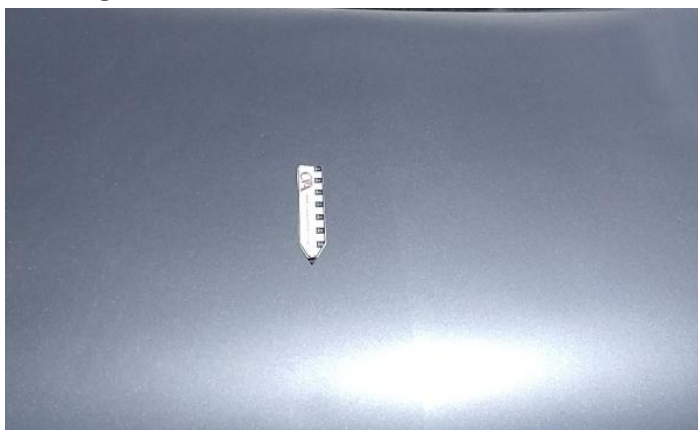
1: Bonnet  
Chipped  
Multiple Chips

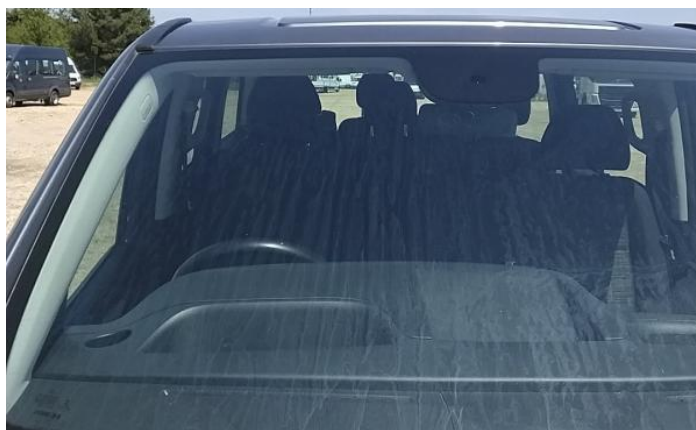
2: Screen Front  
Chipped  
Over 10mm

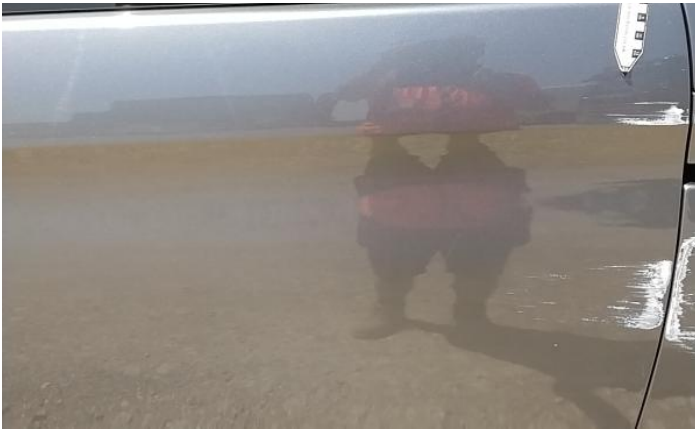
3: Door nsr  
Scratched  
Over 25mm Thru Paint

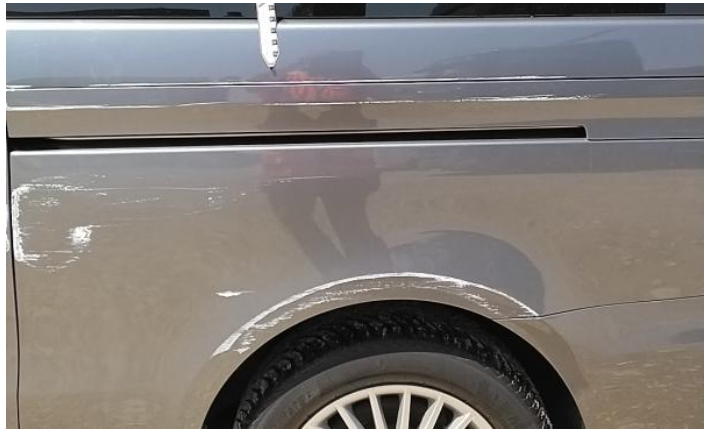
4: Qtr Panel nsr  
Scratched  
Over 25mm Thru Paint

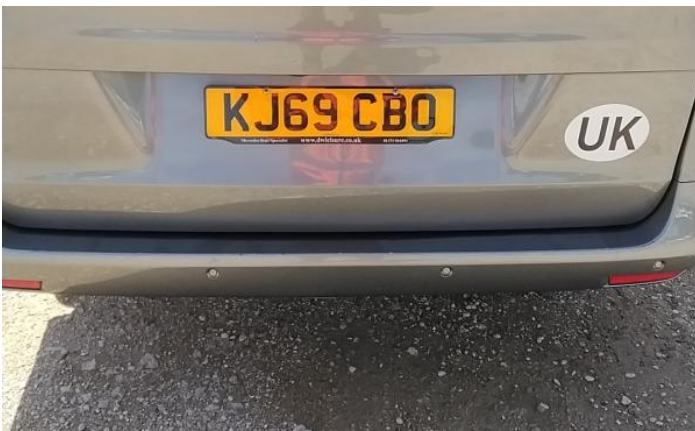
5: Bumper Rear  
Scratched  
25 to 100mm Thru Paint

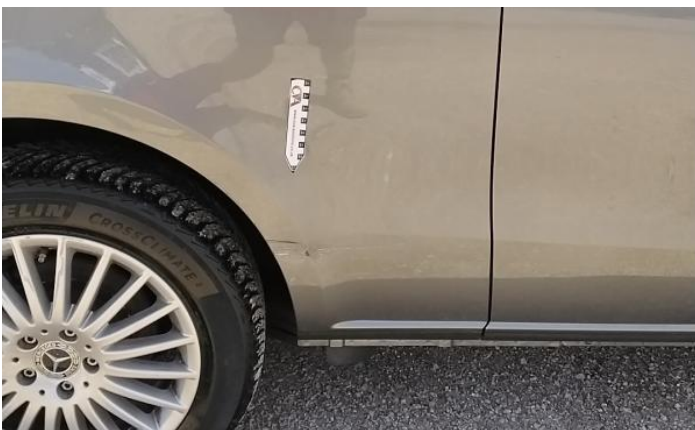
7: Qtr Panel osr  
Dented  
With Paint Damage

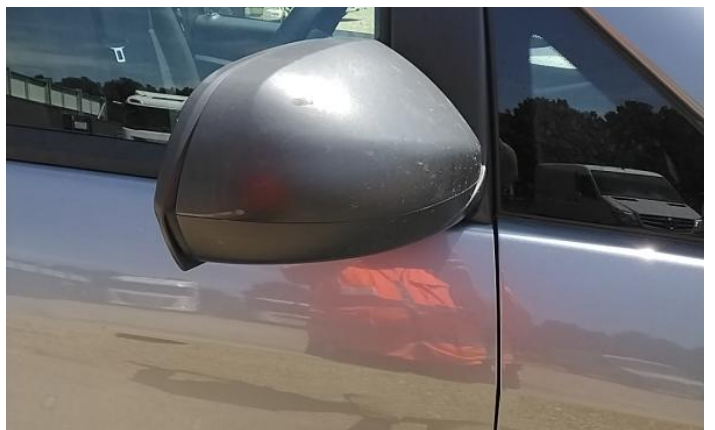
8: Door Mirror Assy osf  
Scuffed (Unpainted)  
UpTo 100mm
