# VEHICLE INSPECTION REPORT

**OK67ASM**

## Daf LF 230

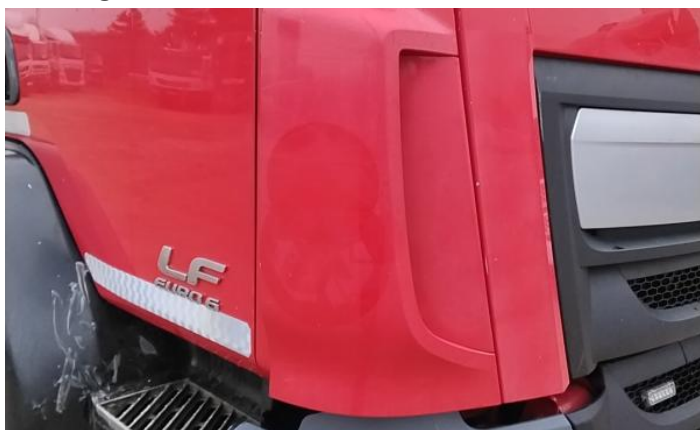
1: Wing osf  
Scratched  
Over 25mm Not Thru Paint

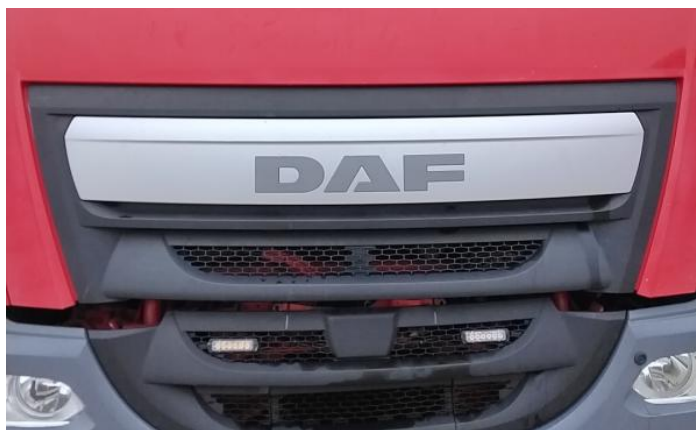
2: Bonnet  
Chipped  
Multiple Chips

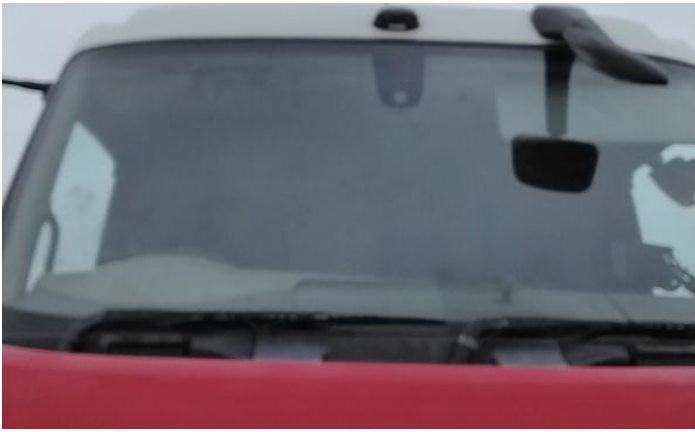
3: Screen Front  
Chipped  
Over 10mm

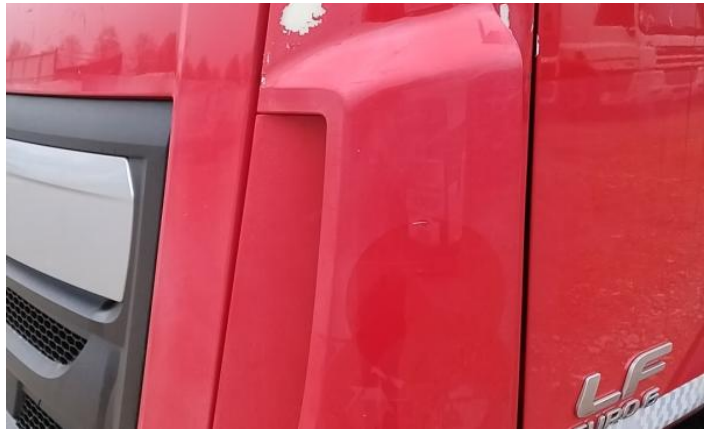
4: Wing nsf  
Scratched  
Over 25mm Thru Paint

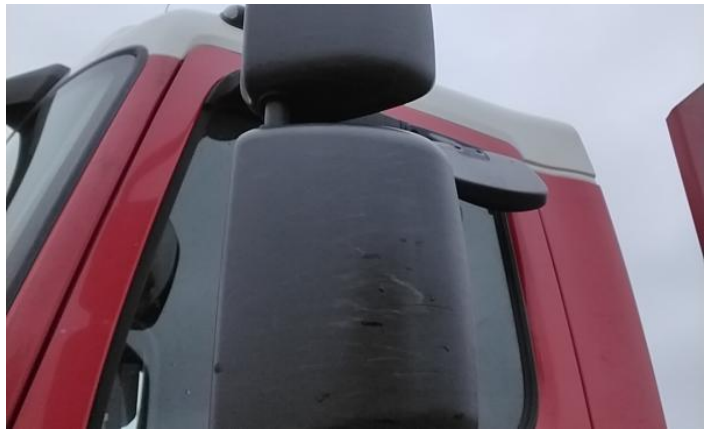
6: Door Mirror Assy nsf  
Scuffed (Unpainted)  
Over 100mm

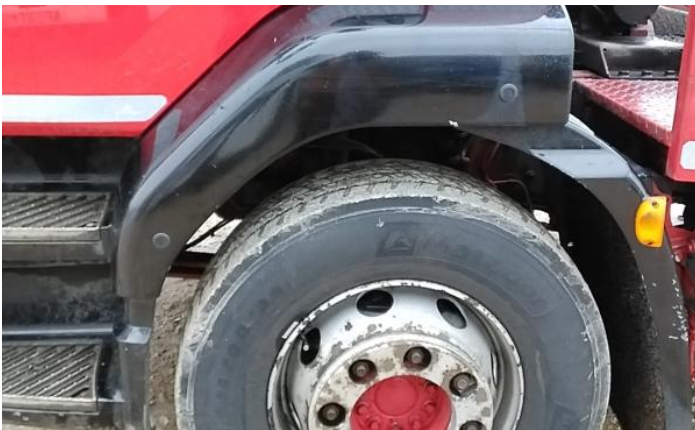
7: Qtr Panel Trim ns  
Scuffed  
UpTo 25mm

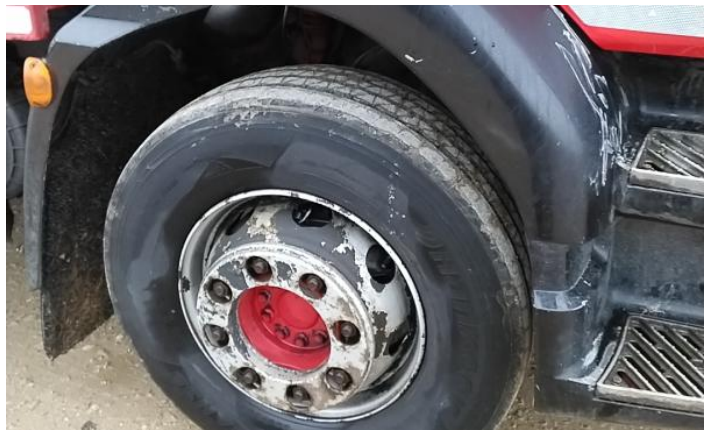
8: Qtr Panel Trim os  
Scuffed  
UpTo 25mm

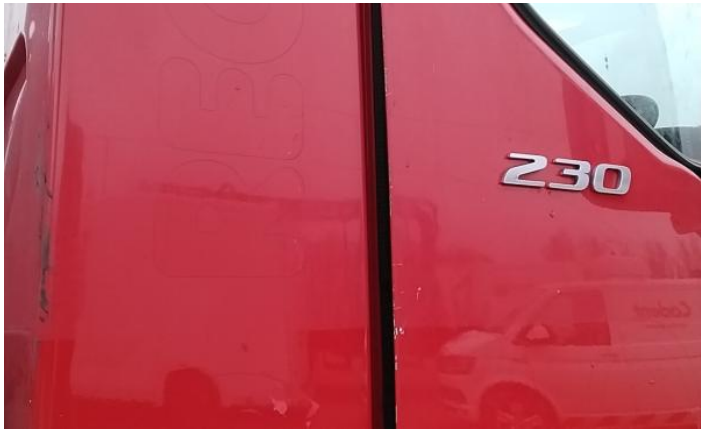
9: Door osf  
 Chipped  
 Edge Chip
