# VEHICLE INSPECTION REPORT

**DG18SUH**

## Isuzu N75 190

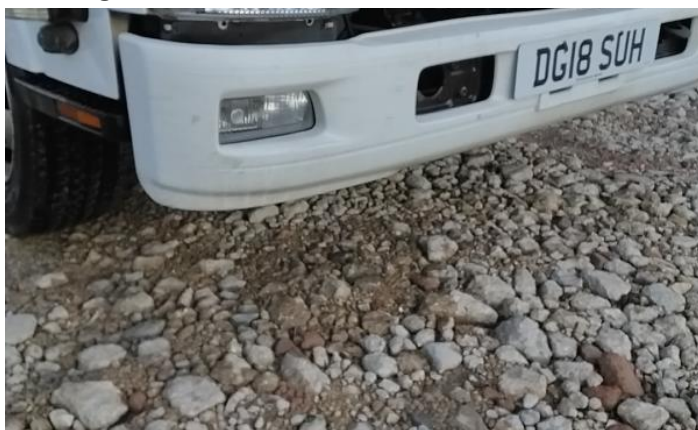
1: Bumper Front  
Scratched  
Over 25mm Not Thru Paint

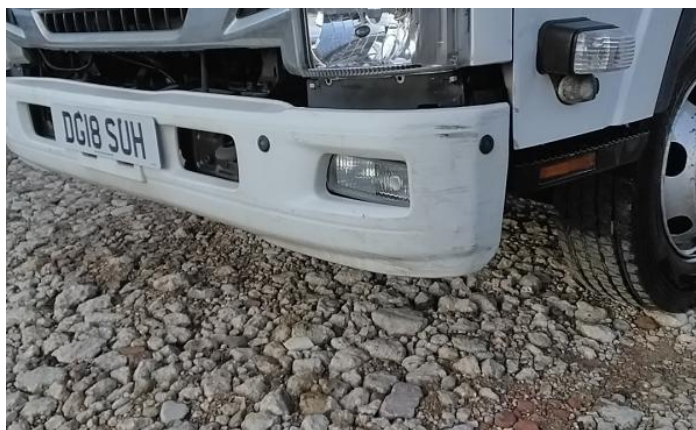
2: Bumper Front  
Scratched  
Over 25mm Not Thru Paint

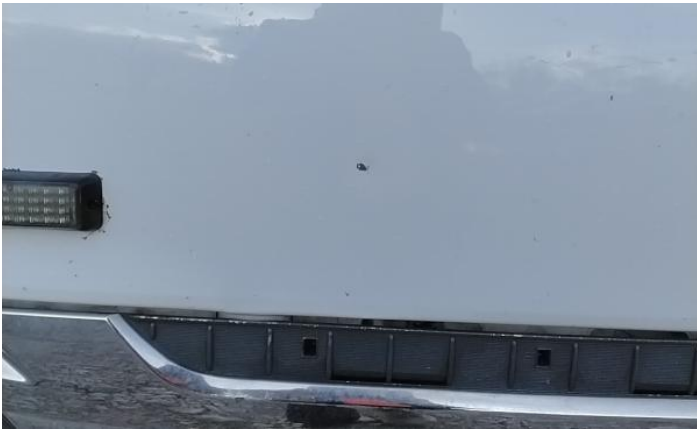
3: Bonnet  
Dented  
Between 10mm + 30mm

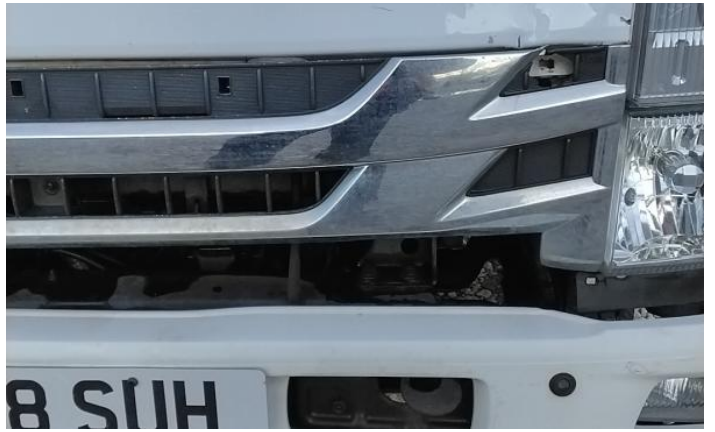
4: Grille Front  
Broken  
Replace

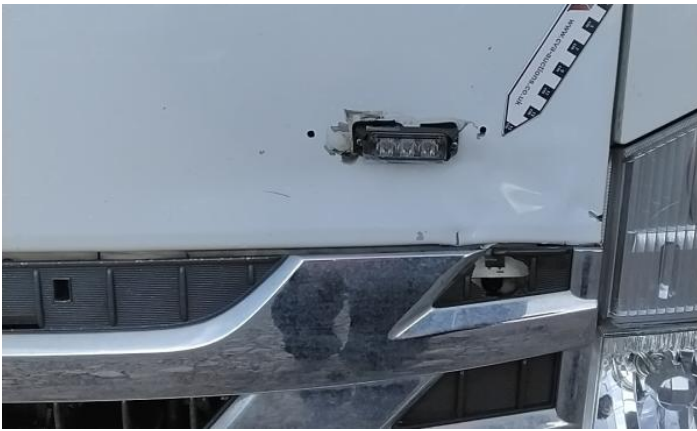
5: Bonnet  
Dented  
With Paint Damage

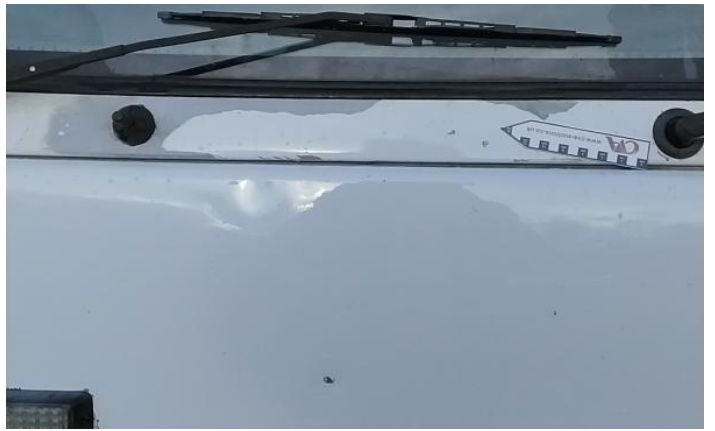
6: Panel Front  
Scratched  
Over 25mm Thru Paint

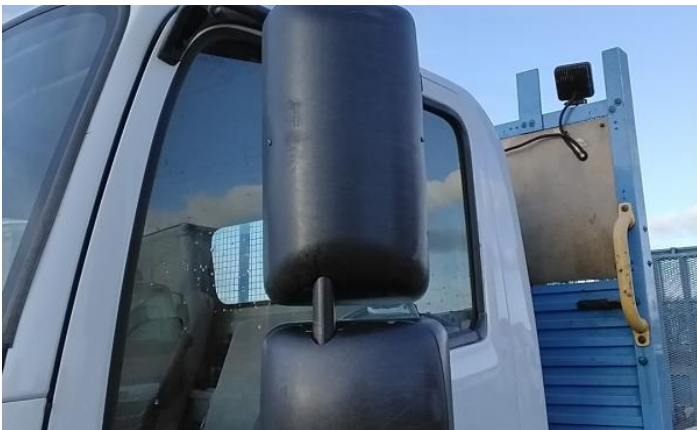
7: Door Mirror Assy nsf  
Broken  
Replace

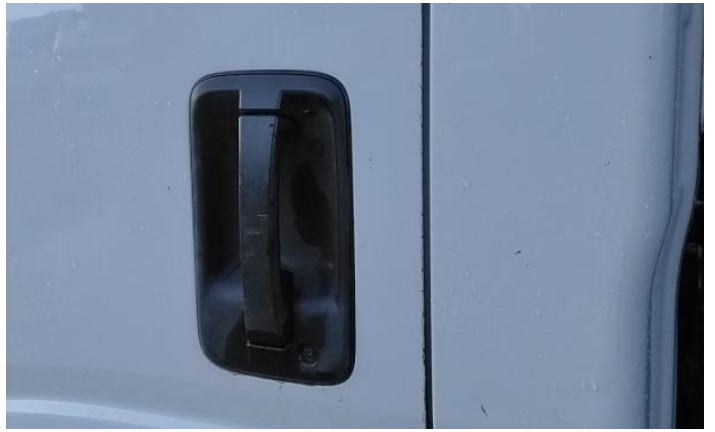
10: Door nsf  
Chipped  
Edge Chip

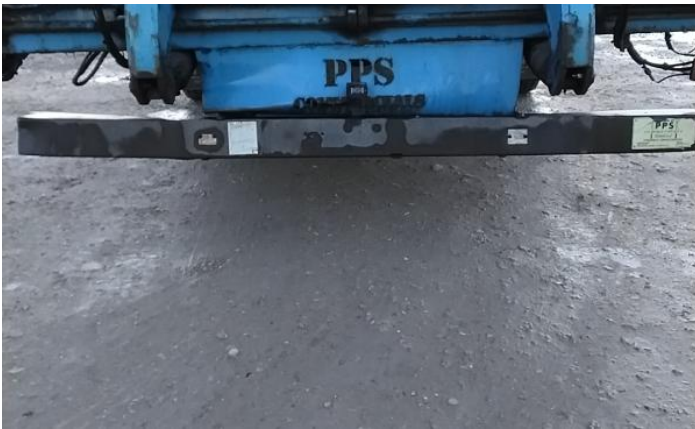
11: Bumper Rear  
Dented  
Over 30mm

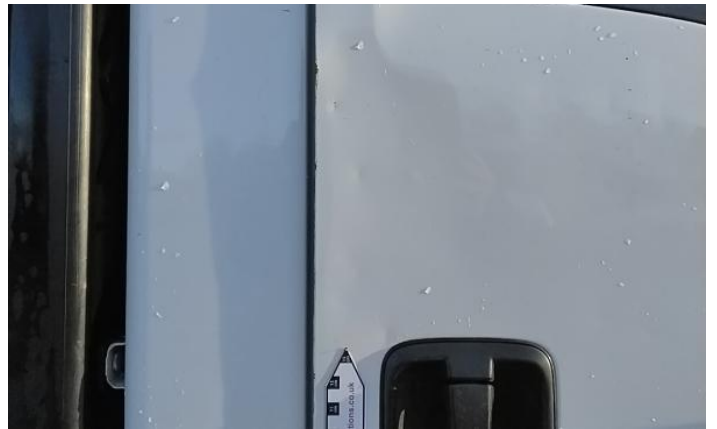
12: Door osf  
Dented  
Between 10mm + 30mm

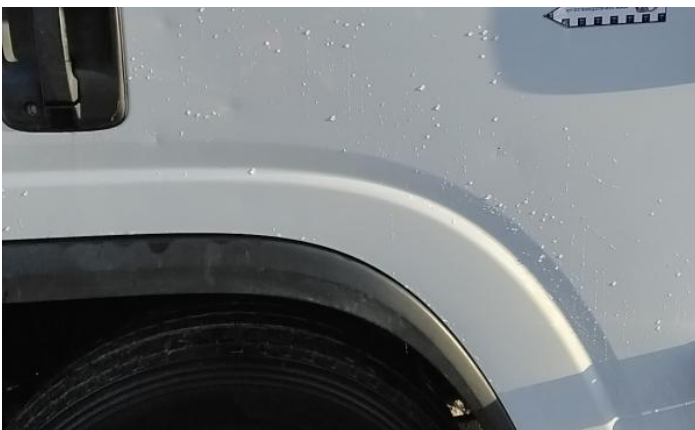
13: Door osf  
Dented  
Over 30mm

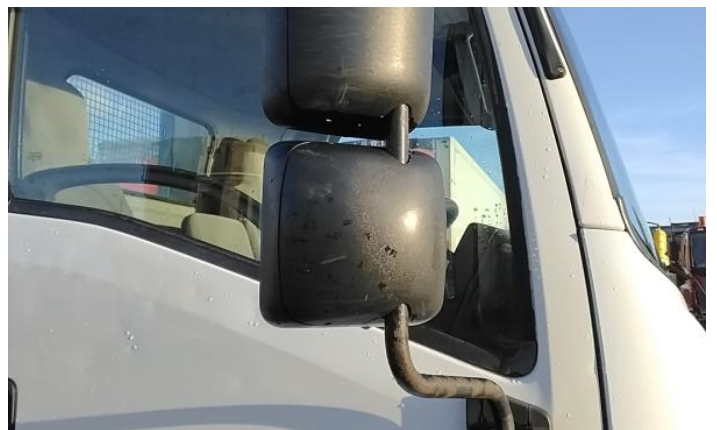
14: Door Mirror Assy osf  
Scuffed (Unpainted)  
Over 100mm

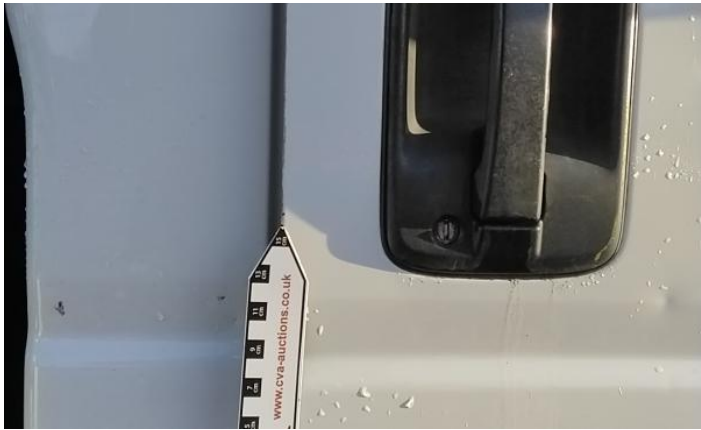
15: Door osf  
Chipped  
Edge Chip

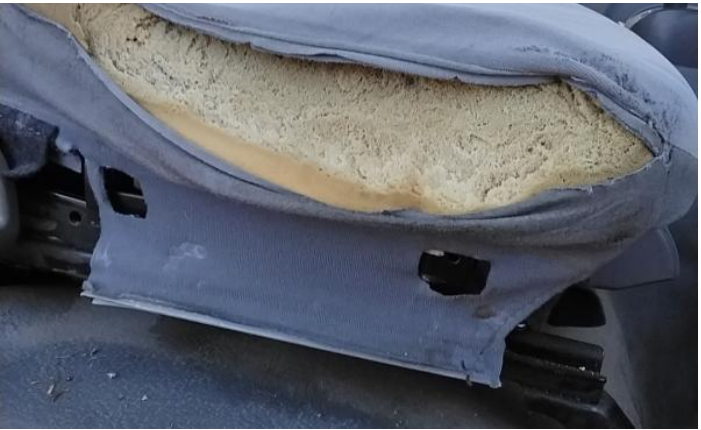
16: Seat Base Cover osf  
Holed  
Over 3mm
