VEHICLE INSPECTION REPORT

LS68XWL

Isuzu N 75.190

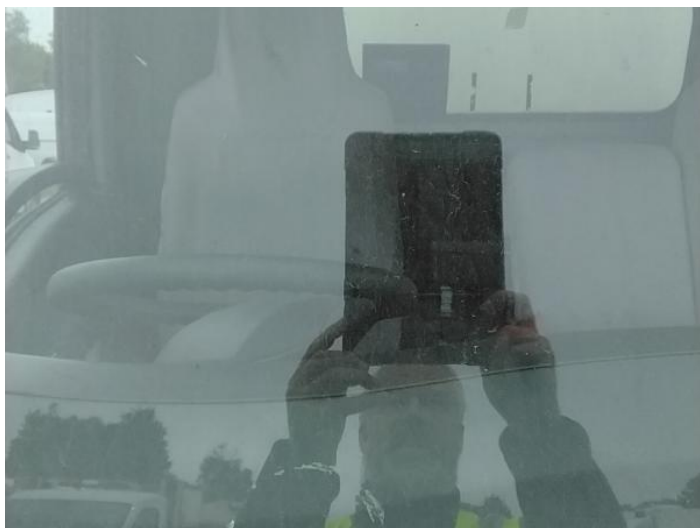
1: Screen Front
Chipped
UpTo 10mm

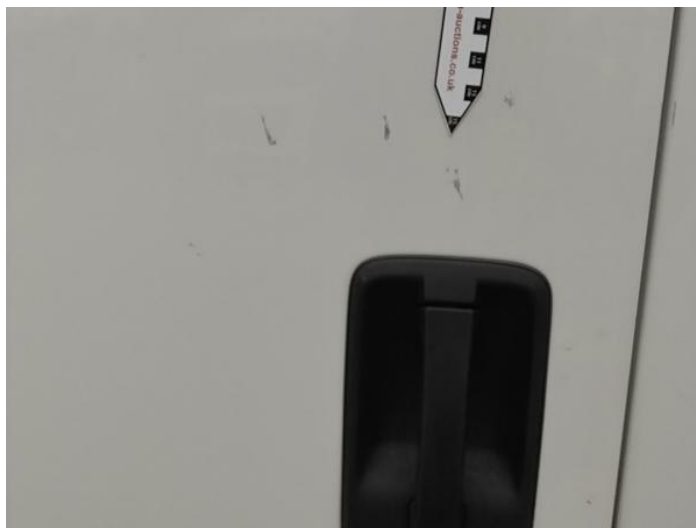
2: Door nsf
Scratched
Over 25mm Thru Paint

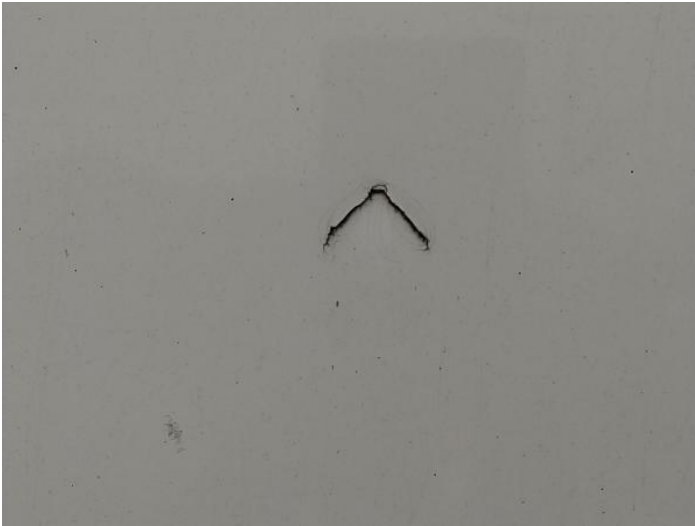
3: Door nsr
Hole
Over 10mm

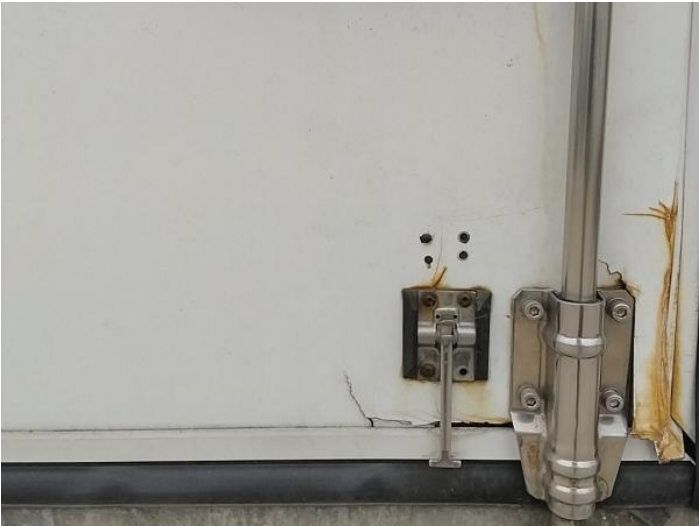
4: Door nsr
Hole
Over 10mm

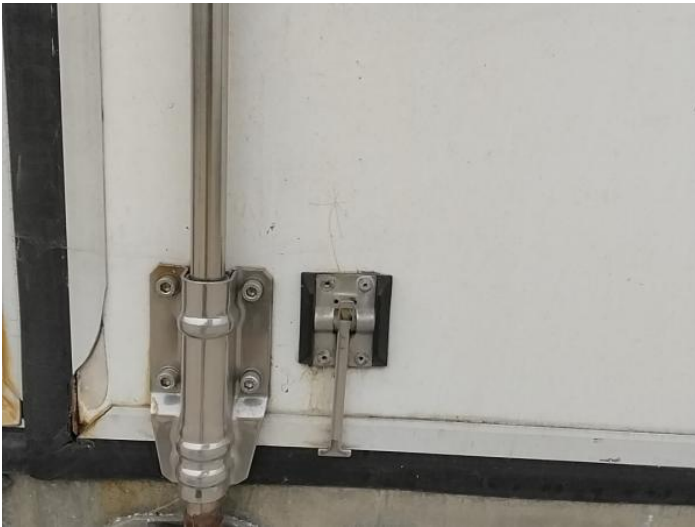
5: Door osr
Rusted
Over 5mm

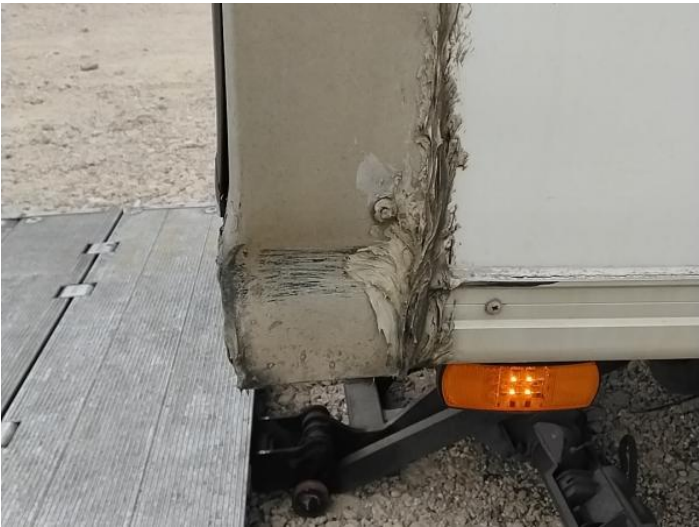
6: Qtr Panel osr
Dented
Over 30mm

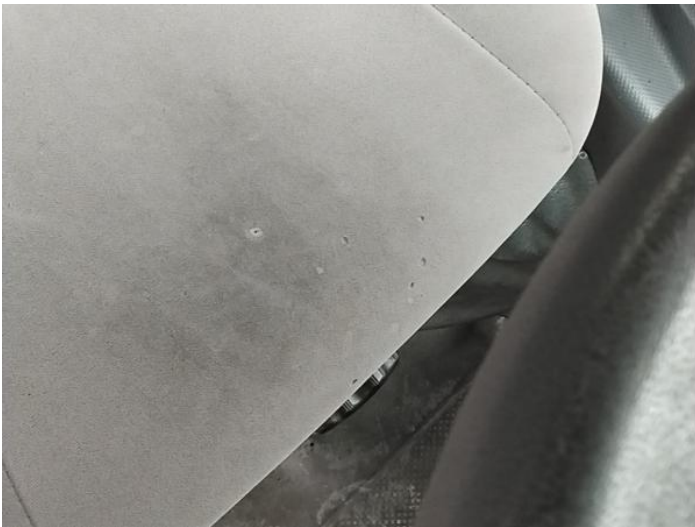
7: Seat Base Cover osf
Holed
Over 3mm
