## VEHICLE INSPECTION REPORT

**GK21RYD**

### Volkswagen Crafter CR35 2.0 TDI 140PS

**Non Runner**

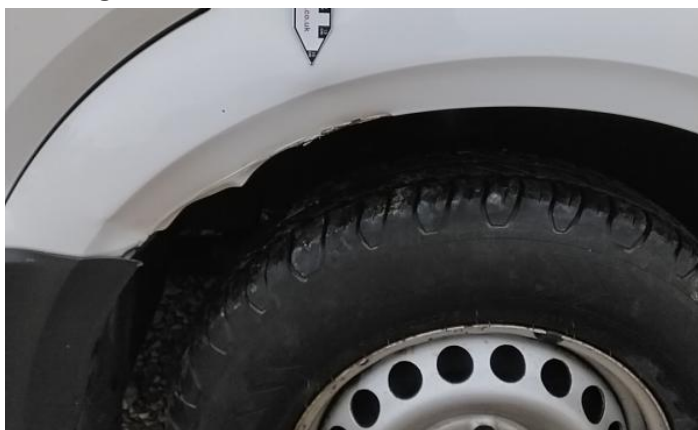
1: Wing of  
Dented  
With Paint Damage

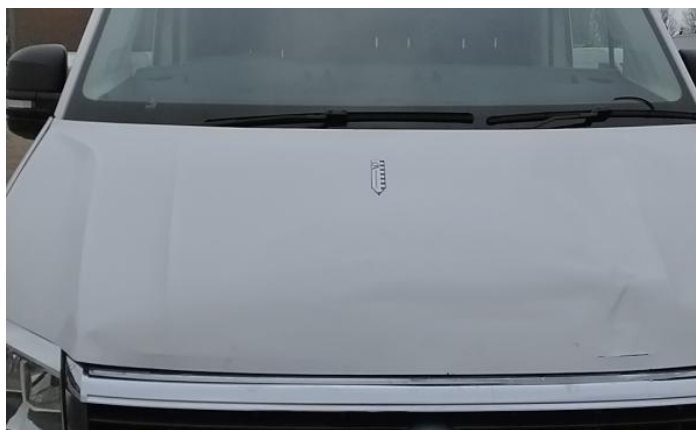
2: Bonnet  
Dented  
Over 30% Of Panel

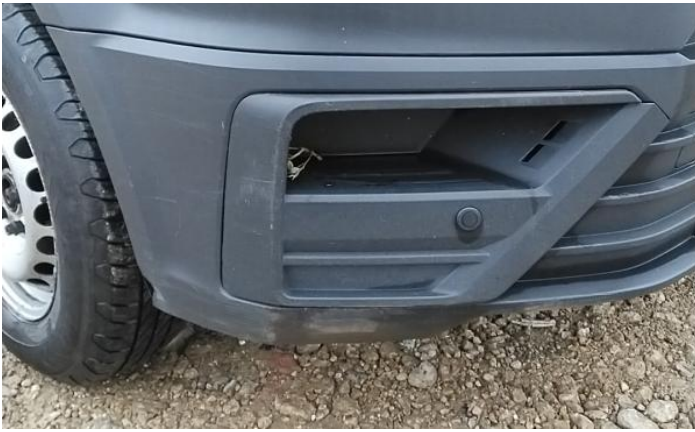
3: Bumper Front Moulding  
Scuffed (Unpainted)  
Over 100mm

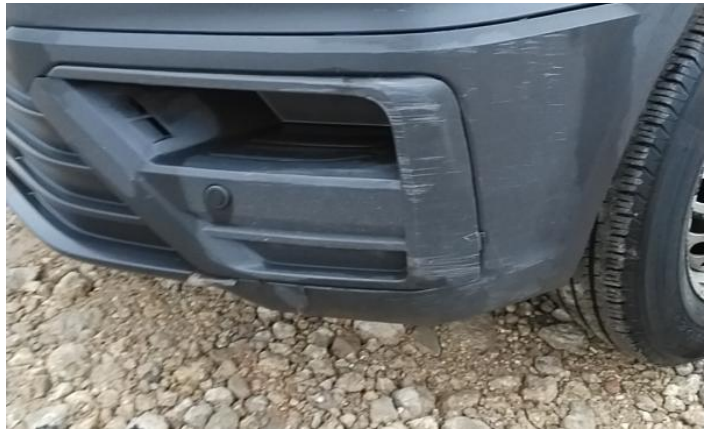
4: Bumper Front Moulding  
Scuffed (Unpainted)  
Over 100mm

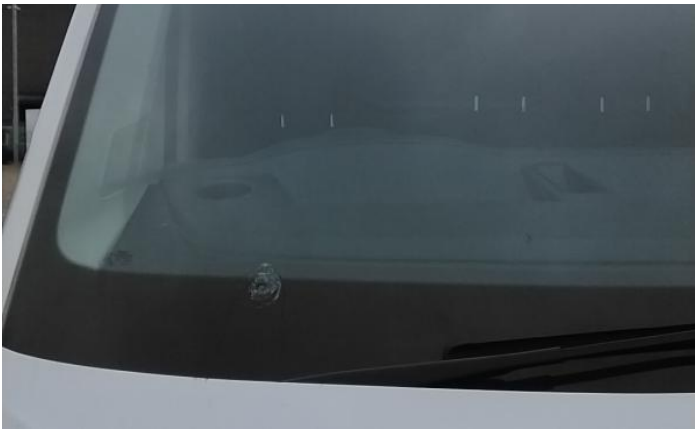
5: Screen Front  
Chipped  
Over 10mm

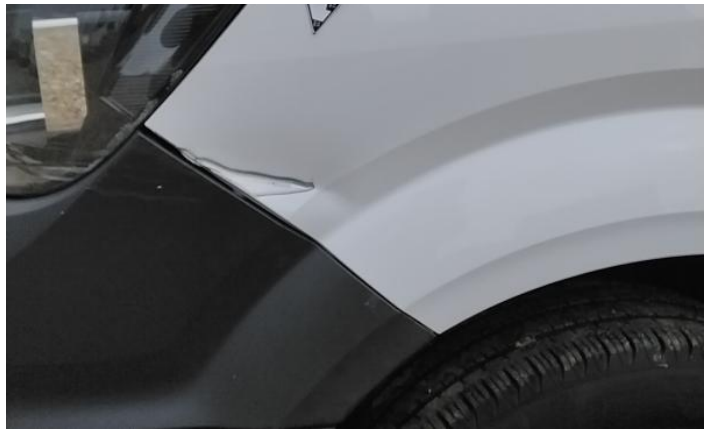
6: Wing nsf  
Dented  
With Paint Damage

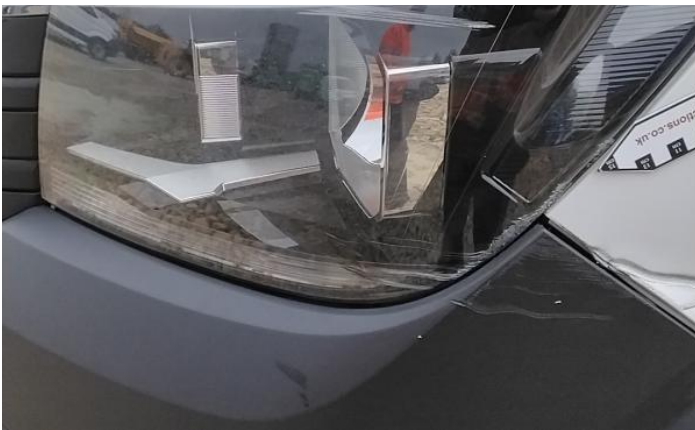
7: Headlamp ns  
Broken  
Replace

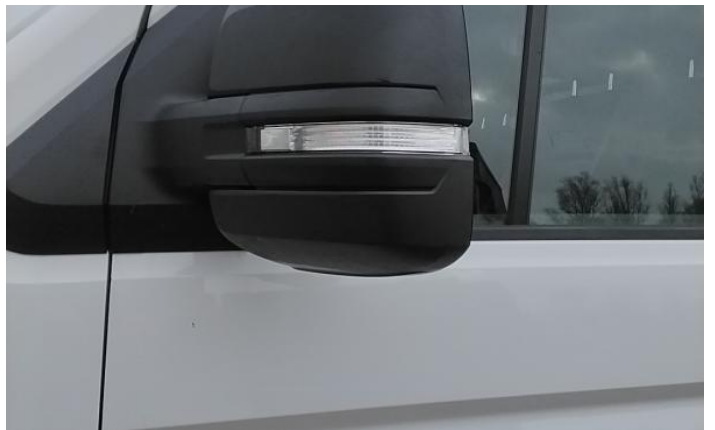
8: Door Mirror Assy nsf  
Scuffed (Unpainted)  
Over 100mm

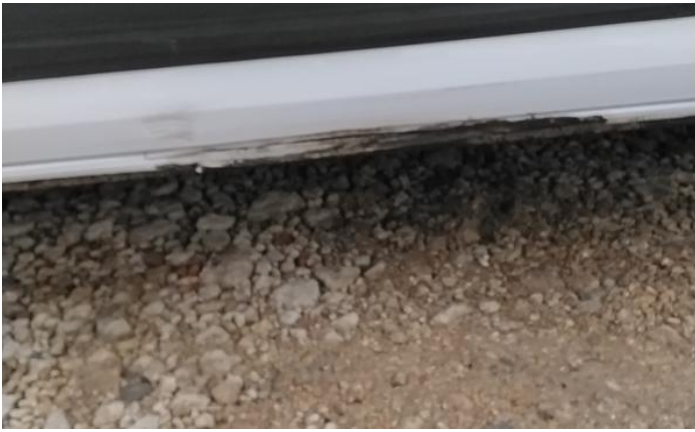
9: Sill ns  
Dented  
With Paint Damage

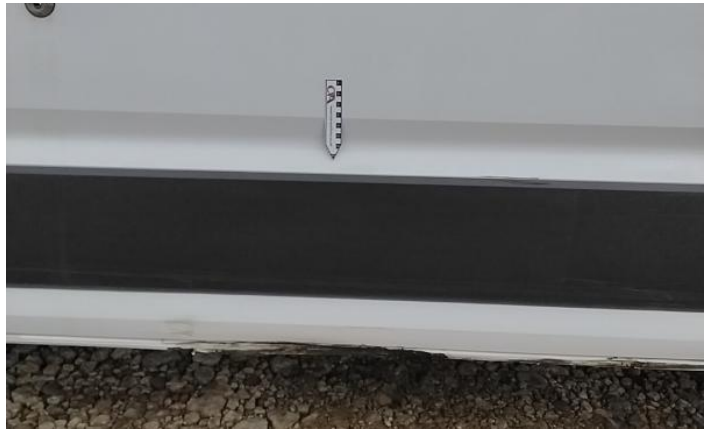
10: Door Moulding nsr  
Scuffed (Unpainted)  
Over 100mm

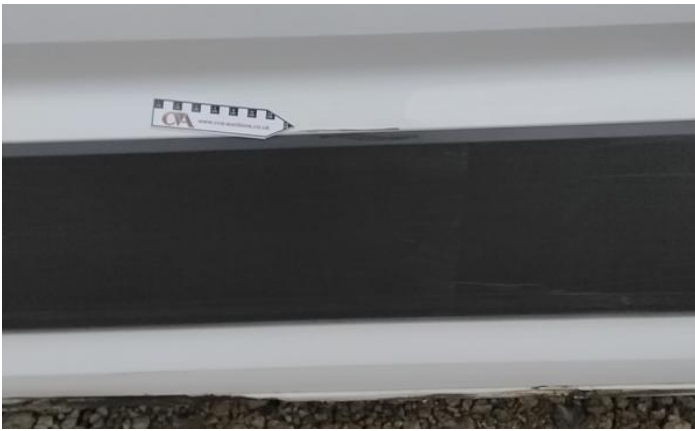
11: Door nsr  
Scratched  
Over 25mm Thru Paint

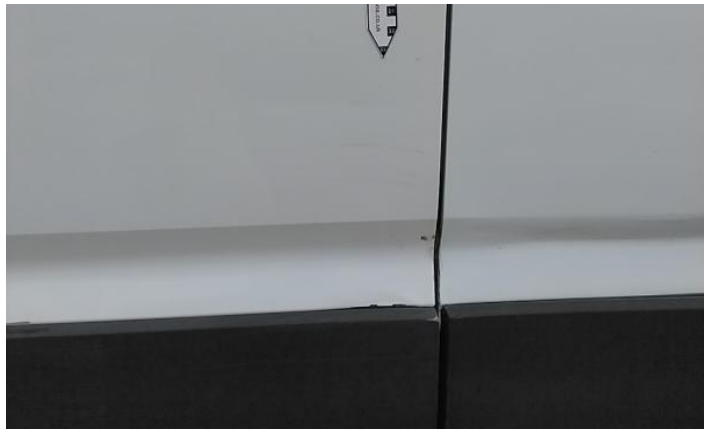
12: Door nsr  
Dented  
With Paint Damage

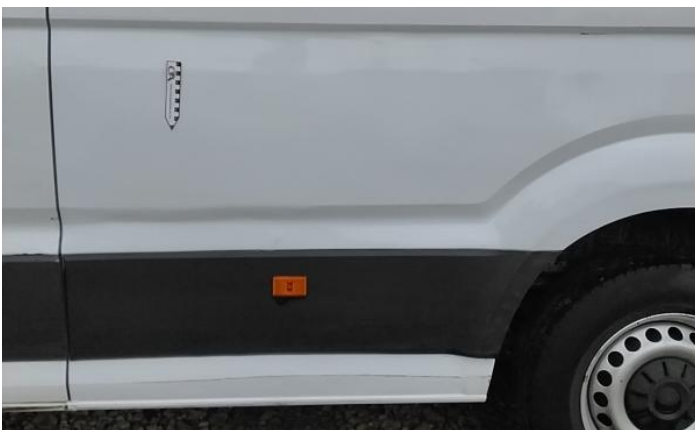
13: Qtr Panel nsr  
Dented  
Between 10mm + 30mm

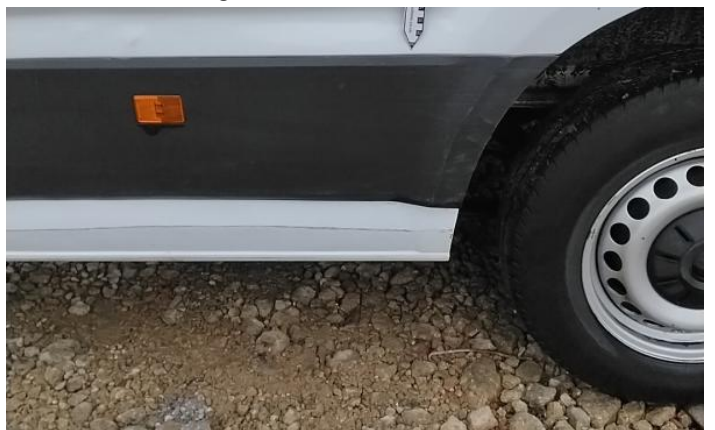
14: Qtr Panel Moulding ns  
Scuffed (Unpainted)  
Over 100mm

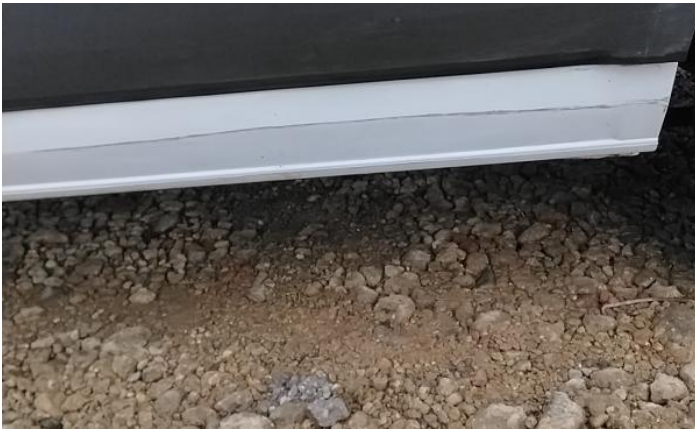
15: Qtr Panel nsr  
Dented  
With Paint Damage

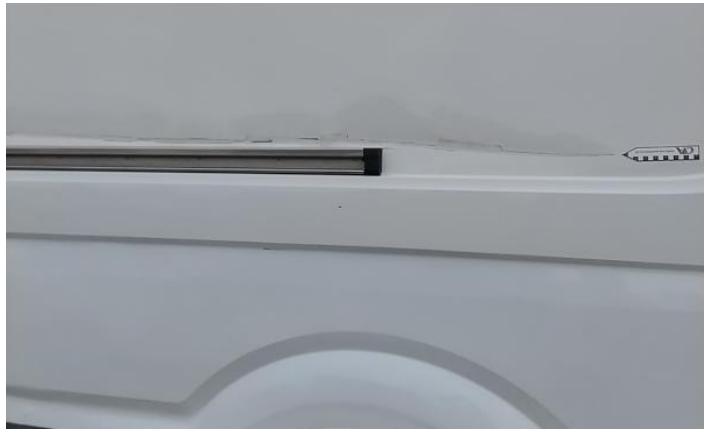
16: Qtr Panel nsr  
Dented  
With Paint Damage

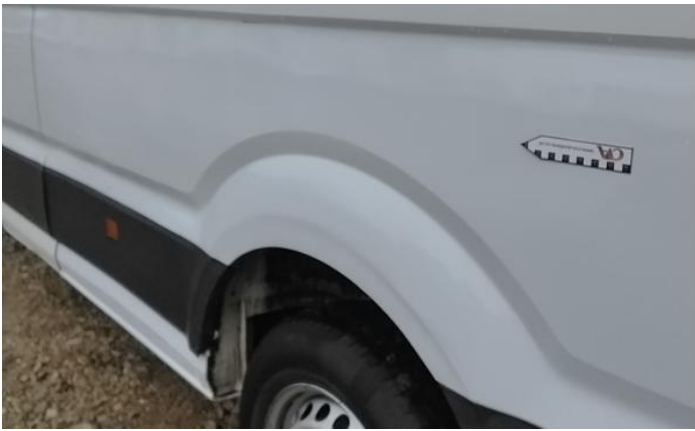
17: Qtr Panel nsr  
Dented  
Over 30mm

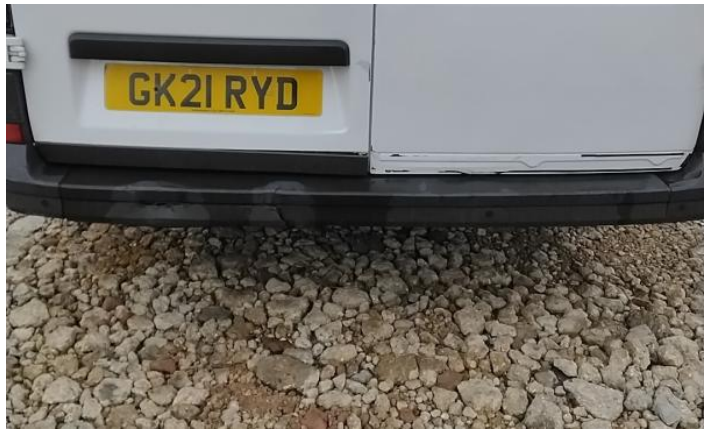
18: Bumper Rear  
Hole  
Over 25mm

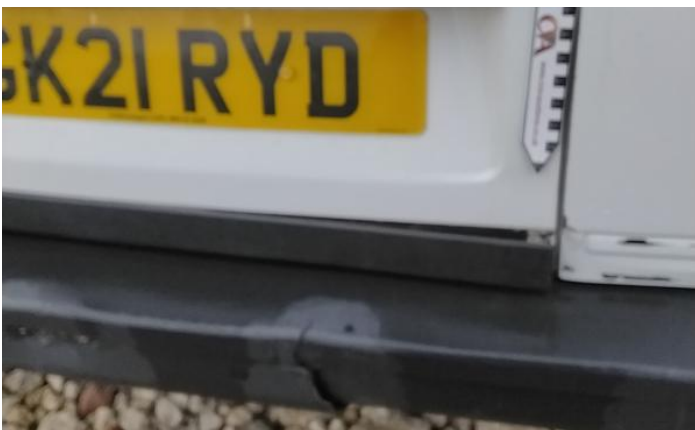
19: Door Moulding nsr  
Broken  
Replace

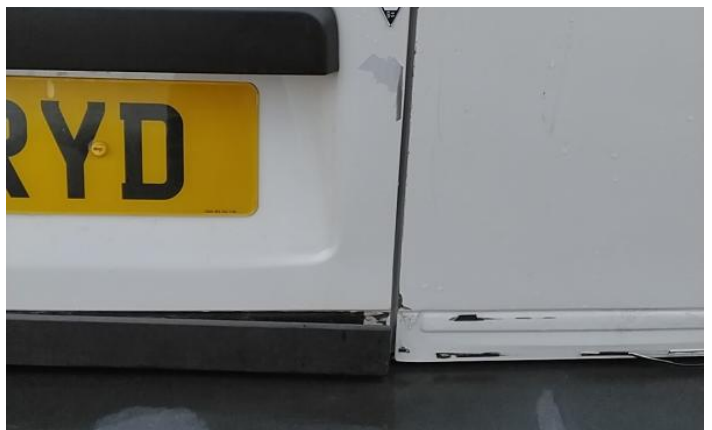
20: Door nsr  
Scratched  
Over 25mm Thru Paint

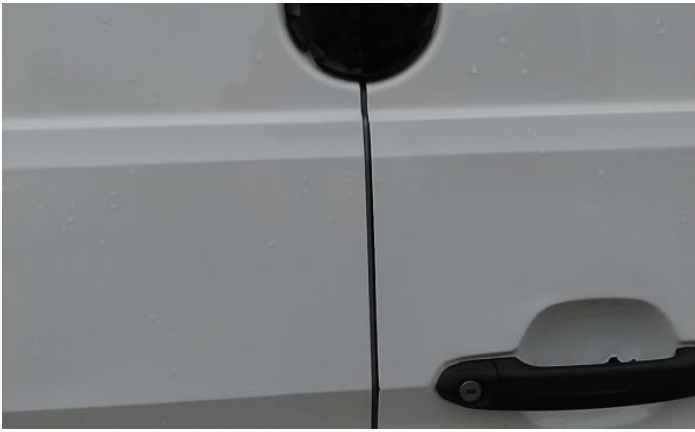
21: Badgedecal Rear  
Missing  
Replace

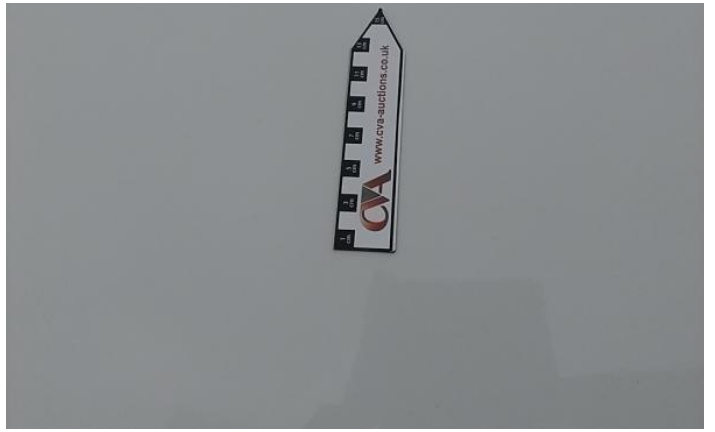
22: Door nsr  
Dented  
With Paint Damage

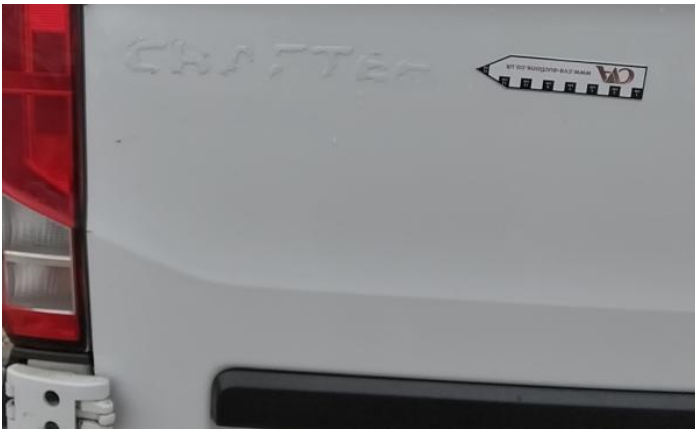
23: Badgedecal Rear  
Missing  
Replace

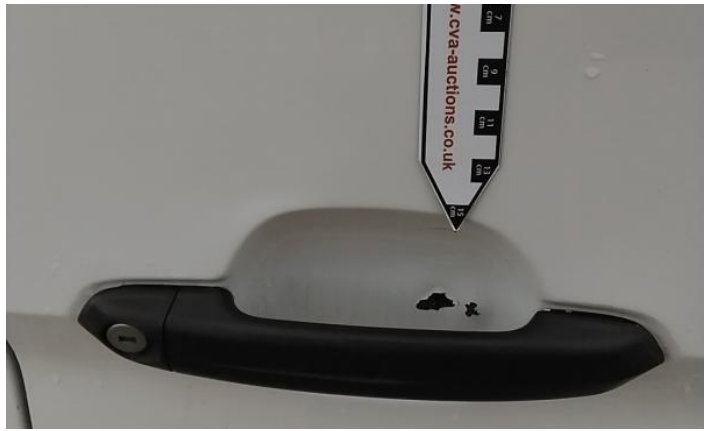
24: Door osr  
Hole  
Over 10mm

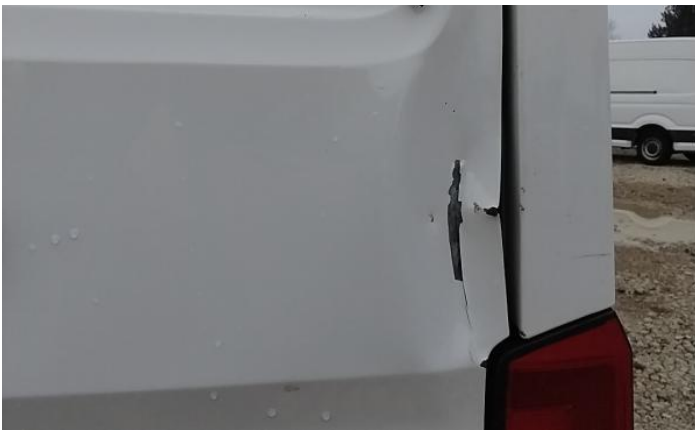
25: Door osr  
Dented  
With Paint Damage

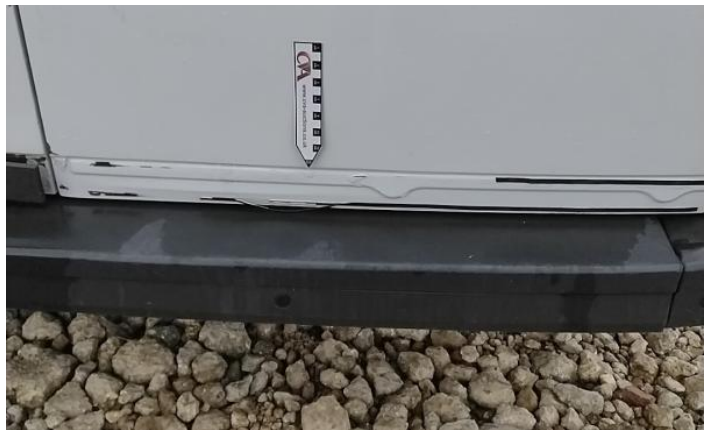
26: Door Moulding osr  
Missing  
Replace

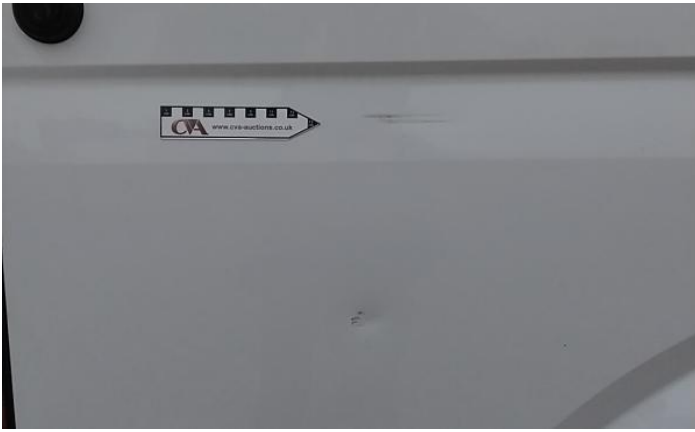
27: Qtr Panel osr  
Scratched  
Over 25mm Not Thru Paint

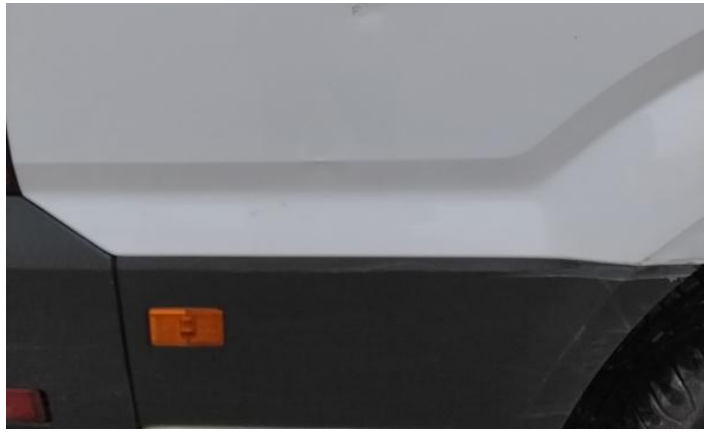
28: Qtr Panel osr  
Dented  
With Paint Damage

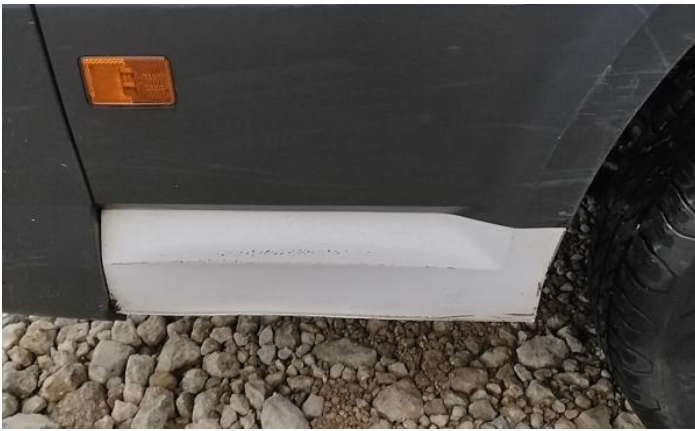
29: Qtr Panel Moulding os  
Scuffed (Unpainted)  
Over 100mm

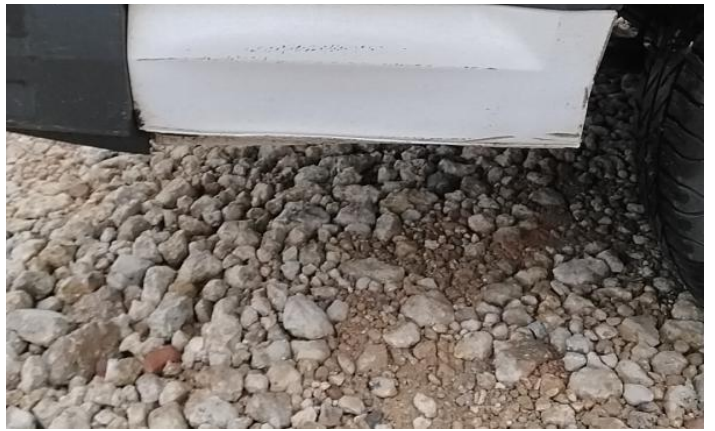
30: Qtr Panel osr  
Dented  
With Paint Damage

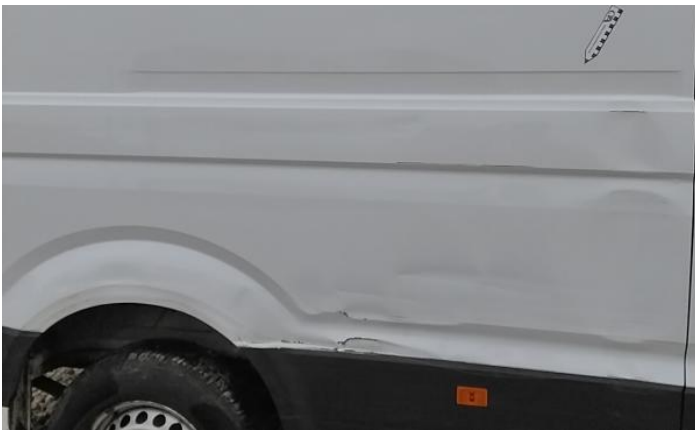
31: Qtr Panel osr  
Dented  
With Paint Damage

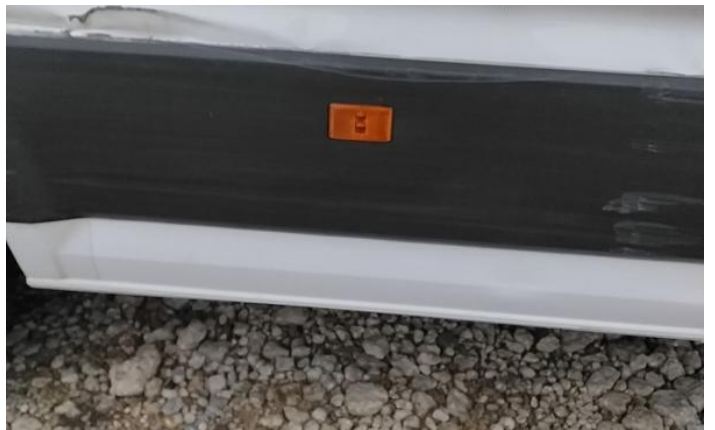
32: Qtr Panel Moulding os  
Scuffed (Unpainted)  
Over 100mm

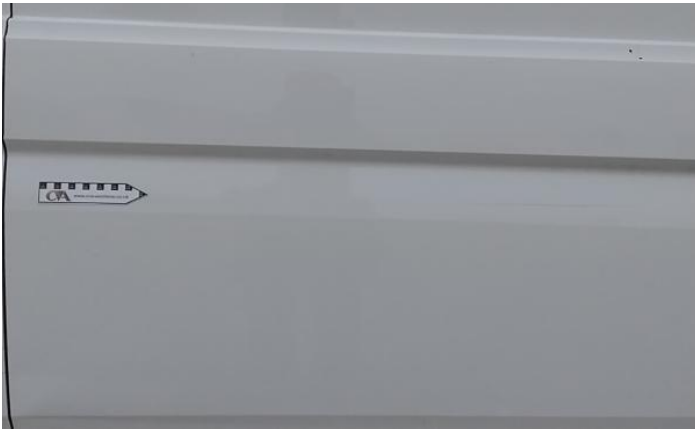
33: Qtr Panel osr  
Scratched  
Over 25mm Not Thru Paint

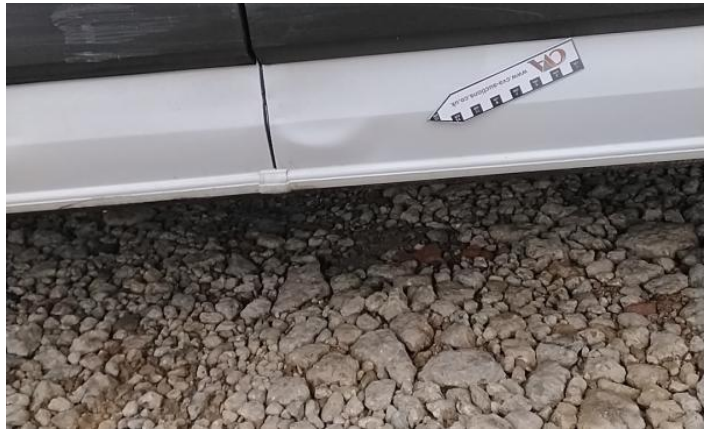
34: Qtr Panel osr  
Dented  
Between 10mm + 30mm

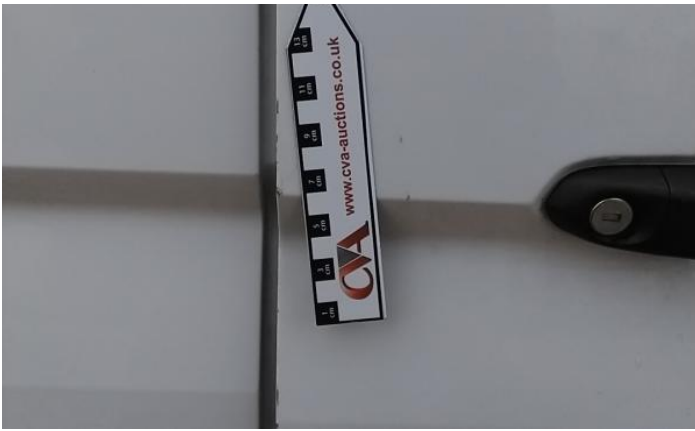
35: Door osf  
Dented  
Between 10mm + 30mm

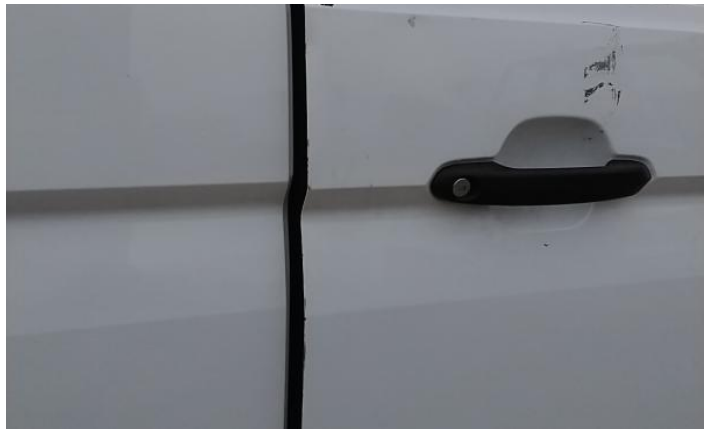
36: Door osf  
Chipped  
Edge Chip

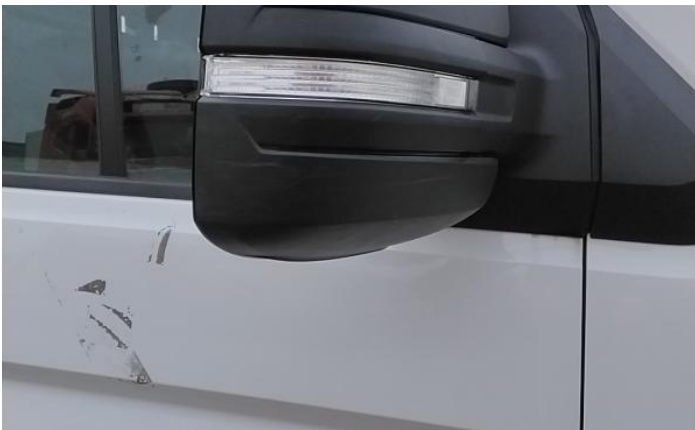
37: Door Mirror Assy osf  
Scuffed (Unpainted)  
Over 100mm

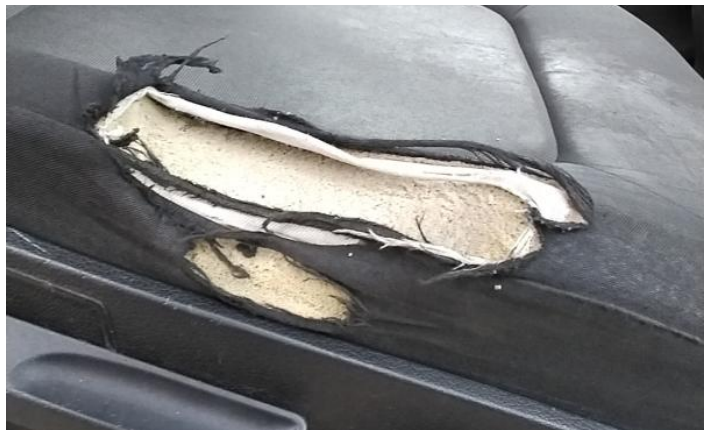
38: Seat Base Cover osf  
Holed  
Over 3mm
