## VEHICLE INSPECTION REPORT

**GL21YJE**

### Volkswagen Crafter CR35 2.0 TDI 140PS

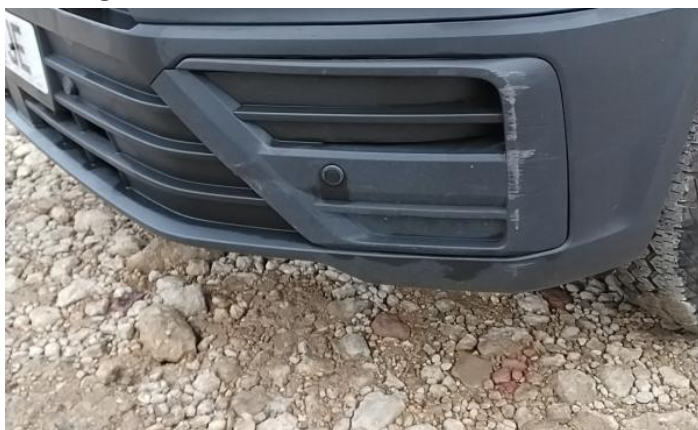
1: Bumper Front Moulding  
Scuffed (Unpainted)  
Over 100mm

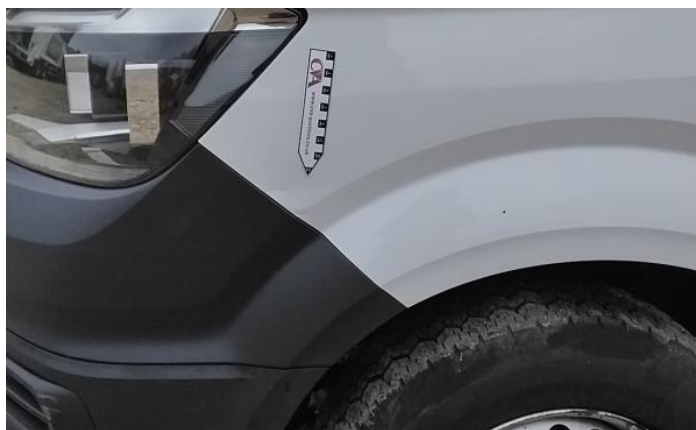
2: Wing nsf  
Dented  
With Paint Damage

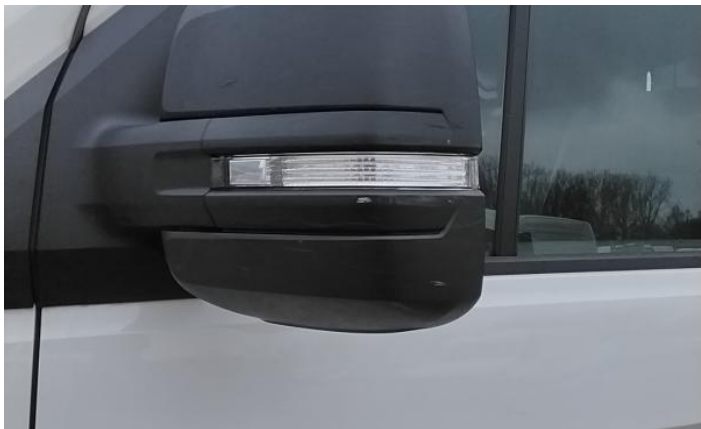
3: Door Mirror Assy nsf  
Scuffed (Unpainted)  
Over 100mm

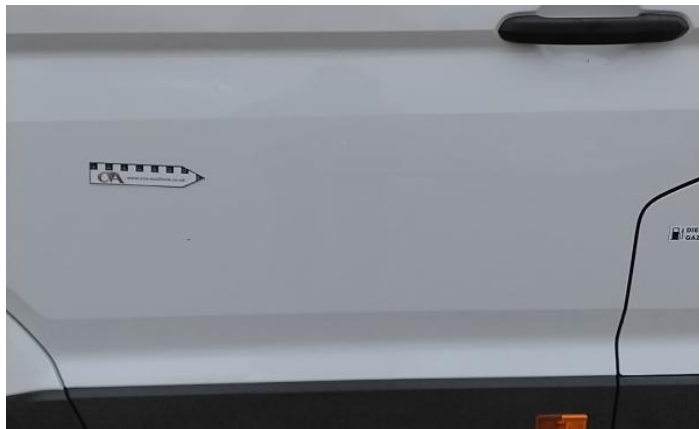
4: Door nsf  
Scratched  
Over 25mm Not Thru Paint

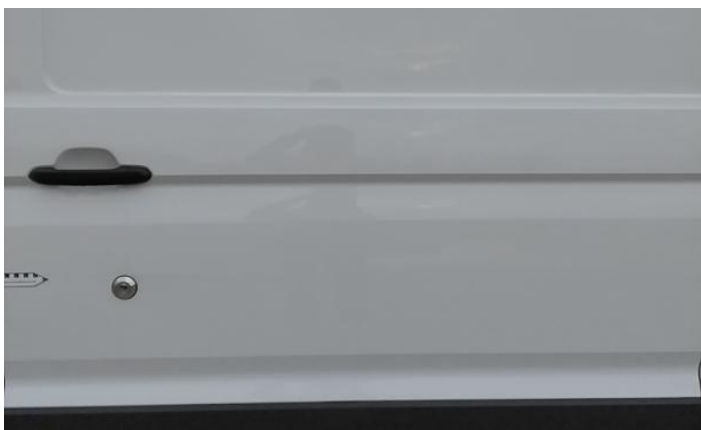
5: Door nsr  
Scratched  
Over 25mm Not Thru Paint

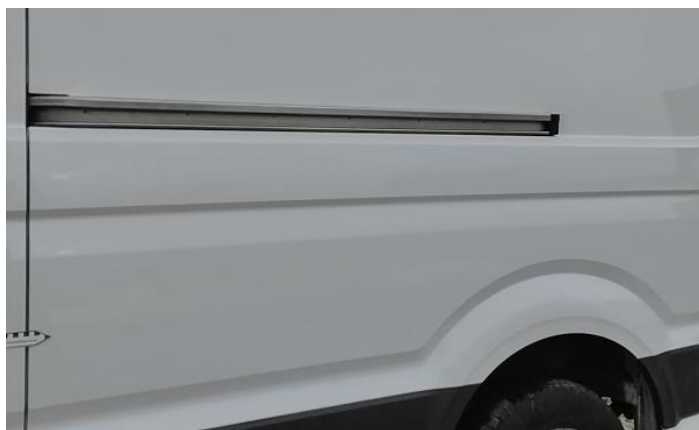
6: Qtr Panel nsr  
Scratched  
Over 25mm Not Thru Paint

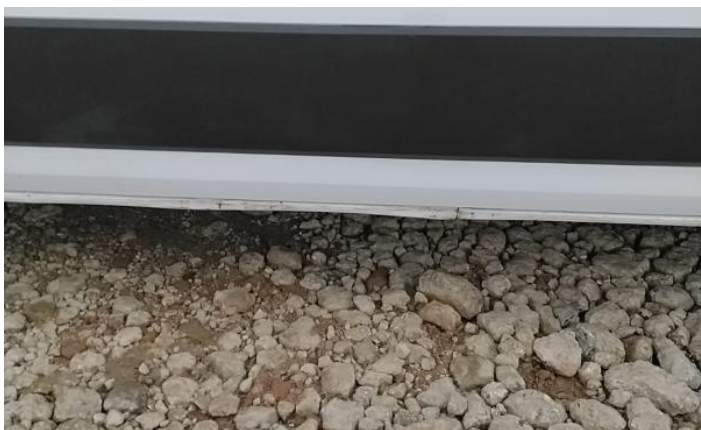
7: Sill ns  
Dented  
Over 30mm

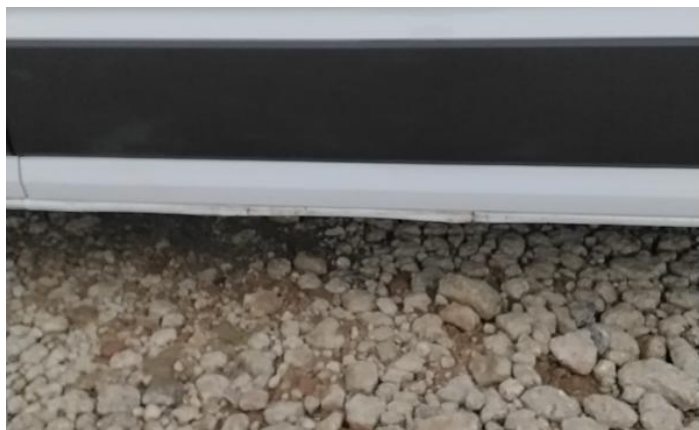
8: Door Moulding nsr  
Scuffed (Unpainted)  
Over 100mm

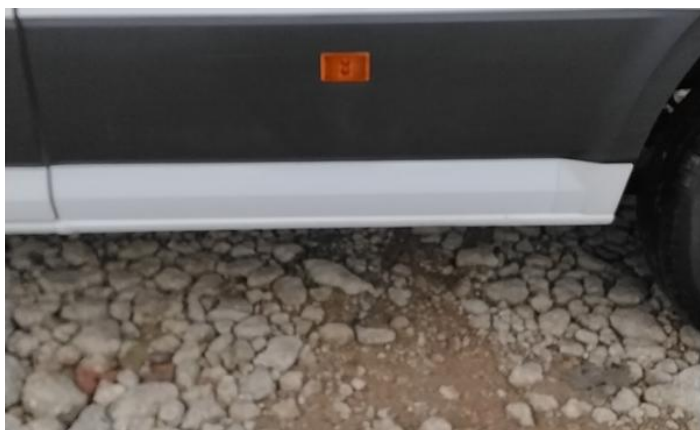
9: Qtr Panel Moulding ns  
Scuffed (Unpainted)  
Over 100mm

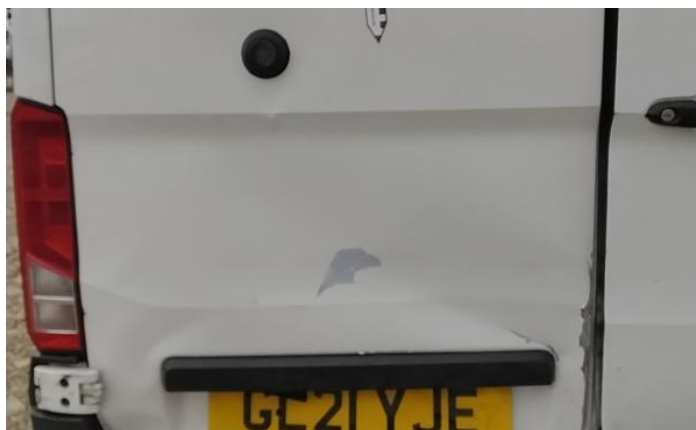
10: Door nsr  
Dented  
Over 30% Of Panel

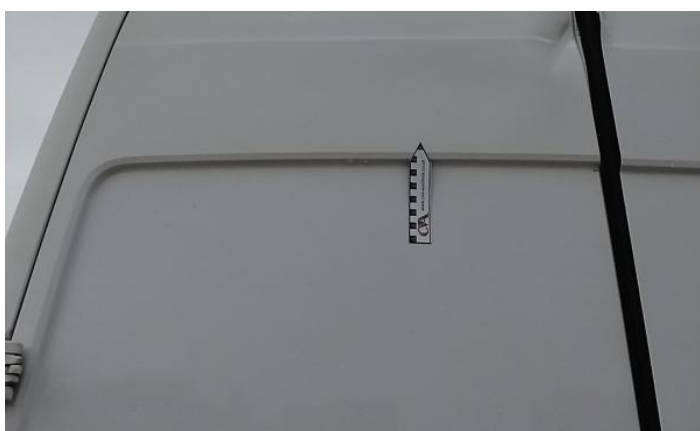
11: Door nsr  
Dented  
Over 30mm

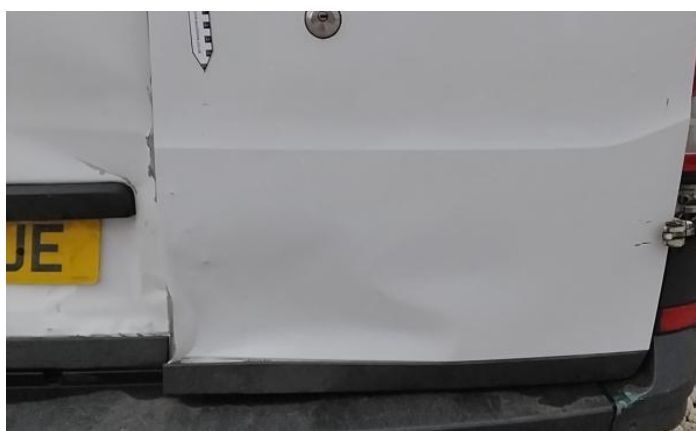
12: Door osr  
Dented  
Over 30% Of Panel

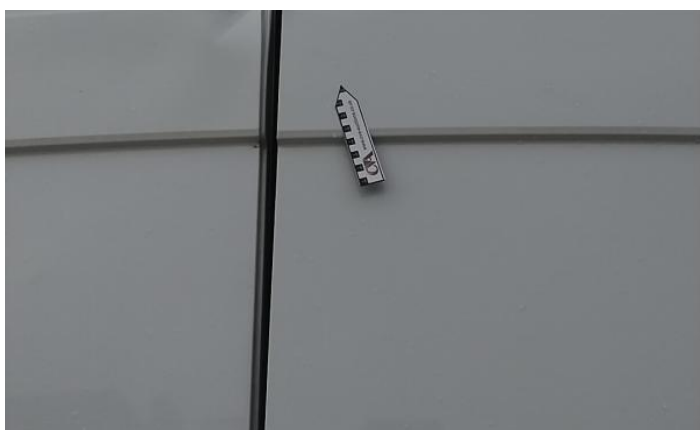
13: Door osr  
Dented  
Over 30mm

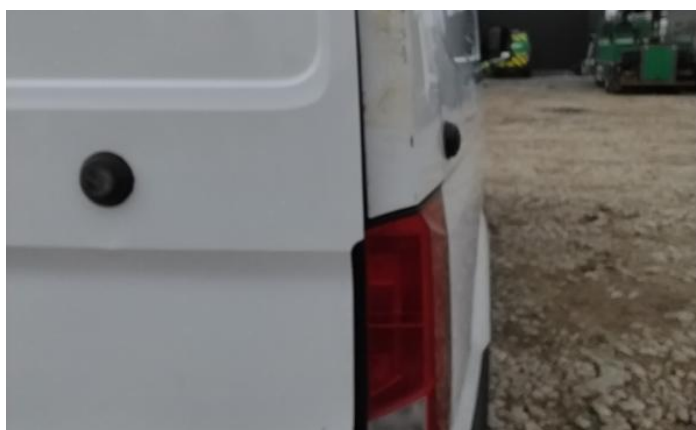
14: Door osr  
Rusted  
Holed

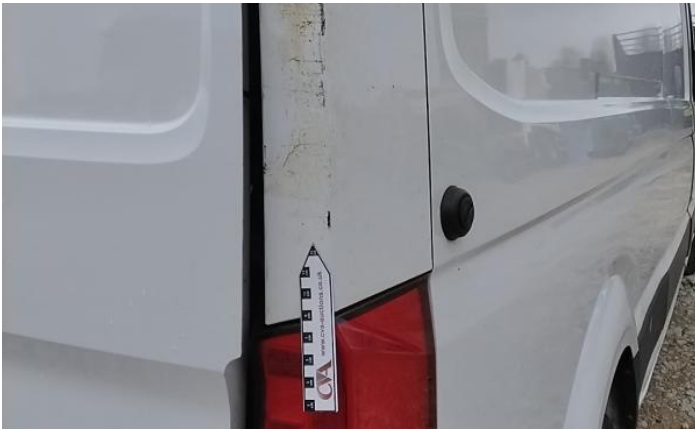
15: Qtr Panel osr  
Dented  
With Paint Damage

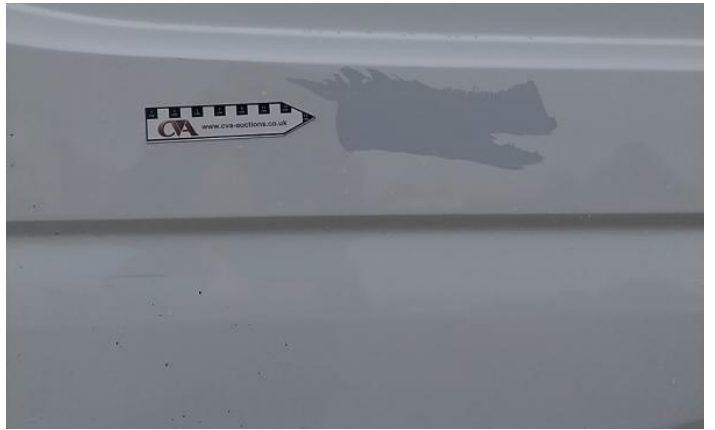
16: Qtr Panel osr  
Scratched  
Over 25mm Thru Paint

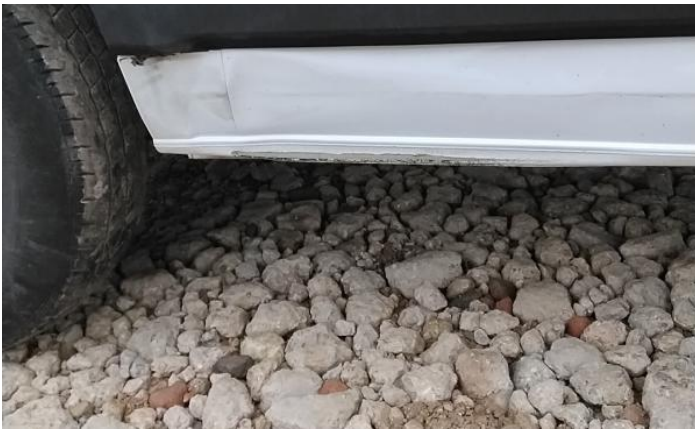
17: Sill os  
Dented  
With Paint Damage

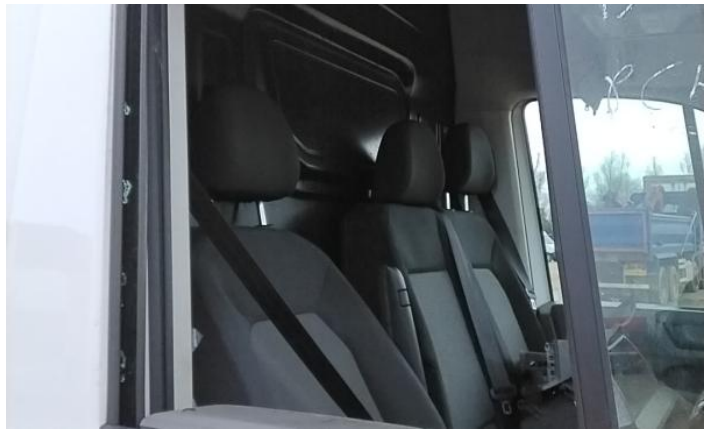
18: Door Window osf  
Missing  
Replace

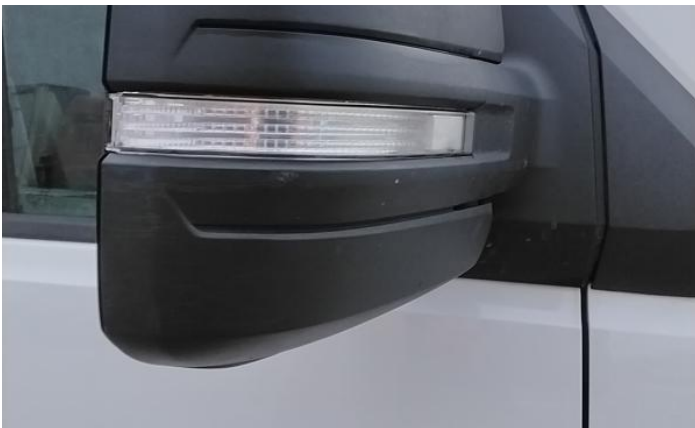
19: Door Mirror Assy osf  
Scuffed (Unpainted)  
Over 100mm

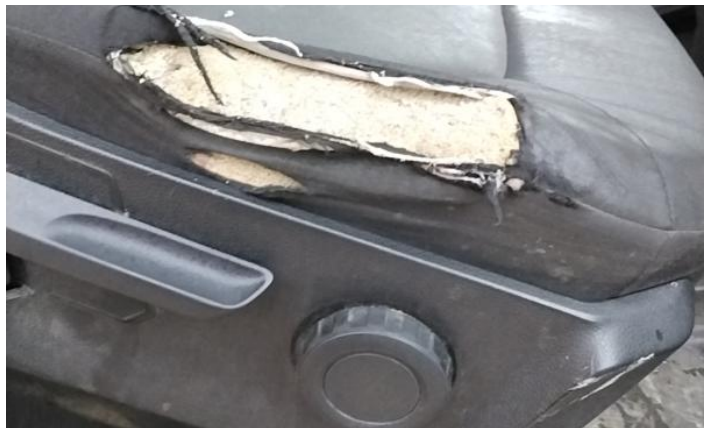
20: Seat Base Cover osf  
Holed  
Over 3mm

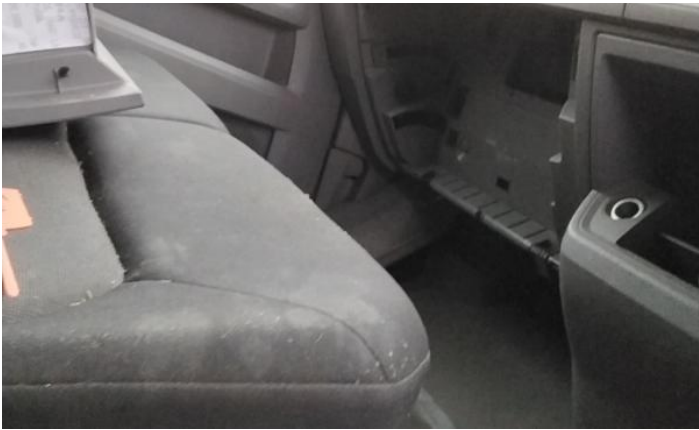
21: Glove Box Lid  
Broken  
Replace

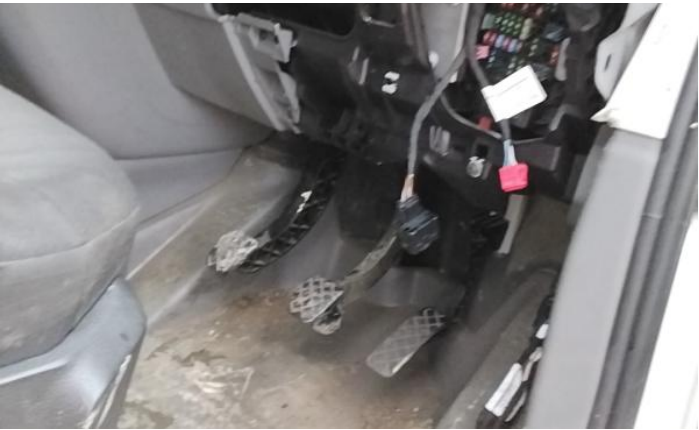
22: Fascia Panel  
Missing  
Replace

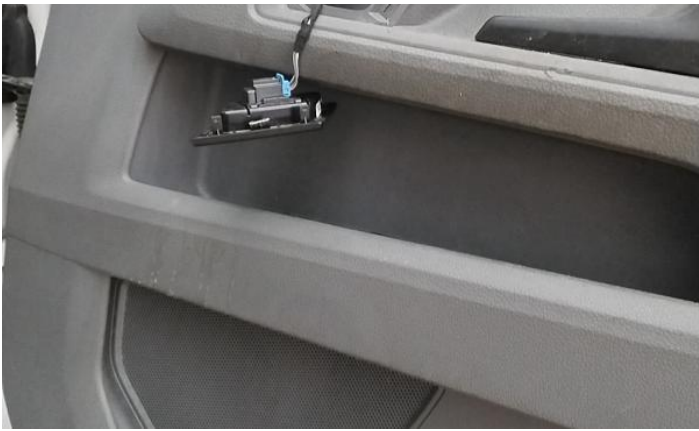
23: Switches And Controls  
Broken  
Replace
