# VEHICLE INSPECTION REPORT

**BN17EOP**

## MERCEDES-BENZ ANTOS 1824

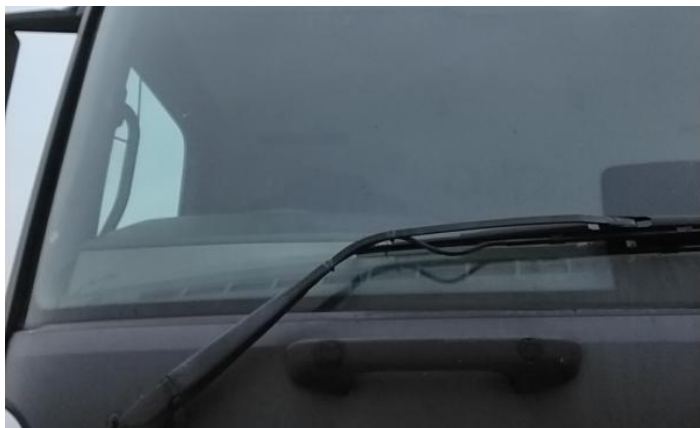
1: Screen Front  
Chipped  
Over 10mm

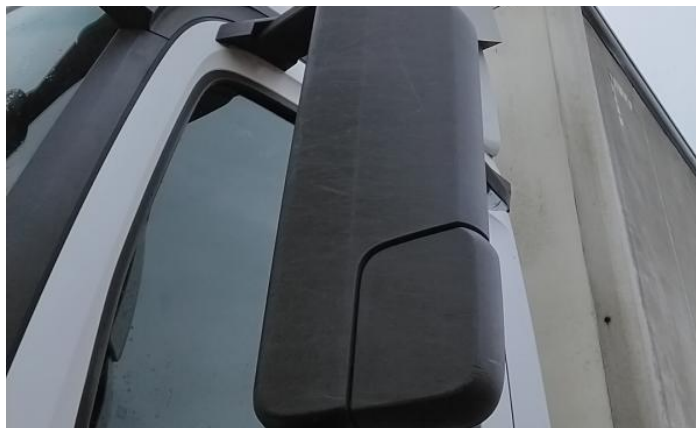
2: Door Mirror Assy nsf  
Scuffed (Unpainted)  
Over 100mm

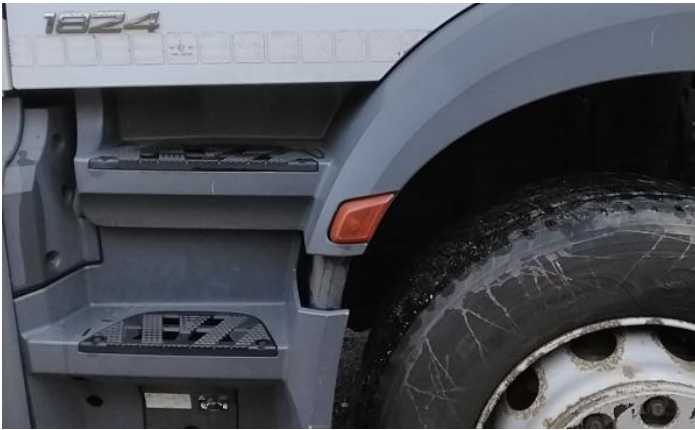
3: Wing Front Arch Extension ns  
 Scratched (Painted)  
 Over 25mm Thru Paint

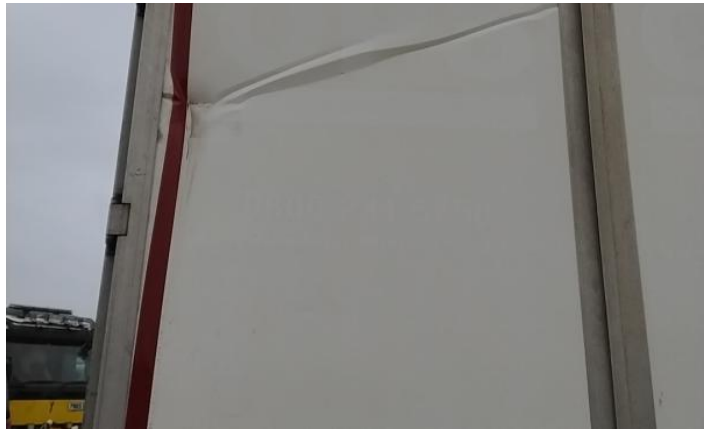
4: Door nsr  
 Dented  
 Over 30mm

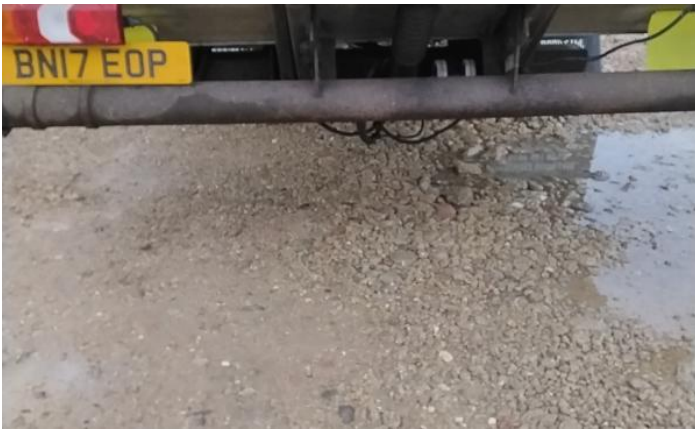
5: Bumper Rear  
 Rusted  
 Over 5mm

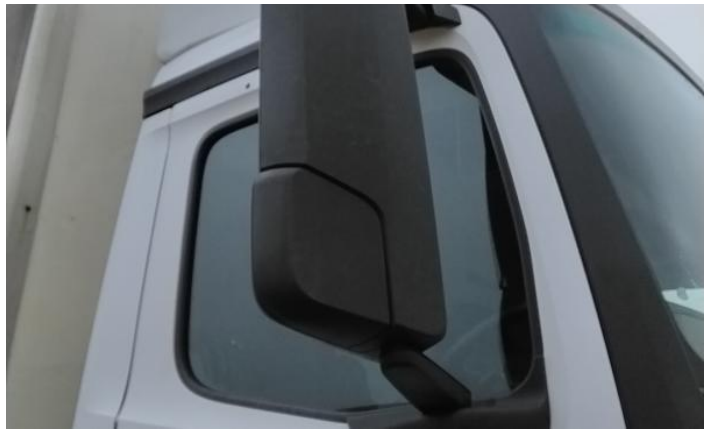
6: Door Mirror Assy osf  
 Scuffed (Unpainted)  
 Over 100mm
