# VEHICLE INSPECTION REPORT

**DK69WKC**

## Isuzu N75 190

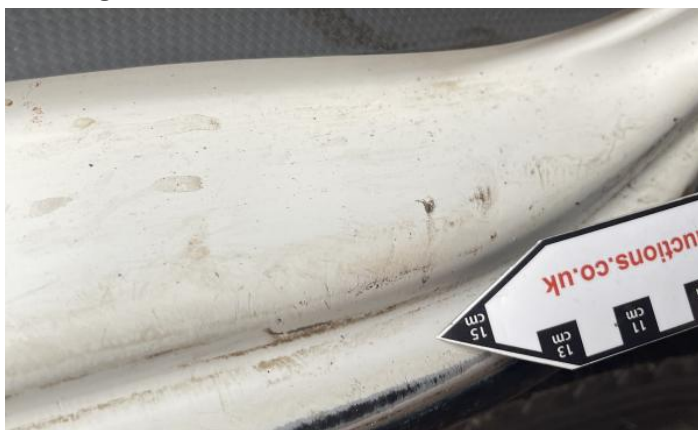
1: Sill os  
Rusted  
Over 5mm

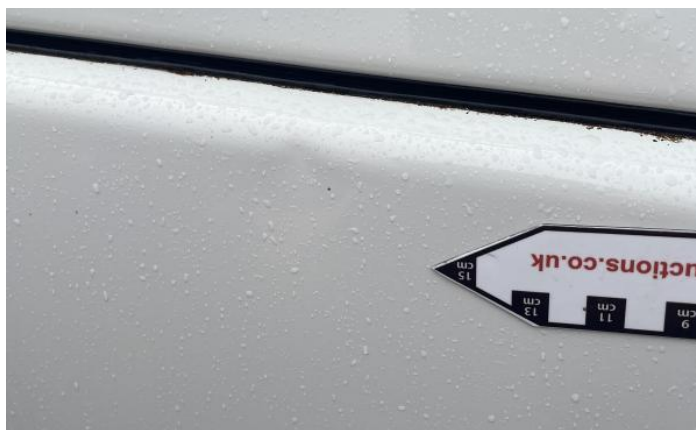
2: Bonnet  
Dented  
Over 30mm

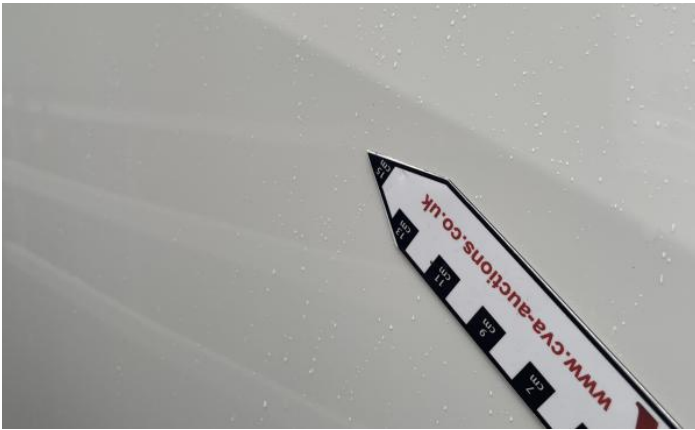
3: Door osf  
Dented  
Over 30mm

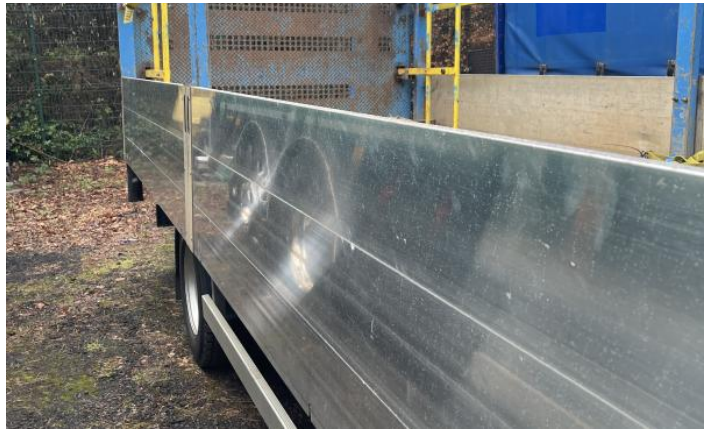
4: Qtr Panel osr  
Dented  
With Paint Damage

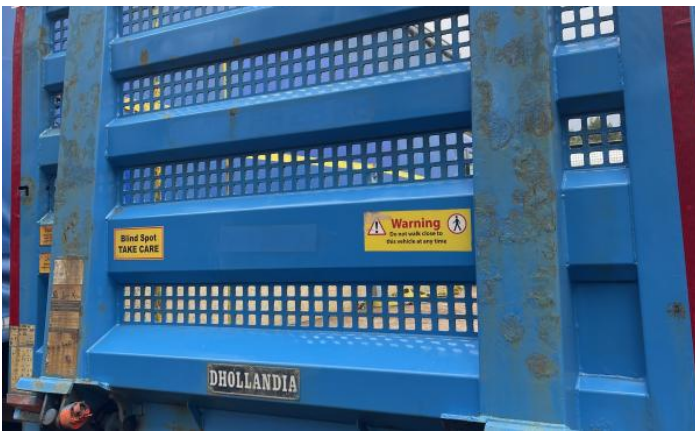
5: Tailgate  
Rusted  
Over 5mm

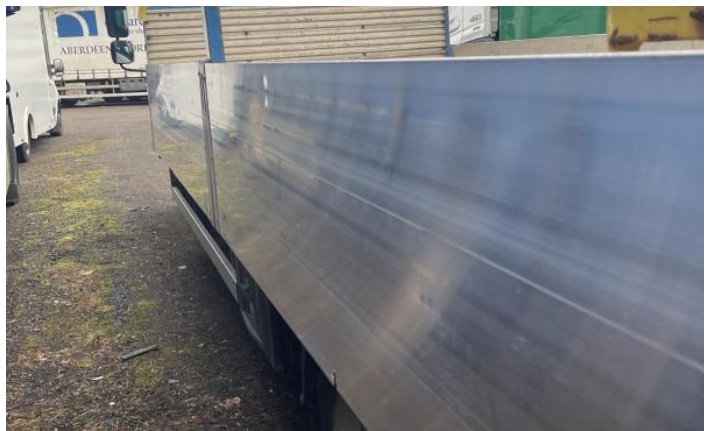
6: Qtr Panel nsr  
Dented  
Over 30mm

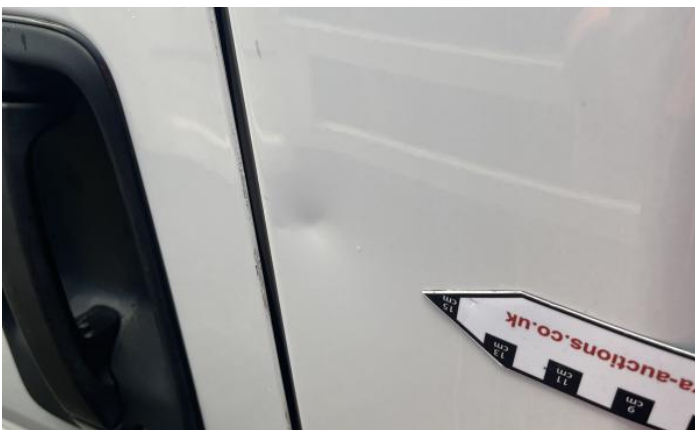
7: B Post ns  
Dented  
Over 30mm

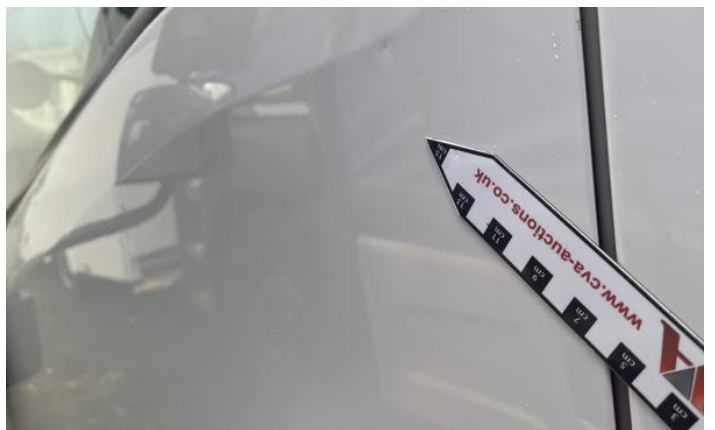
8: Door nsf  
Dented  
Over 30mm
