# VEHICLE INSPECTION REPORT

**MK72FMC**

## Maxus Deliver 9

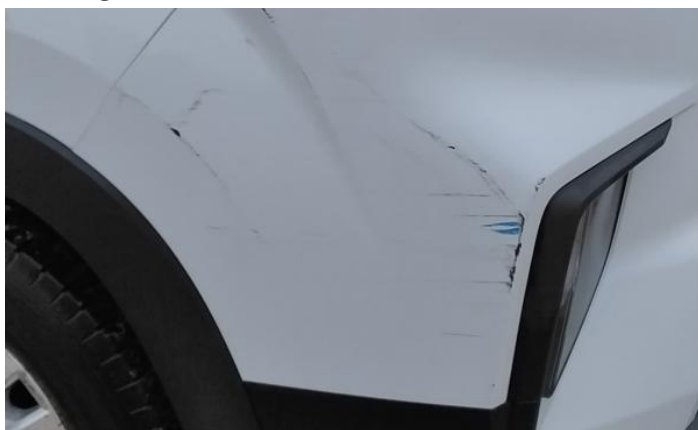
1: Bumper Front  
Scratched  
Over 100mm Thru Paint

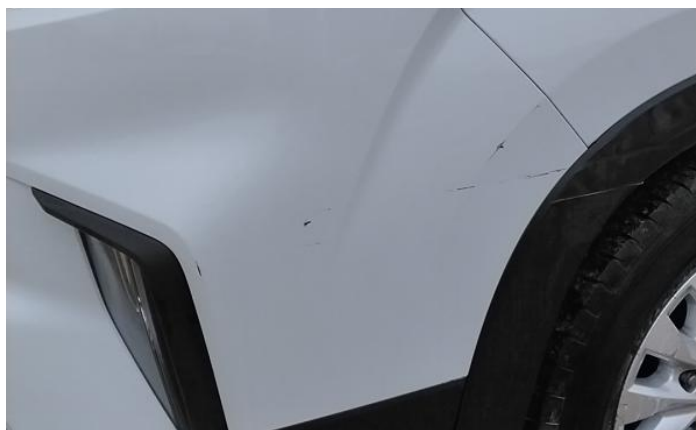
2: Bumper Front  
Scratched  
25 to 100mm Thru Paint

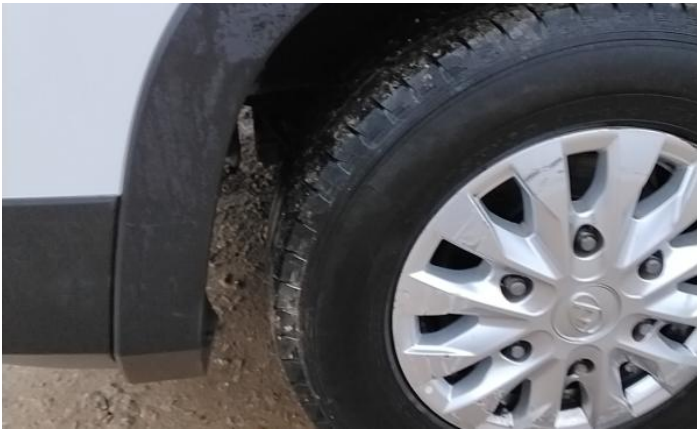
3: Wing Front Arch Extension ns  
Scuffed (Unpainted)  
Over 100mm

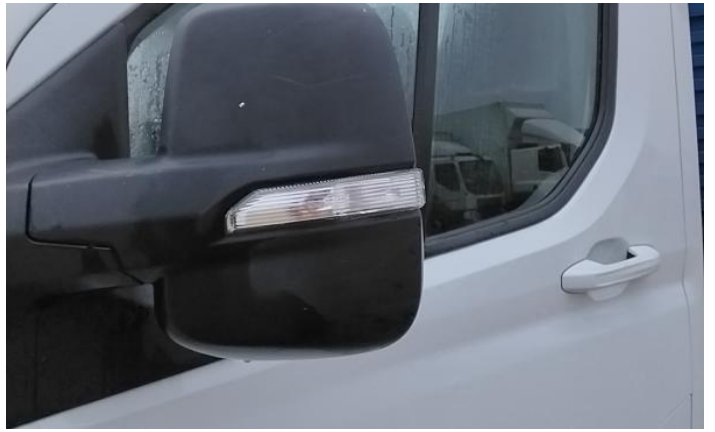
4: Door Mirror Assy nsf  
Scuffed (Unpainted)  
Over 100mm

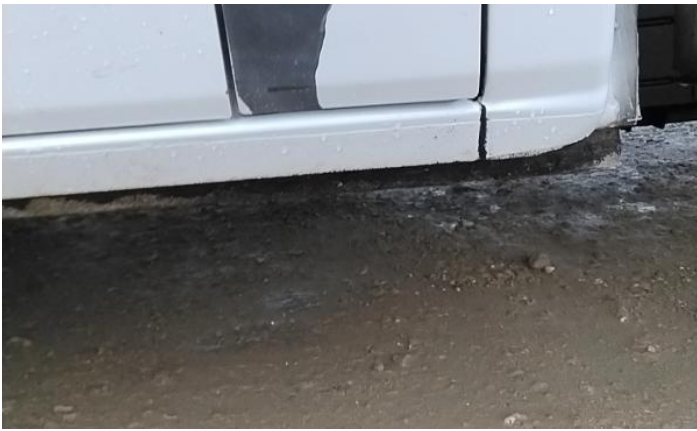
5: B Post ns  
Scratched  
Over 25mm Thru Paint

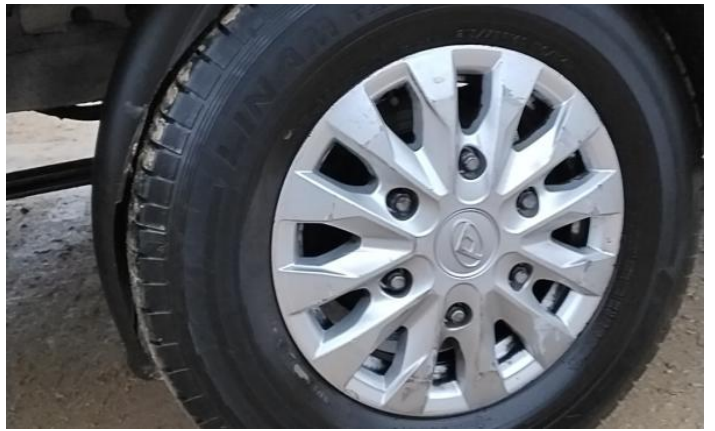
6: Qtr Panel Arch Extension ns  
Broken  
Replace

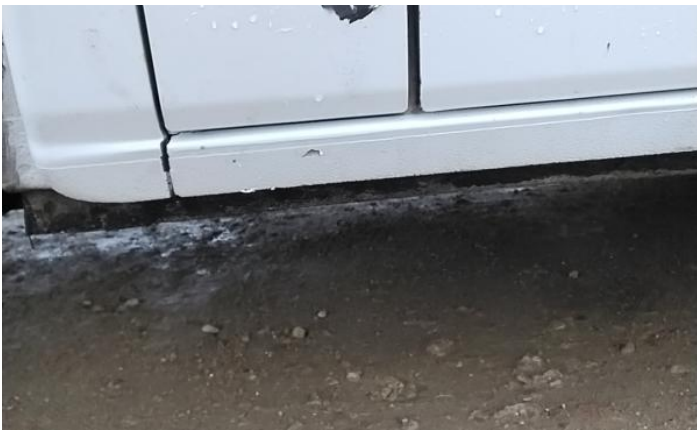
7: B Post os  
Scratched  
Over 25mm Thru Paint

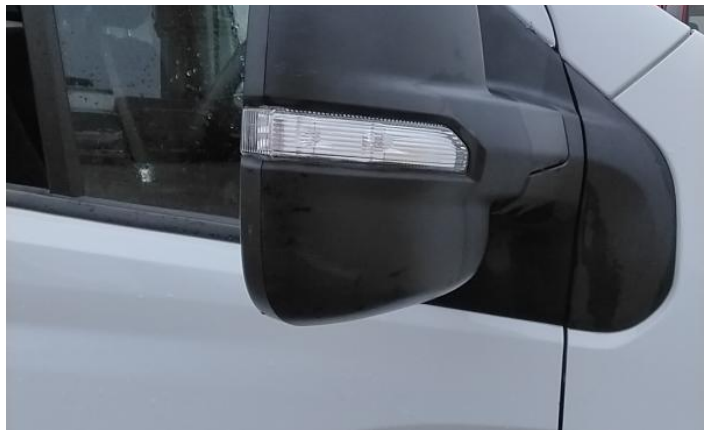
8: Door Mirror Assy osf  
Scuffed (Unpainted)  
Over 100mm

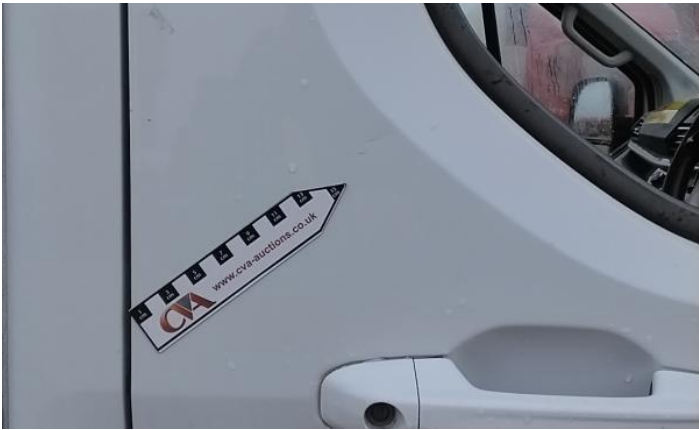
9: Door osf  
 Scratched  
 UpTo 25mm Thru Paint

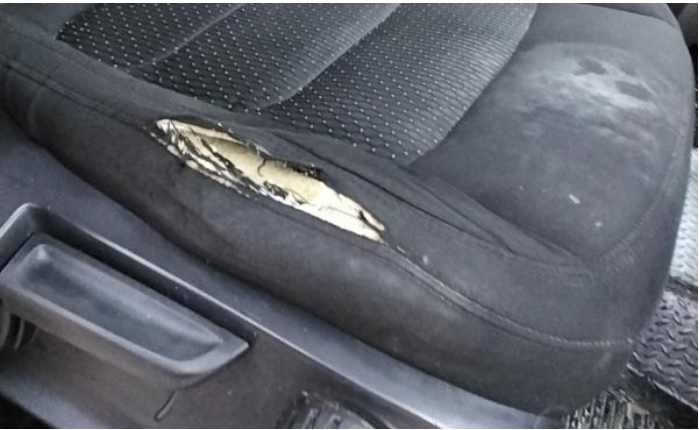
10: Seat Base Cover osf  
 Holed  
 Over 3mm
