# VEHICLE INSPECTION REPORT

**YD66EVU**

## Daf LF 150

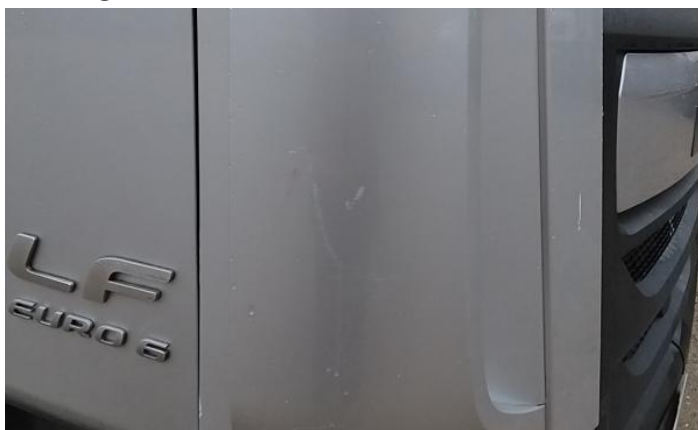
1: Wing osf  
Scratched  
Over 25mm Thru Paint

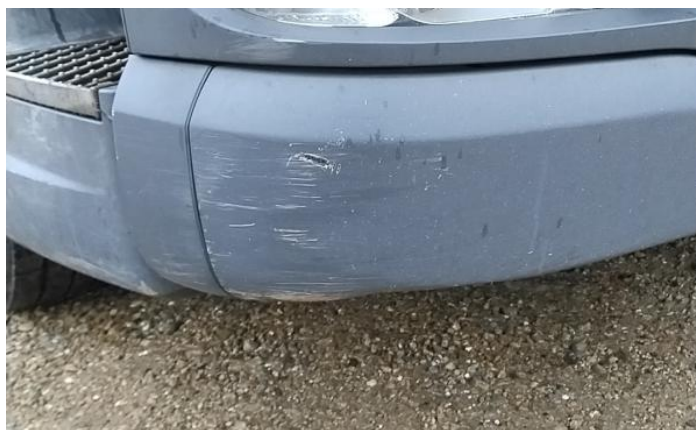
2: Bumper Front  
Scratched  
25 to 100mm Thru Paint

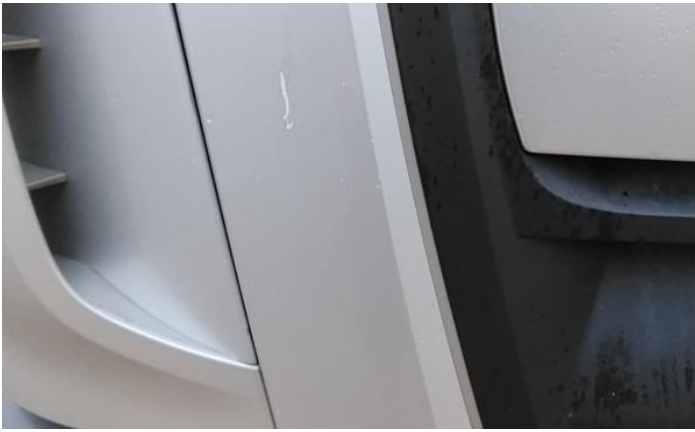
3: Bonnet  
Scratched  
UpTo 25mm Thru Paint

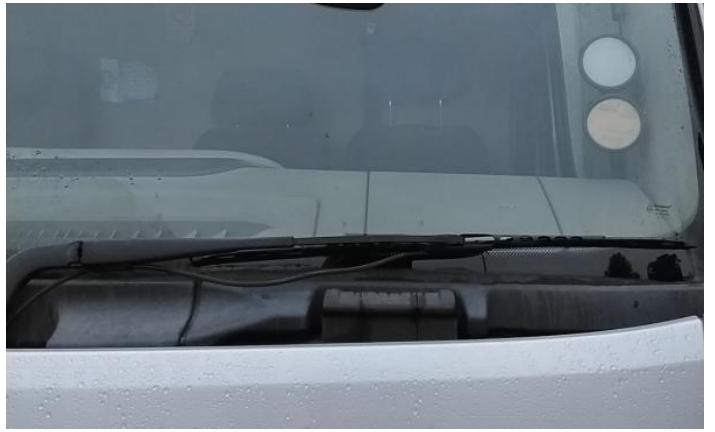
4: Screen Front  
Cracked  
Replace

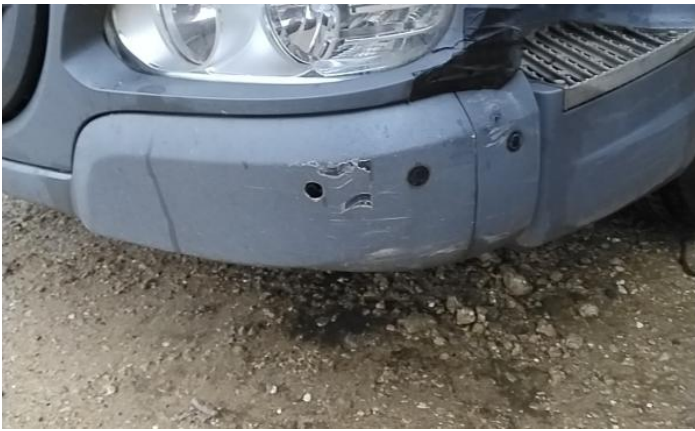
5: Bumper Front  
Scratched  
25 to 100mm Thru Paint

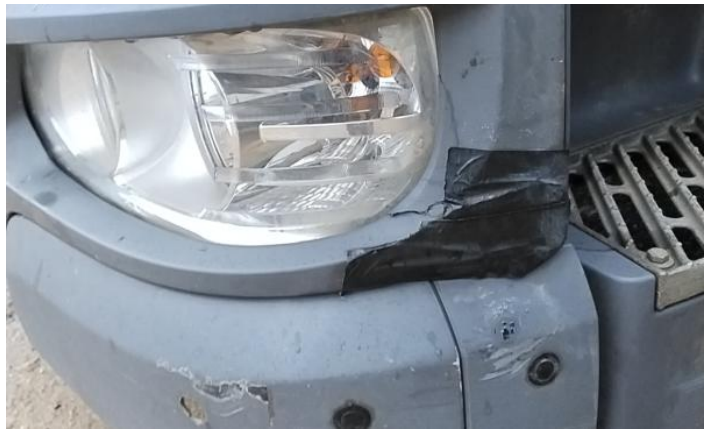
6: Fog Lamp Surround ns  
Broken  
Replace

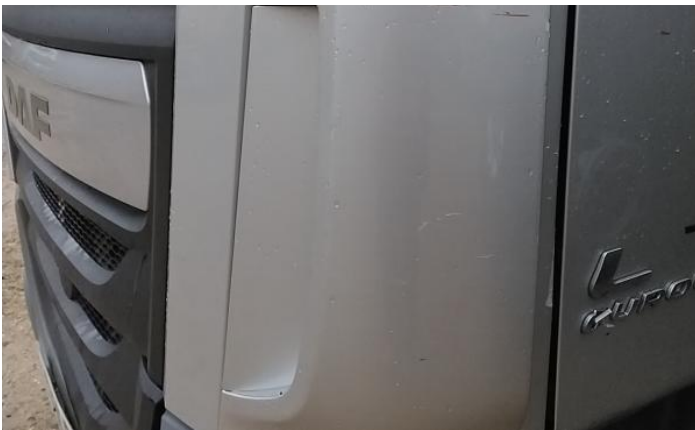
7: Wing nsf  
Scratched  
Over 25mm Thru Paint

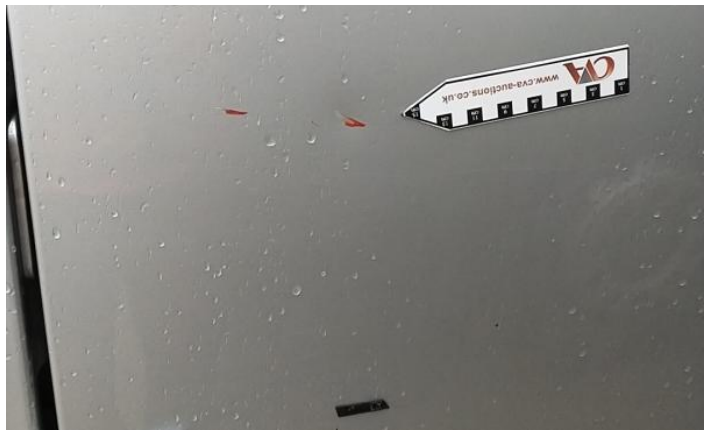
8: Door nsf  
Dented  
Over 2 UpTo 10mm

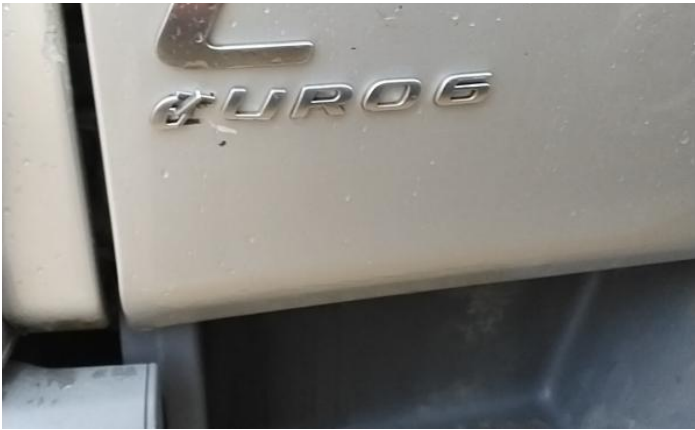
9: Badgedecal Front  
Broken  
Replace

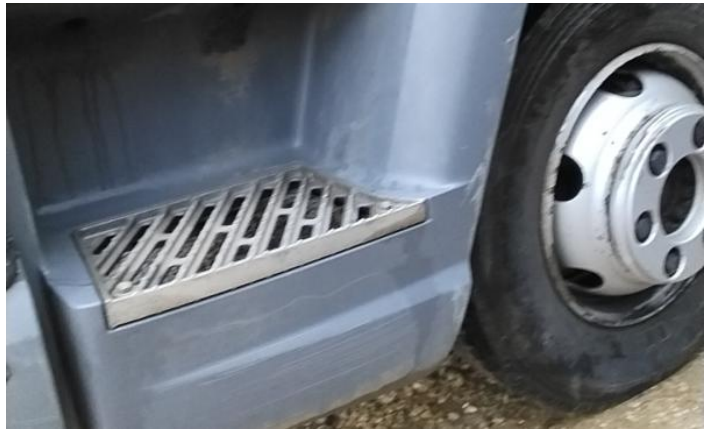
10: Wing Front Arch Extension ns  
Scratched (Painted)  
Over 25mm Thru Paint

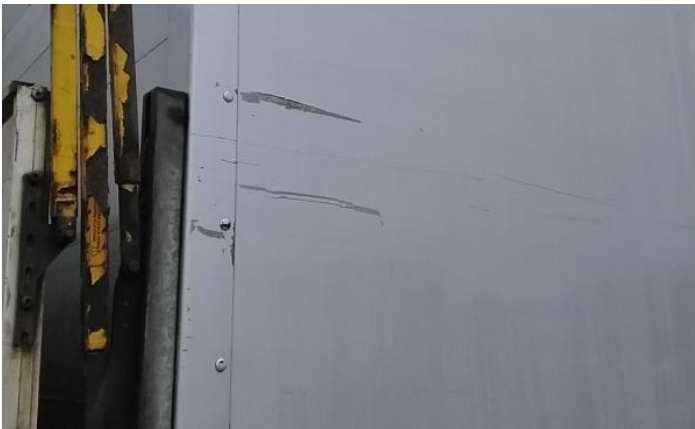
11: Qtr Panel osr  
Scratched  
Over 25mm Thru Paint

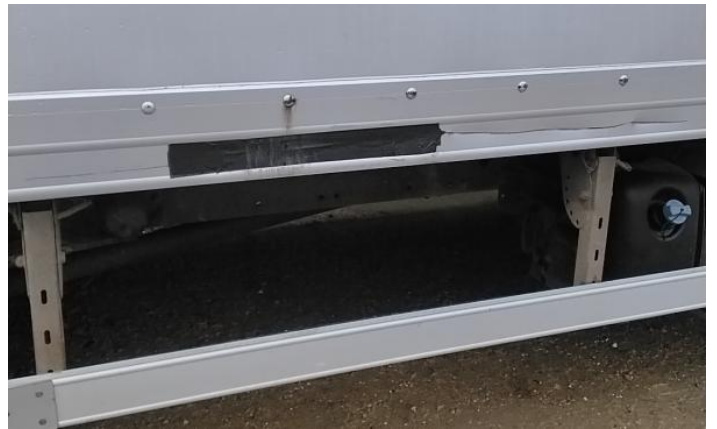
12: Qtr Panel osr  
Scratched  
Over 25mm Thru Paint

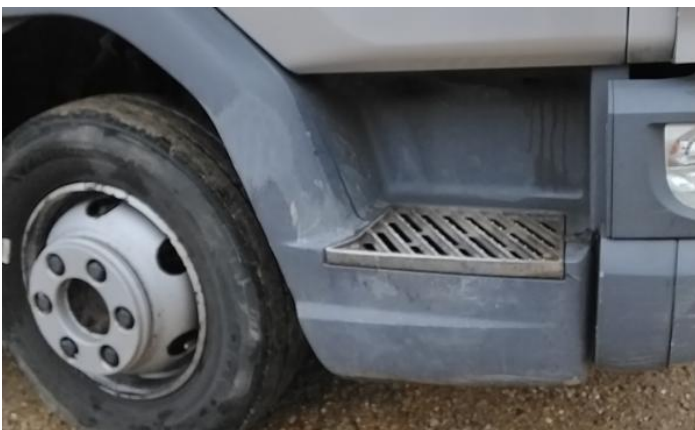
13: Wing Front Arch Extension os  
Scratched (Painted)  
Over 25mm Thru Paint

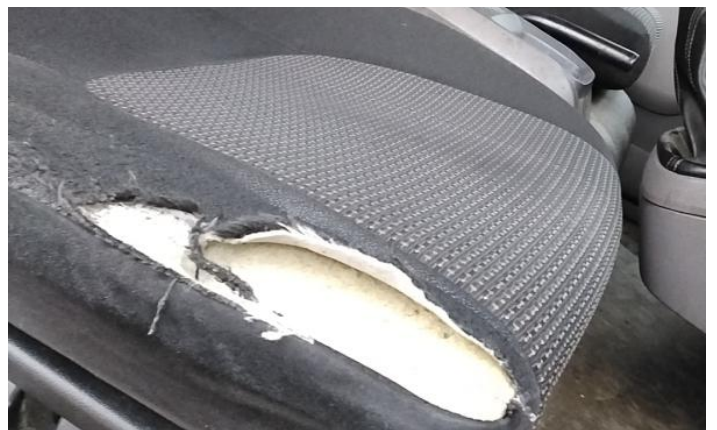
14: Seat Base Cover osf  
Holed  
Over 3mm
