**COMMERCIAL VEHICLE AUCTIONS LTD**  
THE UK'S MOST ESTABLISHED COMMERCIAL VEHICLE AUCTIONEERS

# VEHICLE INSPECTION REPORT

**BX13LWO**

## Mitsubishi L200

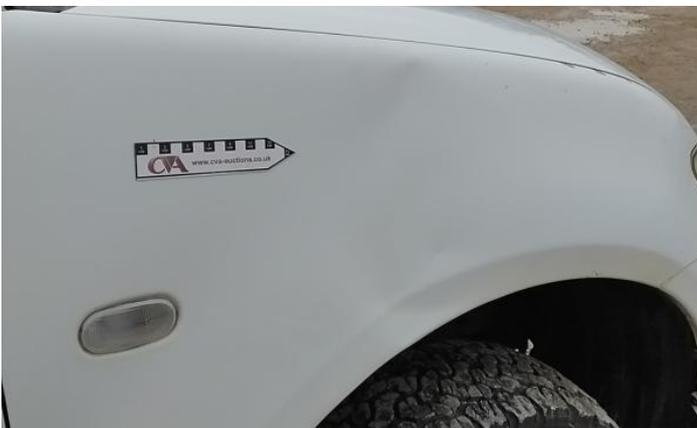
1: Wing osf  
Dented  
Over 30mm

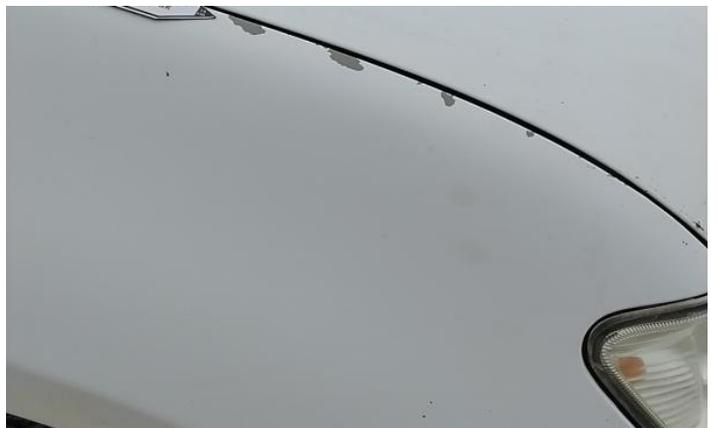
2: Wing osf  
Scratched  
Over 25mm Thru Paint

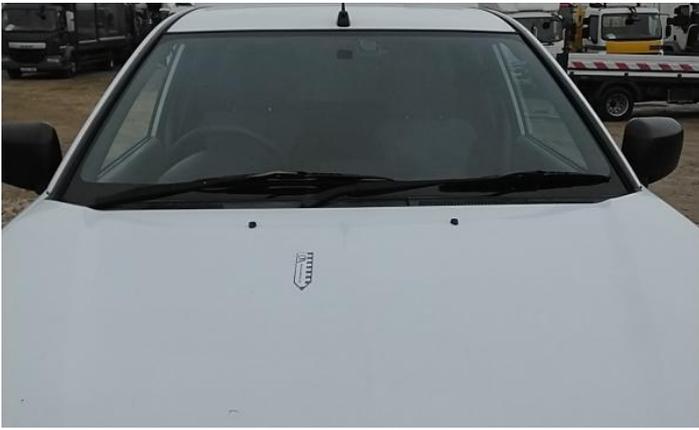
3: Bonnet  
Chipped  
Multiple Chips

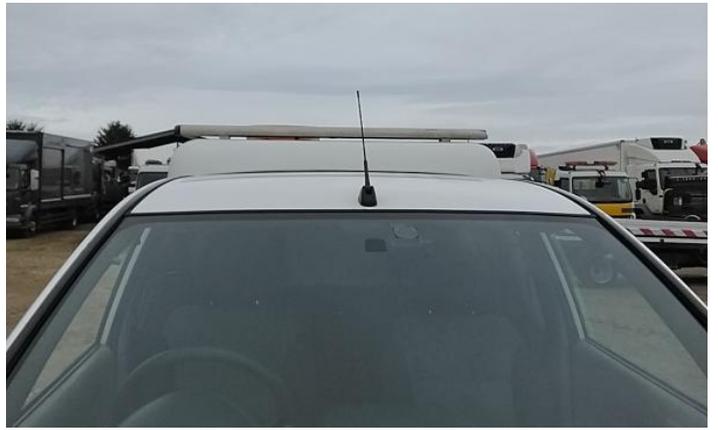
4: Screen Front  
Chipped  
Over 10mm

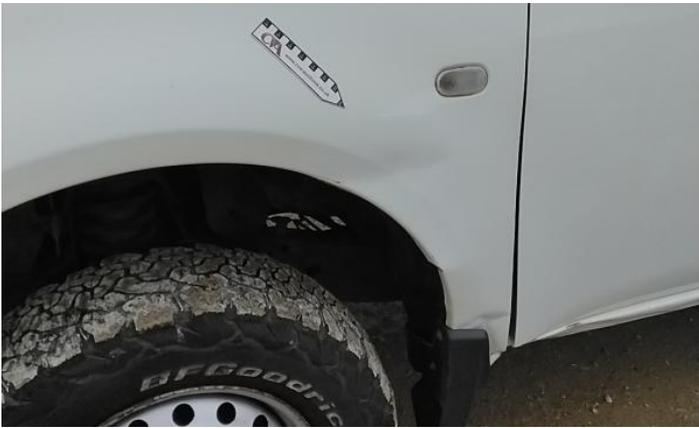
5: Wing nsf  
Dented  
With Paint Damage

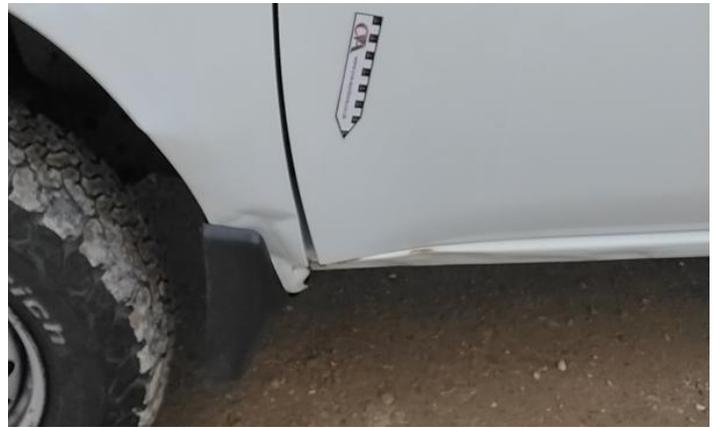
6: Door nsf  
Dented  
Over 30mm

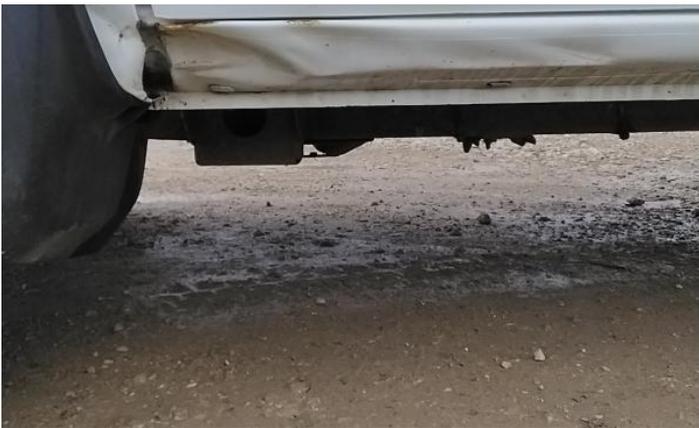
7: Sill ns  
Dented  
With Paint Damage

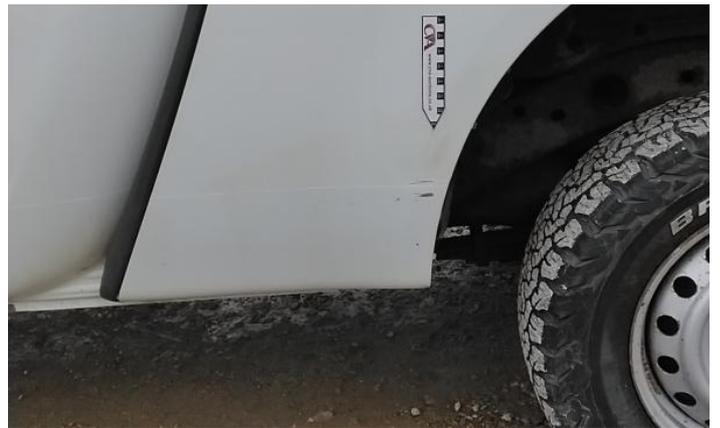
8: Qtr Panel nsr  
Scratched  
Over 25mm Thru Paint

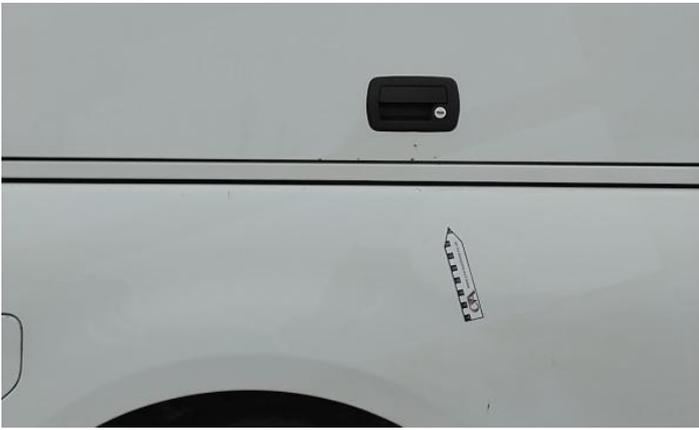
9: Qtr Panel nsr  
Chipped  
Multiple Chips

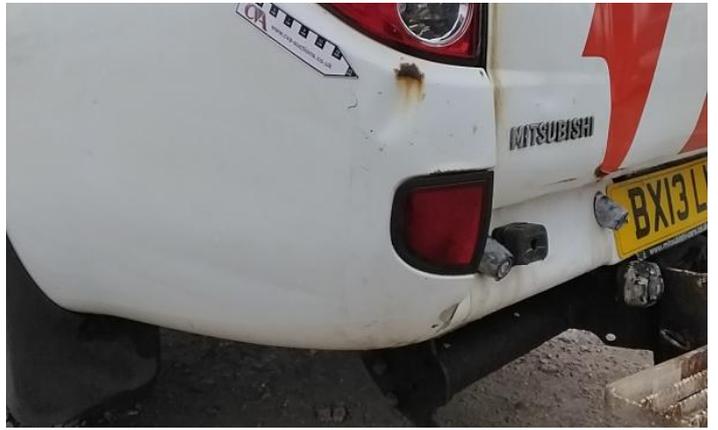
10: Qtr Panel nsr  
Dented  
With Paint Damage

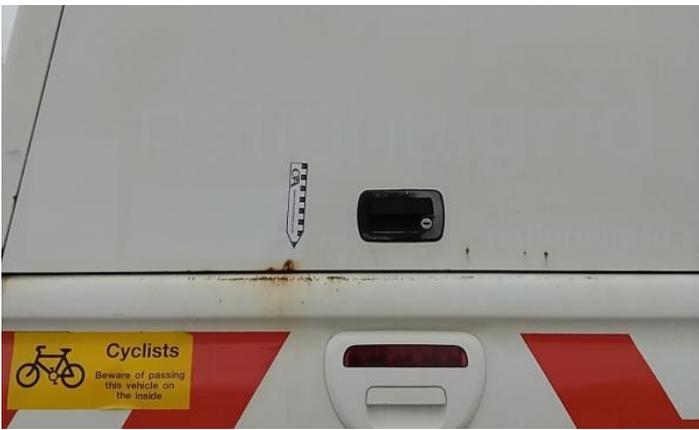
11: Panel Rear  
Rusted  
Over 5mm

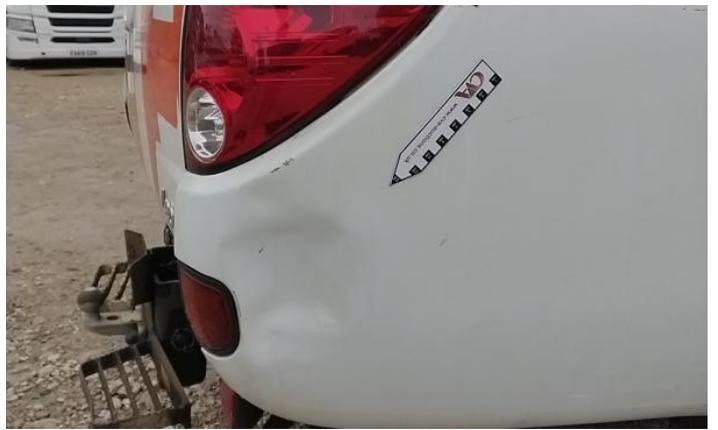
12: Qtr Panel osr  
Dented  
Over 30mm

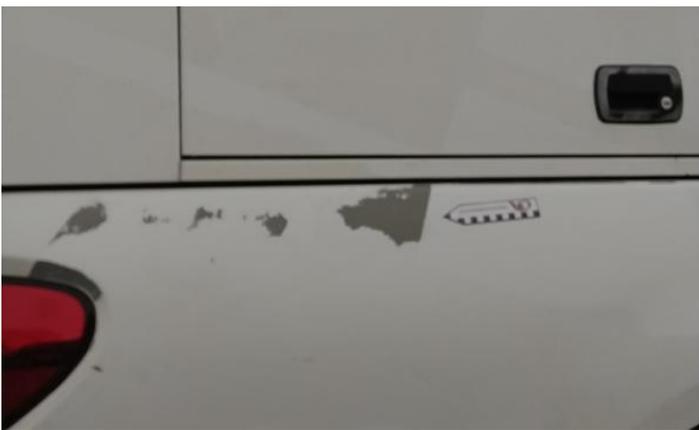
13: Qtr Panel osr  
Scratched  
Over 25mm Thru Paint

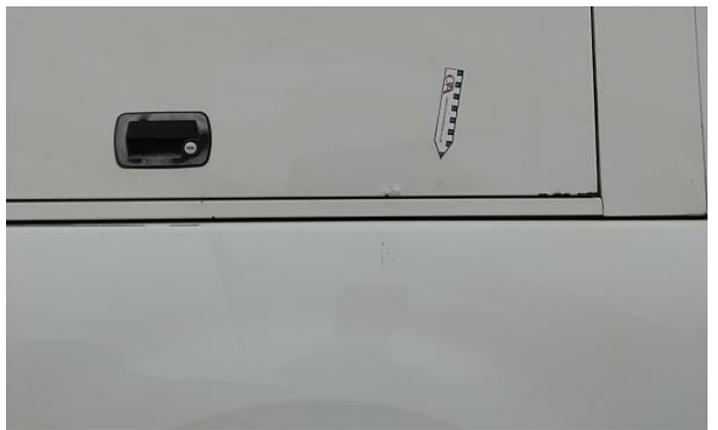
14: Qtr Panel osr  
Rusted  
Over 5mm

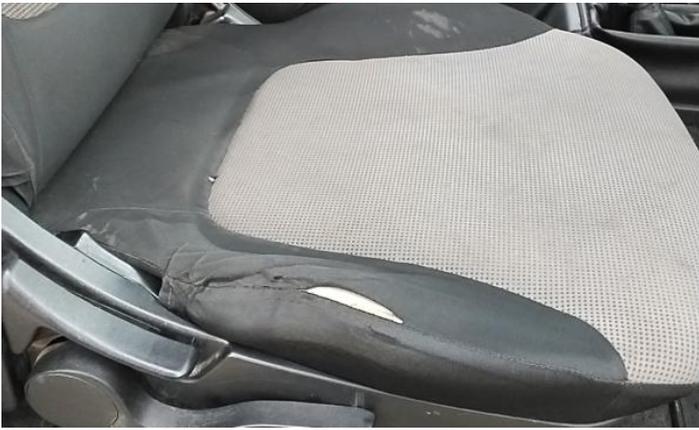
15: Seat Base Cover osf  
 Holed  
 Over 3mm
