# VEHICLE INSPECTION REPORT

**DK69WJJ**

## Isuzu N75 190

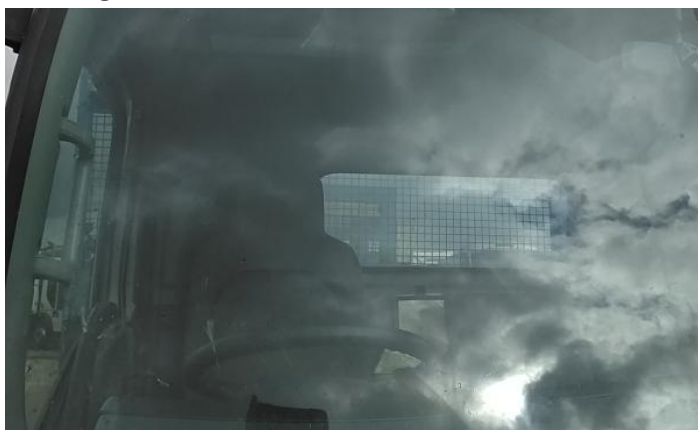
1: Screen Front  
Cracked  
Replace

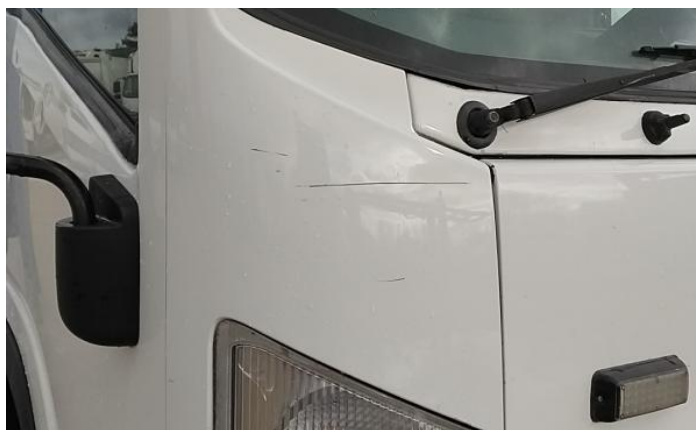
2: Wing osf  
Scratched  
Over 25mm Not Thru Paint

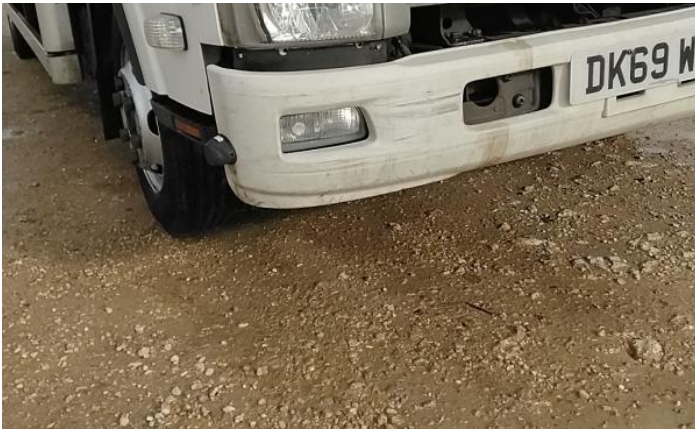
3: Bumper Front  
Scratched  
Over 25mm Not Thru Paint

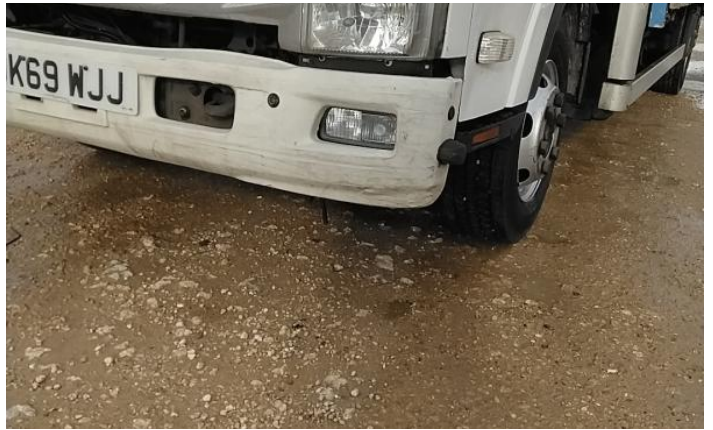
4: Bumper Front  
Scratched  
Over 25mm Not Thru Paint

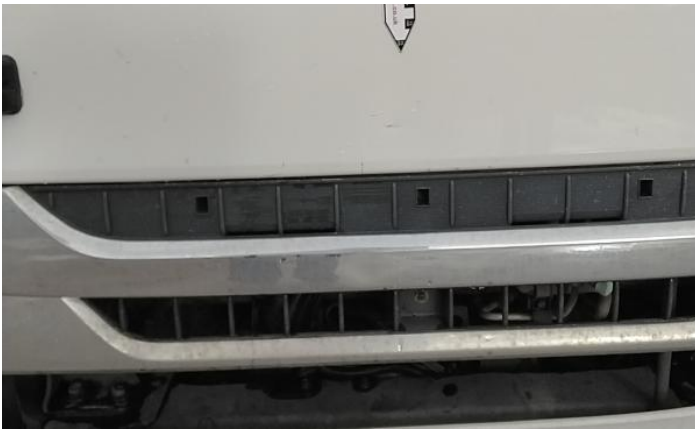
5: Bonnet  
Dented  
With Paint Damage

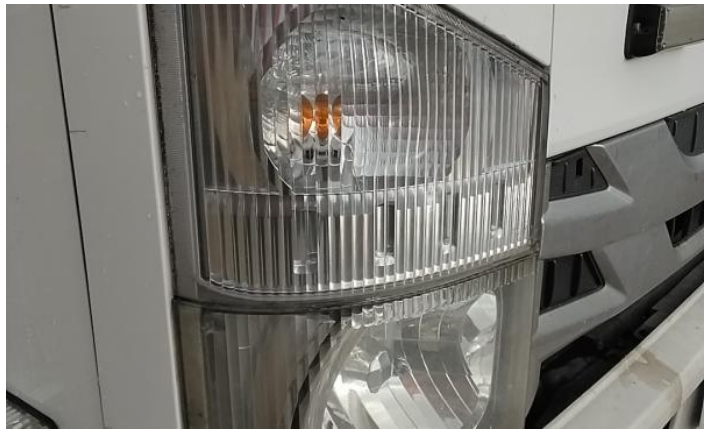
6: Headlamp os  
Broken  
Replace

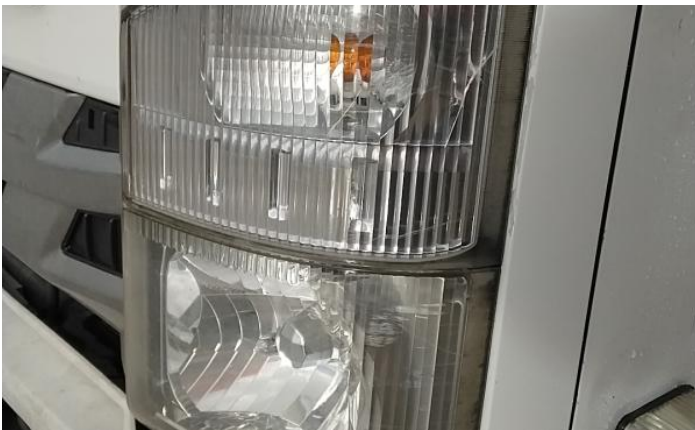
7: Headlamp ns  
Broken  
Replace

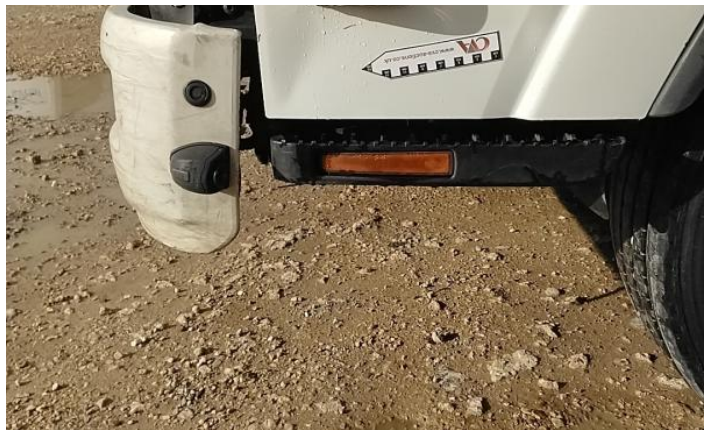
8: Door nsf  
Dented  
Over 30mm

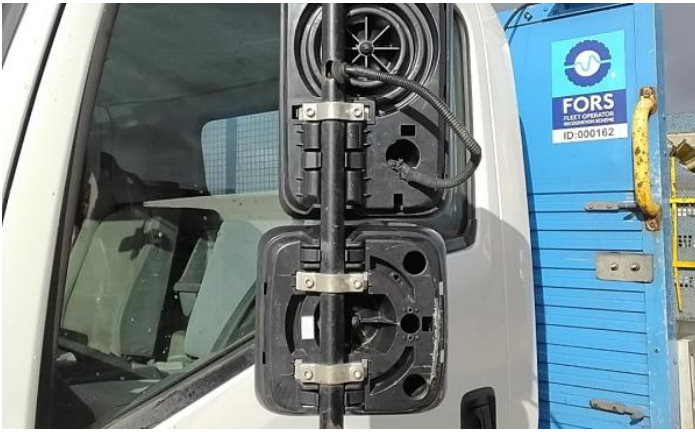
9: Door Mirror Assy nsf  
Broken  
Replace

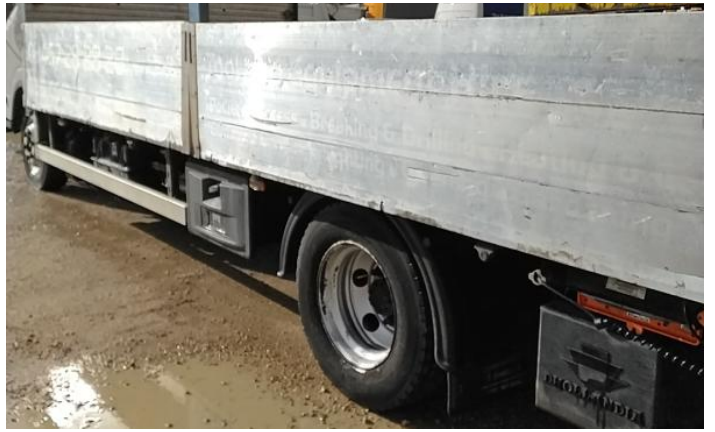
10: Qtr Panel nsr  
Dented  
With Paint Damage

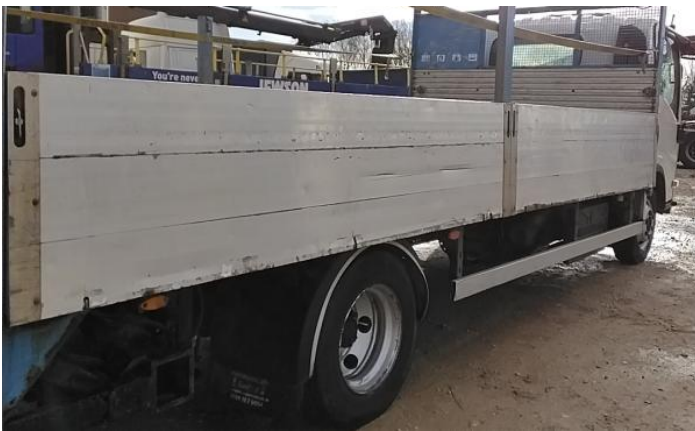
11: Qtr Panel osr  
Dented  
With Paint Damage

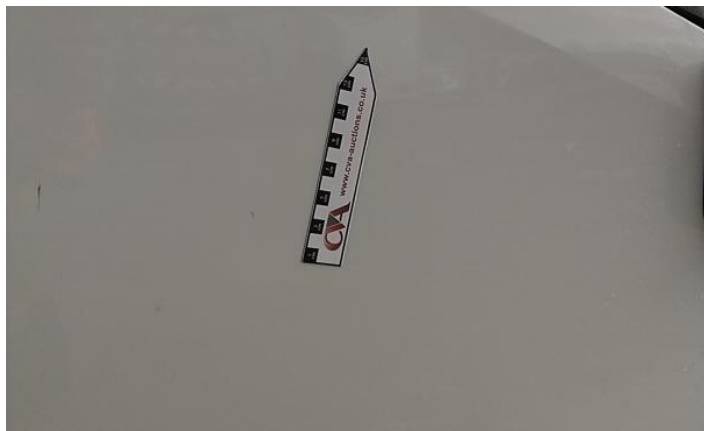
12: Door osf  
Dented  
Between 10mm + 30mm

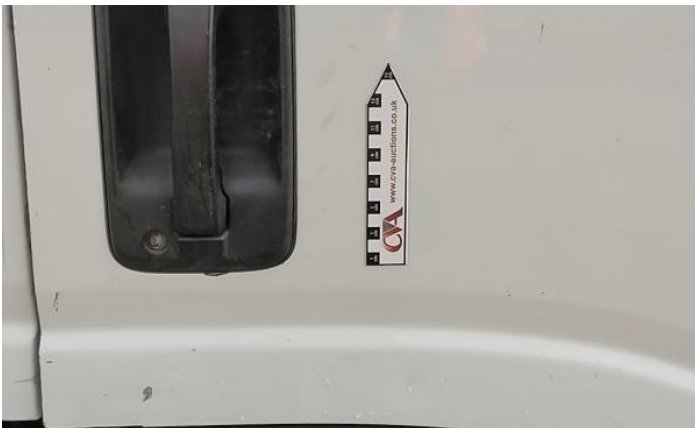
13: Door osf  
Dented  
Between 10mm + 30mm

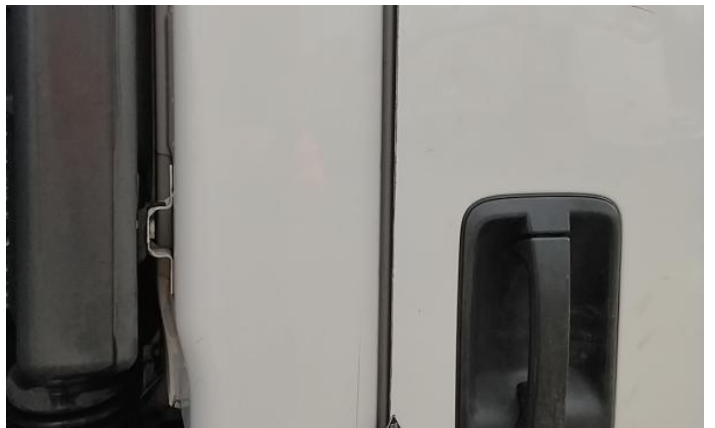
14: Door osf  
Chipped  
Multiple Chips

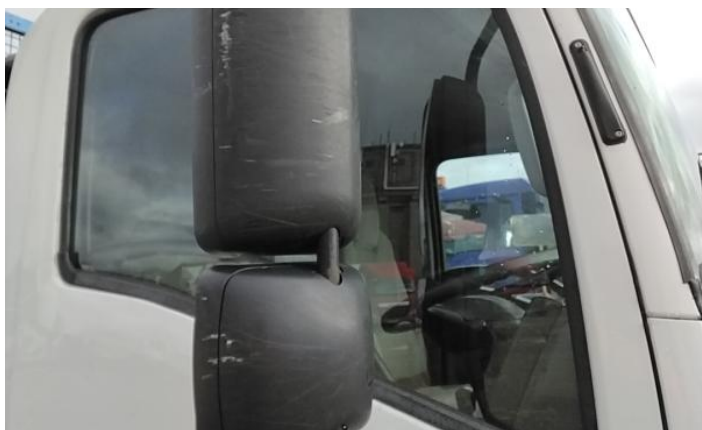
15: Door Mirror Assy osf  
Scuffed (Unpainted)  
Over 100mm

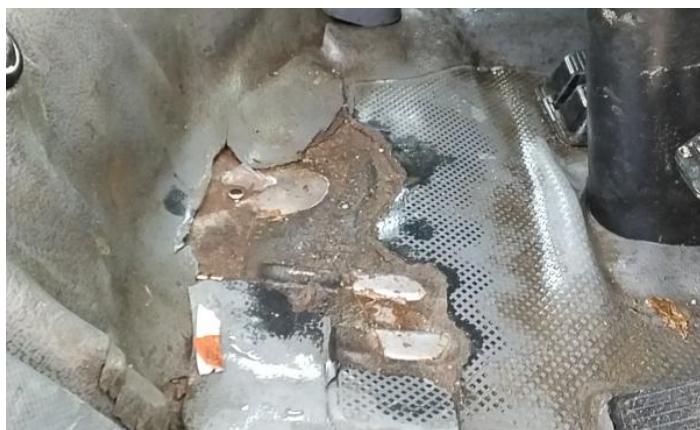
16: Carpets Front  
Holed  
Over 3mm

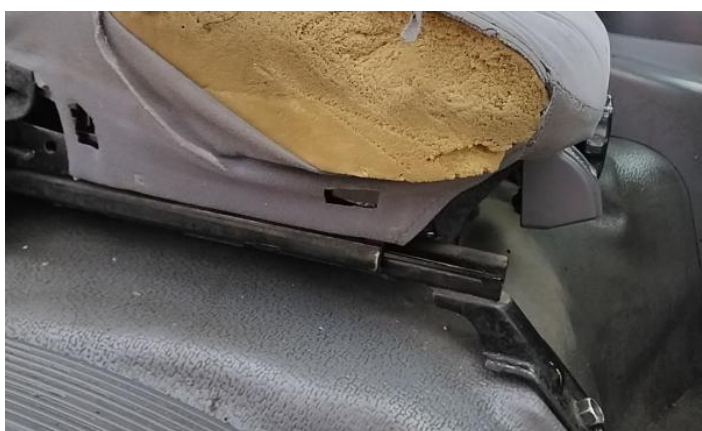
17: Seat Base Cover osf  
Holed  
Over 3mm

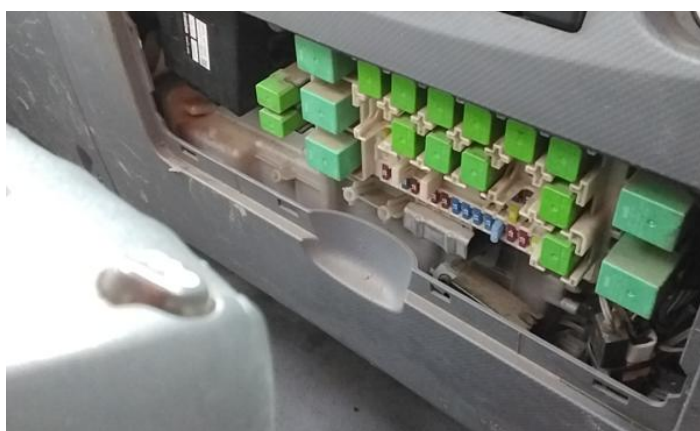
18: Centre Console Front  
Missing  
Replace
