VEHICLE INSPECTION REPORT

HX15YDH

Daf LF 220

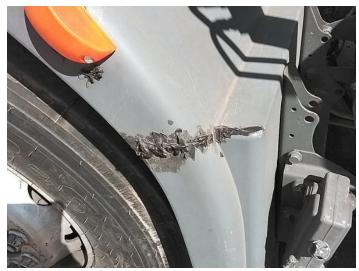
1: Moulding osf Wing Broken Replace

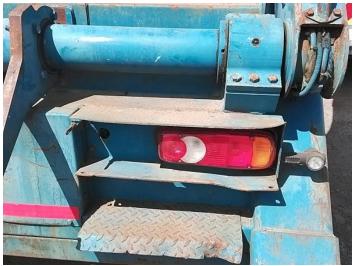
2: Lamp nsr Broken Replace

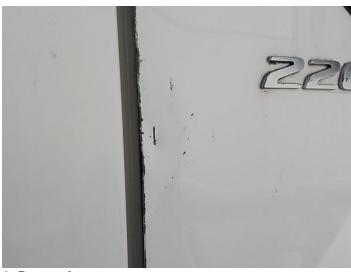
3: Door nsf Dented With Paint Damage
