VEHICLE INSPECTION REPORT

FJ72VRN

Mercedes-Benz eVito 85KW Progressive

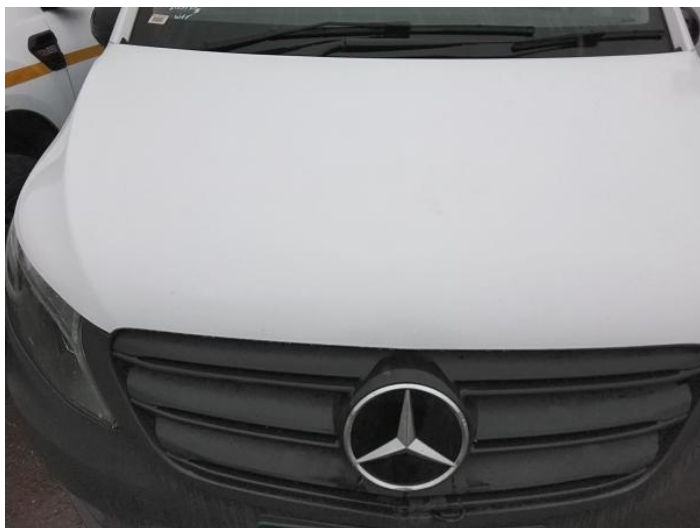
1: Bonnet
Chipped
Multiple Chips

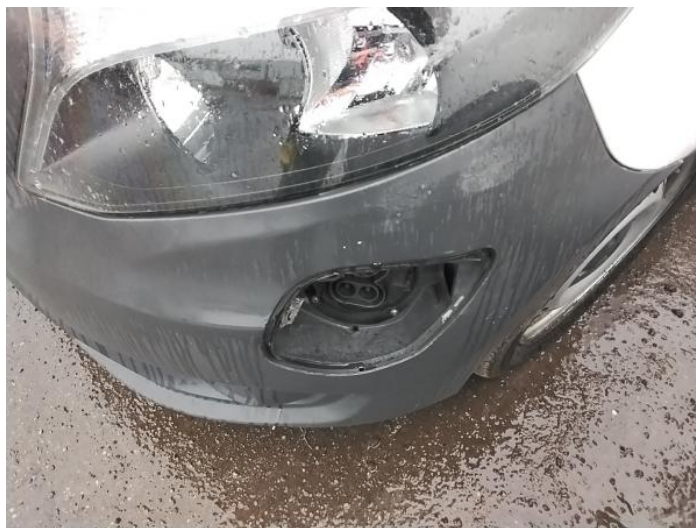
2: Bumper Front Moulding
Missing
Replace

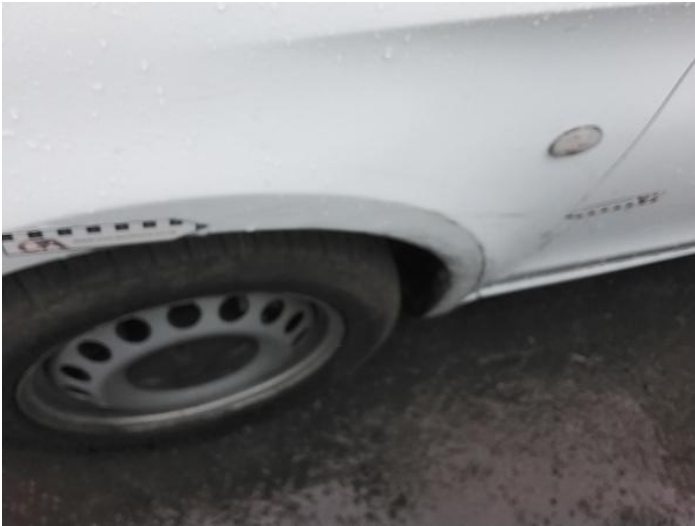
3: Wing nsf
Scratched
Over 25mm Thru Paint

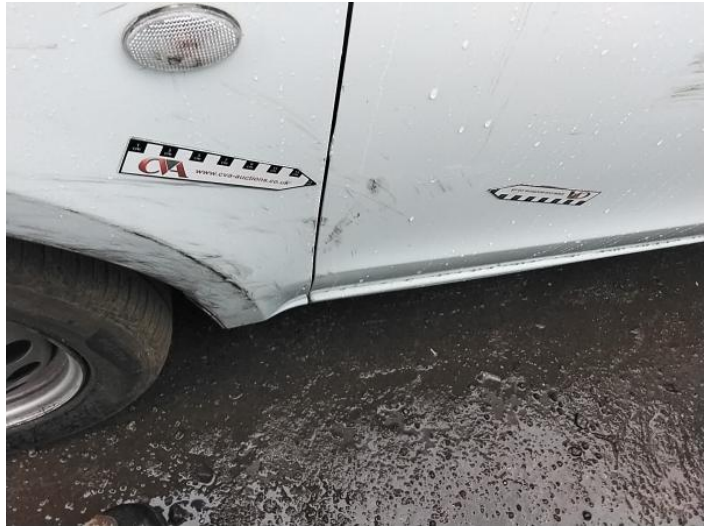
4: Door nsf
Scratched
Over 25mm Thru Paint

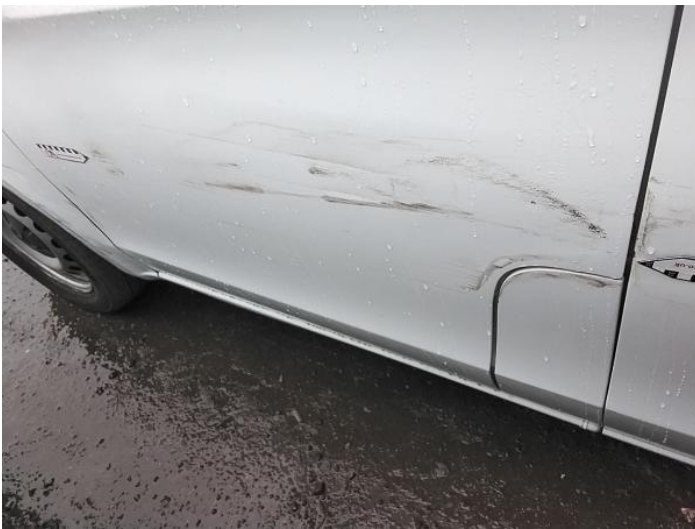
5: Door nsf
Dented
Over 30mm

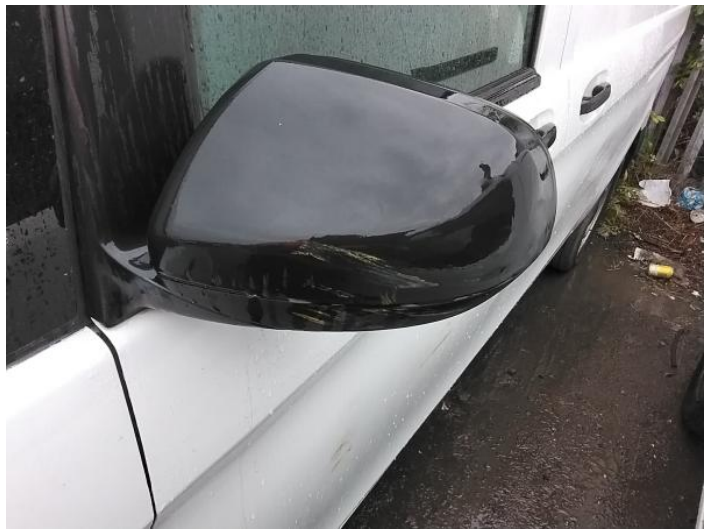
6: Door Mirror Assy nsf
Scuffed (Unpainted)
Over 100mm

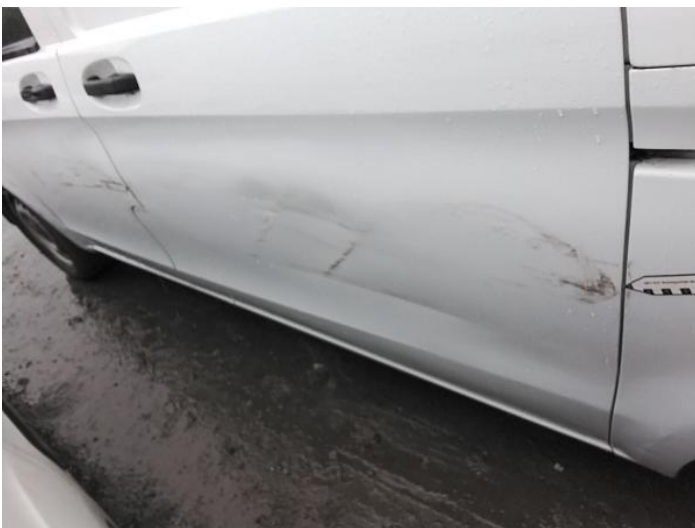
7: Qtr Panel nsr
Dented
Over 30% Of Panel

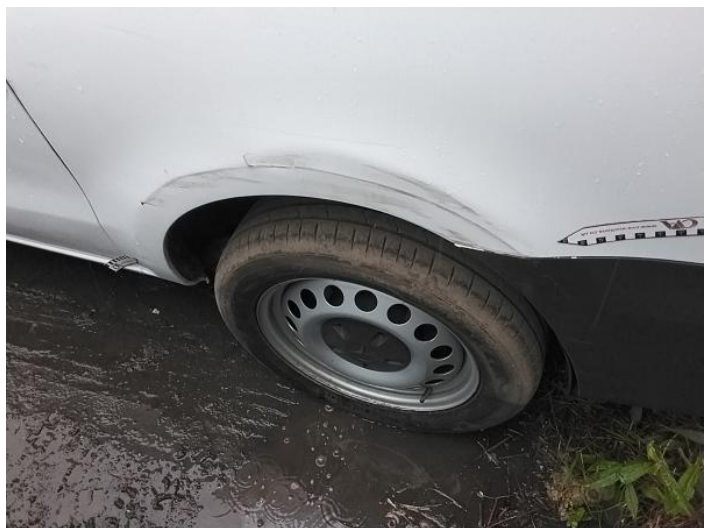
8: Qtr Panel nsr
Dented
Over 30mm

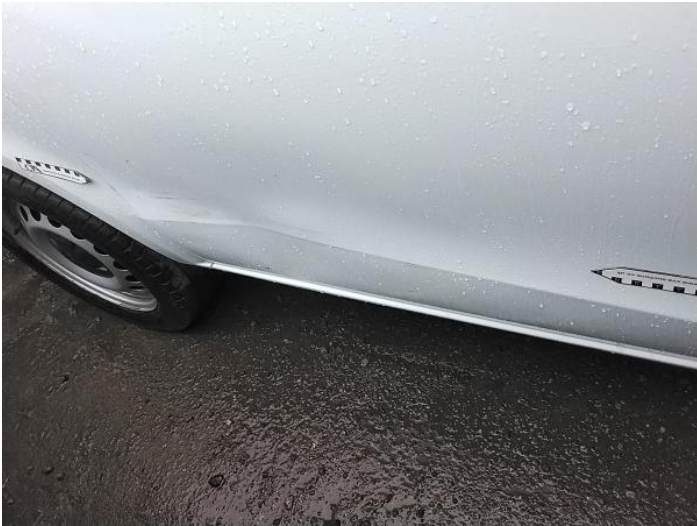
9: Qtr Panel osr
Dented
Over 30mm

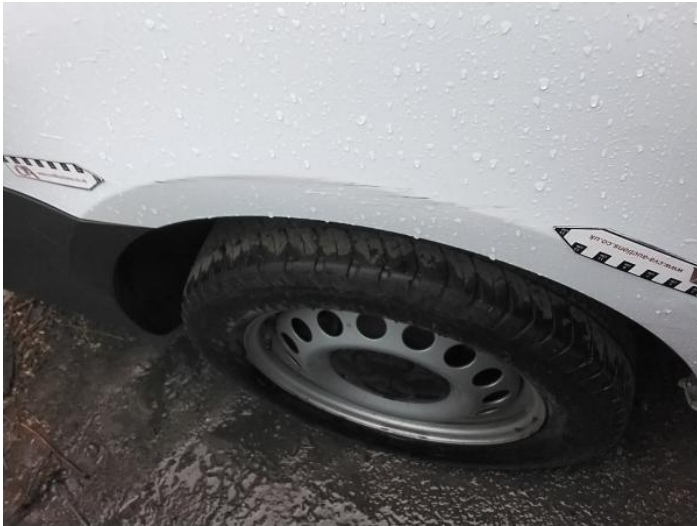
10: Qtr Panel osr
Scratched
Over 25mm Thru Paint

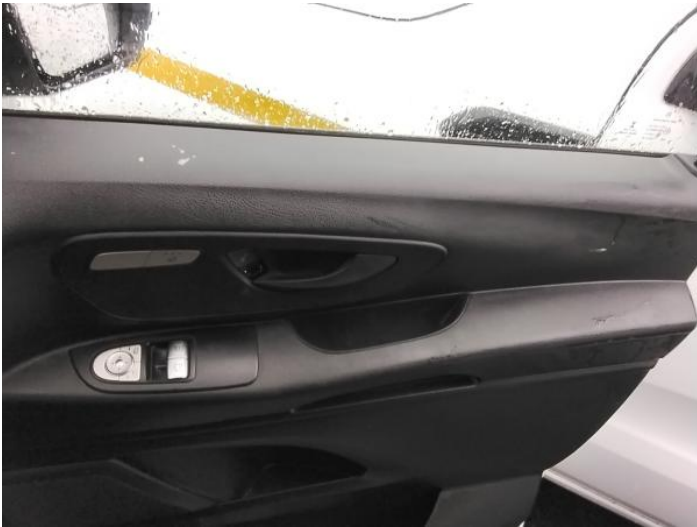
11: Door Pad osf
Soiled
Heavy

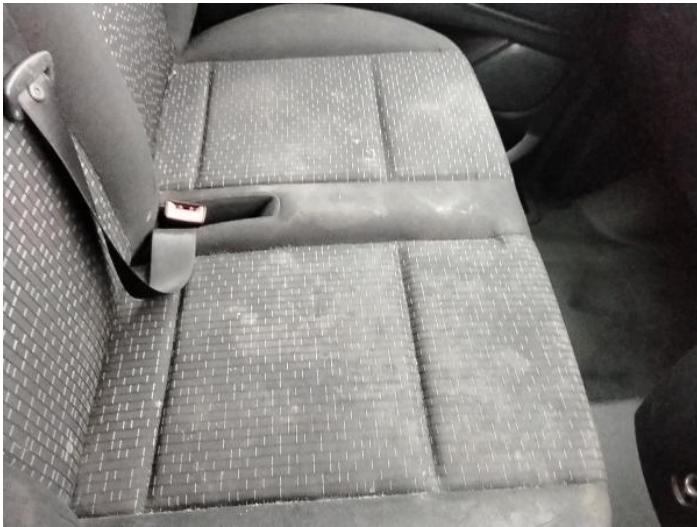
12: Seat Base Cover nsf
Soiled
Heavy
