VEHICLE INSPECTION REPORT

FJ72VRP

Mercedes-Benz eVito 66 85KW Progressive

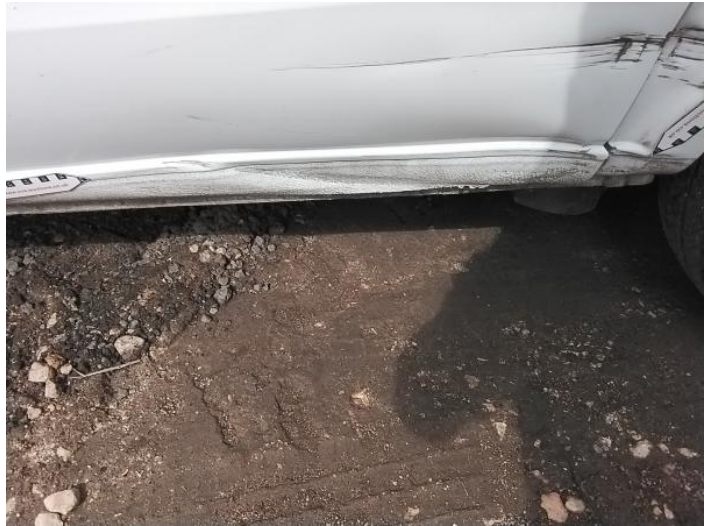
4: Sill ns
Dented
Over 30mm

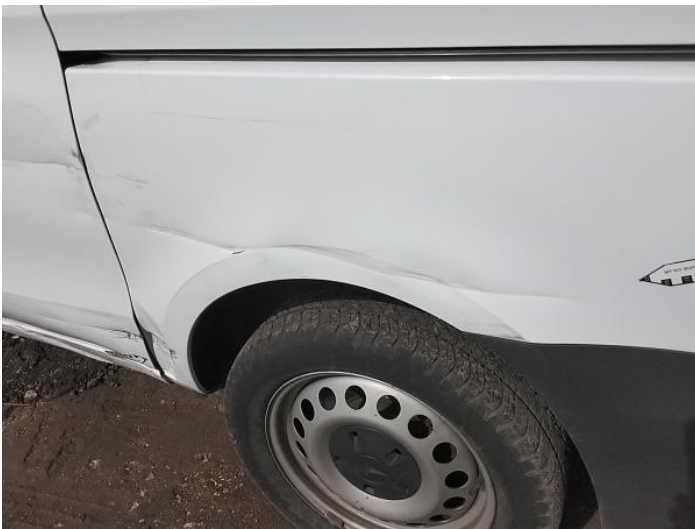
5: Qtr Panel nsr
Dented
Over 30mm

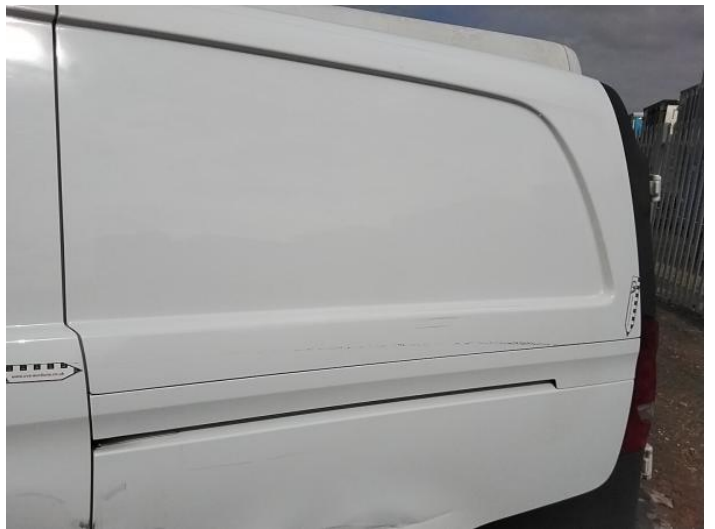
6: Qtr Panel nsr
Scratched
Over 25mm Not Thru Paint

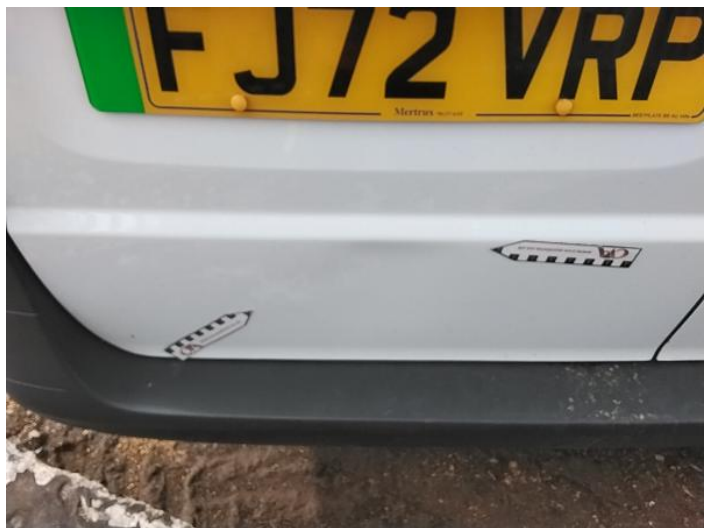
8: Door nsr
Dented
Over 30mm

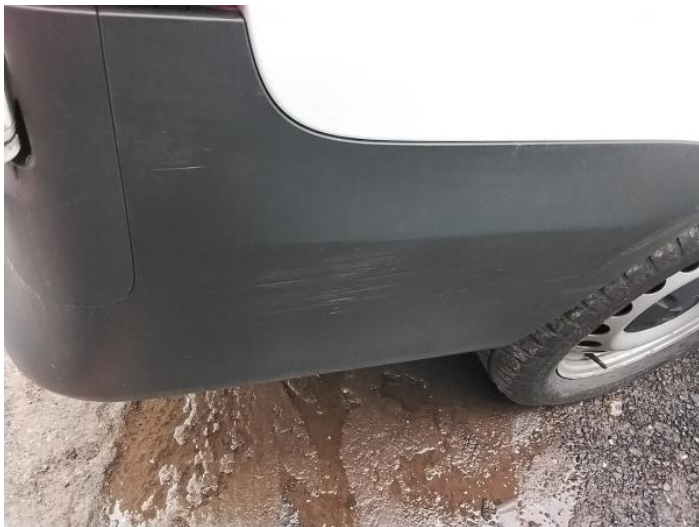
9: Bumper Rear Moulding
Scuffed (Unpainted)
Over 100mm

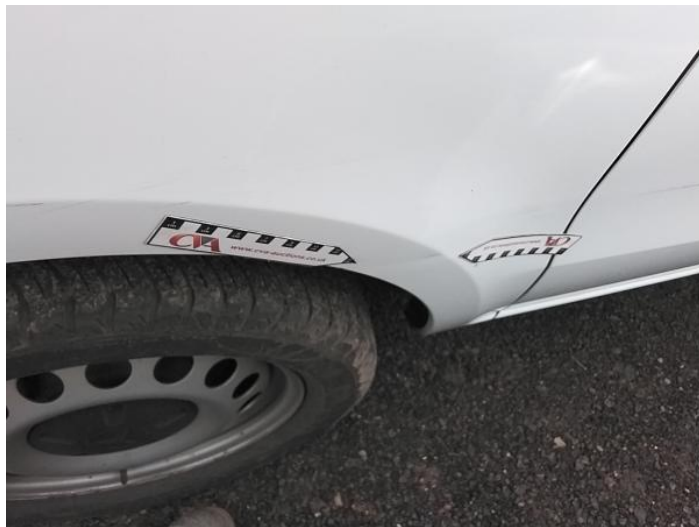
10: Qtr Panel osr
Dented
Over 30mm

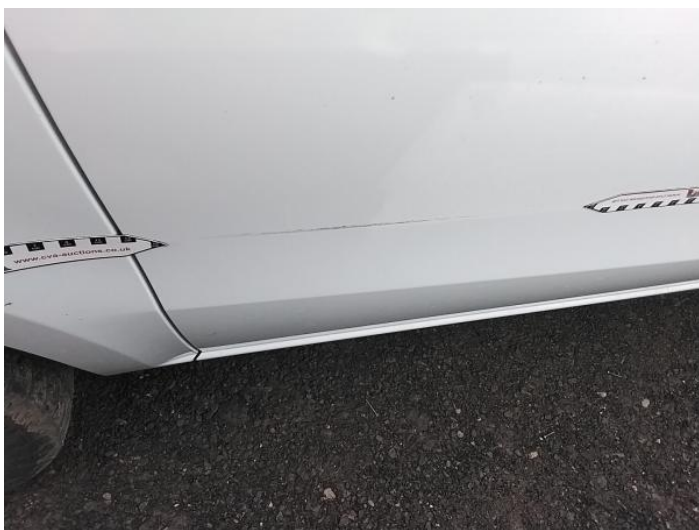
11: Qtr Panel osr
Scratched
Over 25mm Not Thru Paint

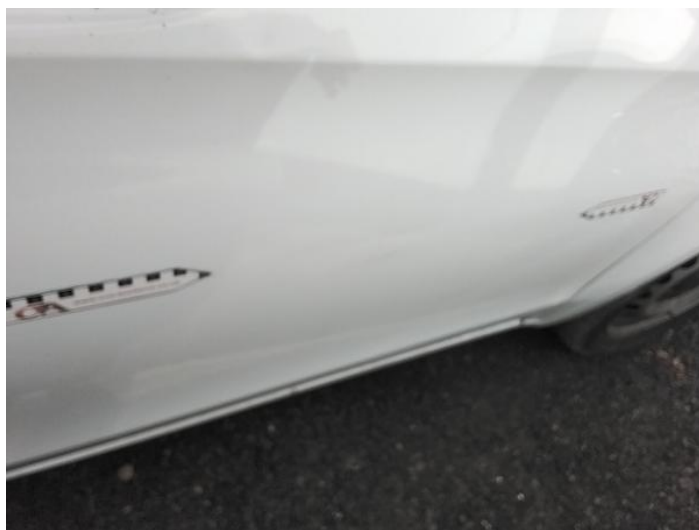
12: Door osf
Dented
Over 30mm

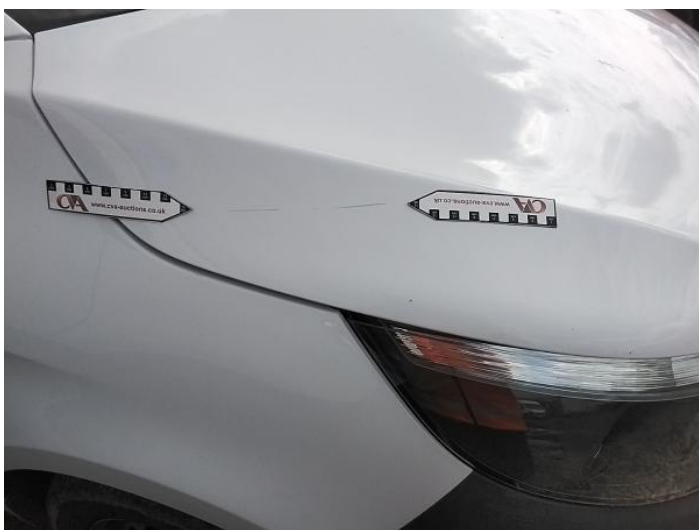
13: Bonnet
Scratched
Over 25mm Not Thru Paint

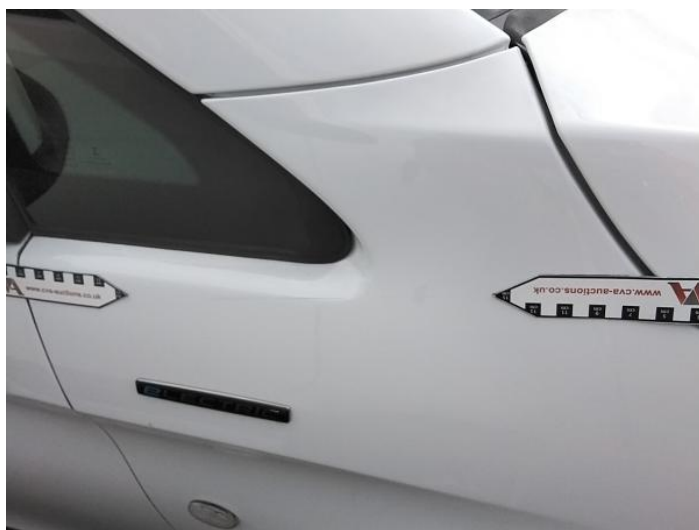
14: Wing osf
Scratched
Over 25mm Not Thru Paint

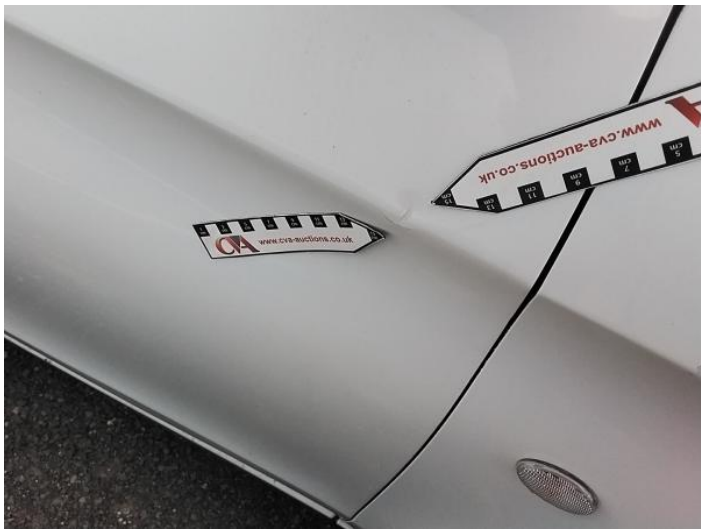
15: Door osf
Dented
Between 10mm + 30mm
