VEHICLE INSPECTION REPORT

FJ72VRD

Mercedes-Benz eVito 85kW 66kWh Progressive Van

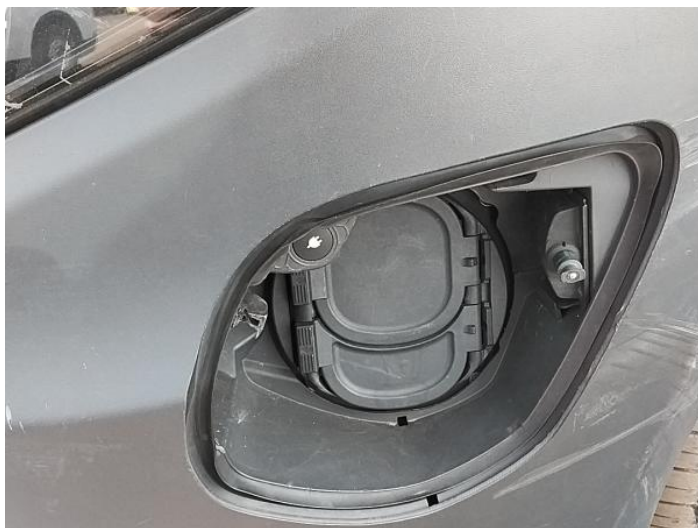
1: Bumper Front
Missing
Replace

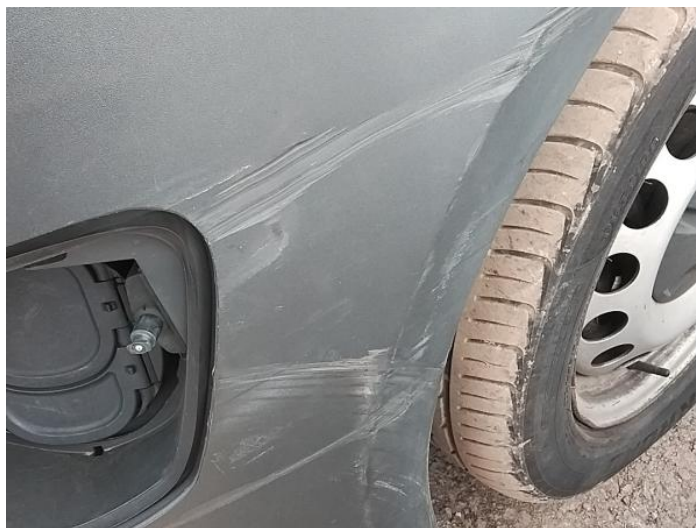
2: Bumper Front Moulding
Scuffed (Unpainted)
Over 100mm

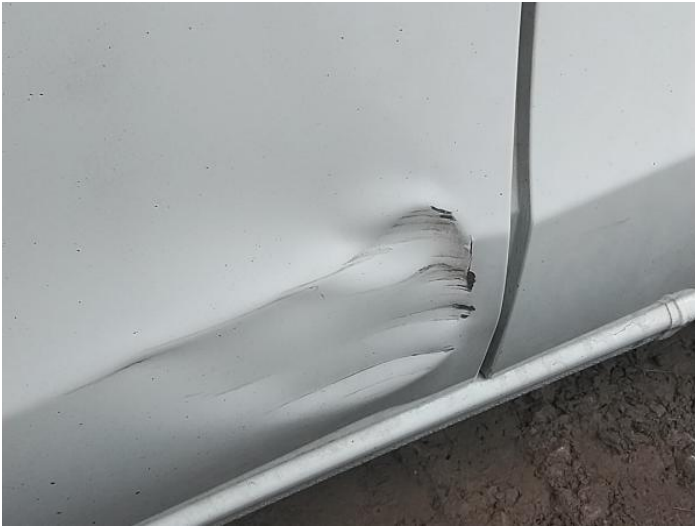
3: Door osf
Dented
With Paint Damage

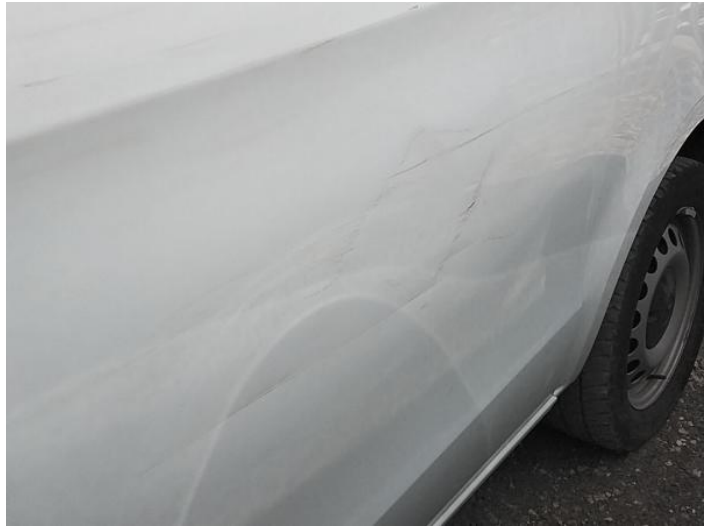
4: Panel Rear
Scratched
Over 25mm Thru Paint

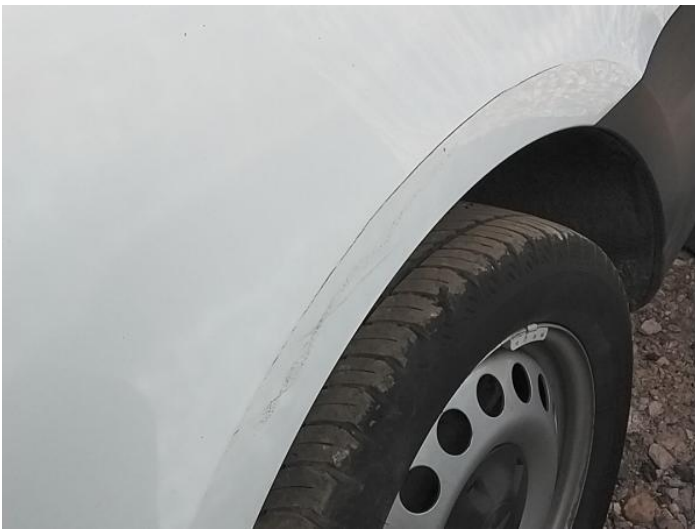
5: Qtr Panel osr
Scratched
Over 25mm Thru Paint

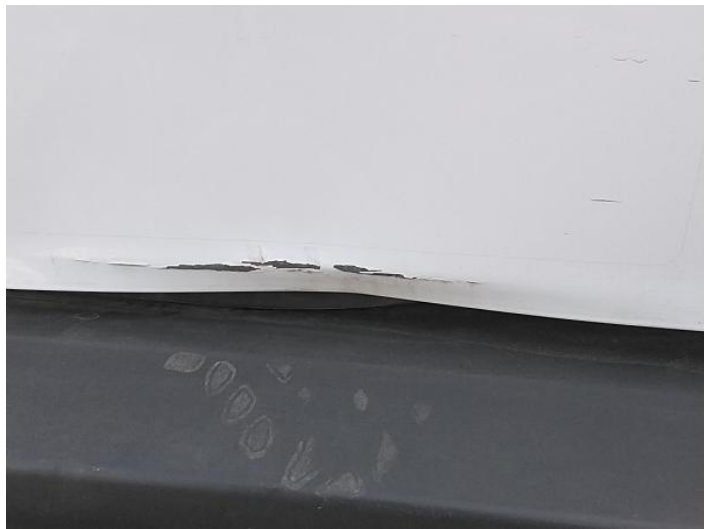
6: Door nsr
Dented
With Paint Damage

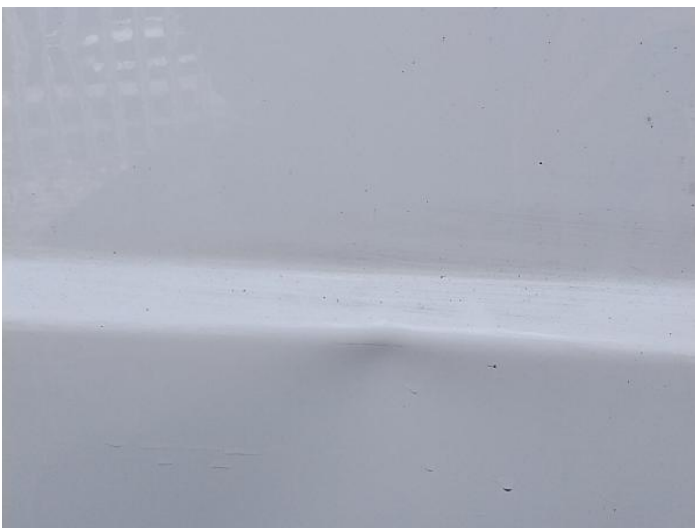
7: Door nsr
Dented
Over 30mm

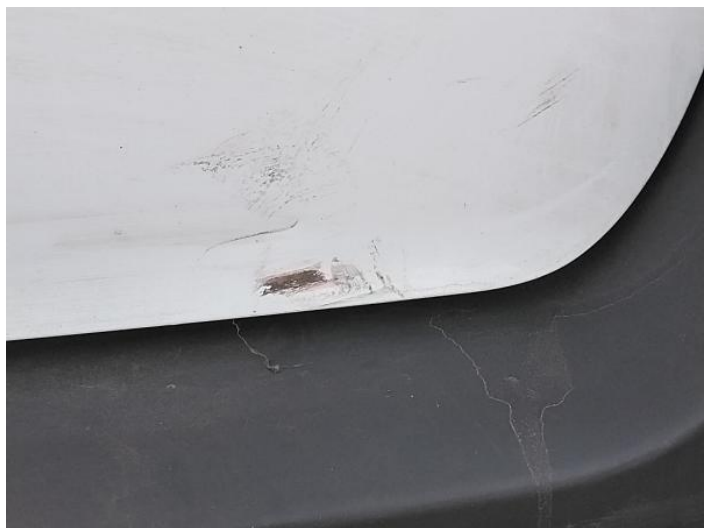
8: Door nsr
Scratched
Over 25mm Thru Paint

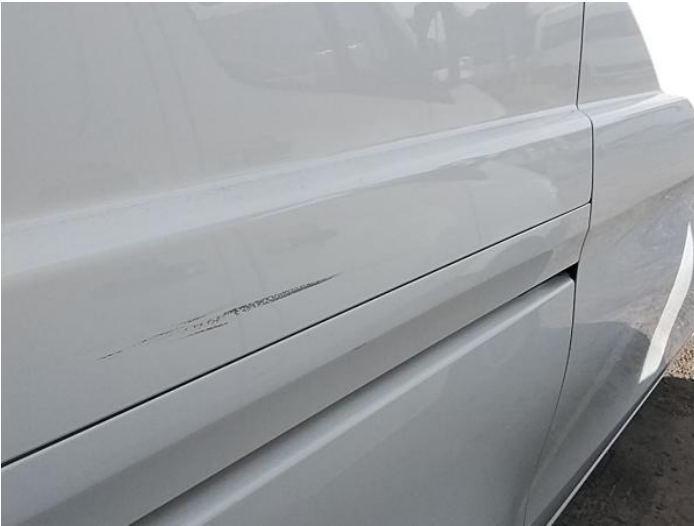
9: Panel Rear
Scratched
Over 25mm Thru Paint

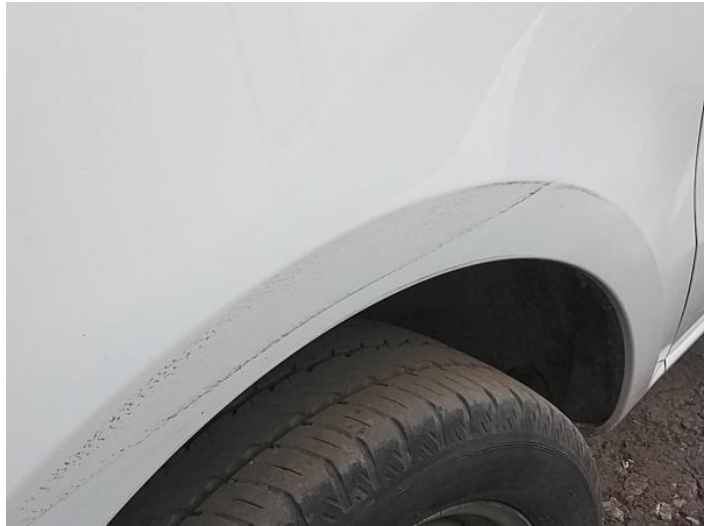
10: Qtr Panel nsr
Scratched
Over 25mm Thru Paint

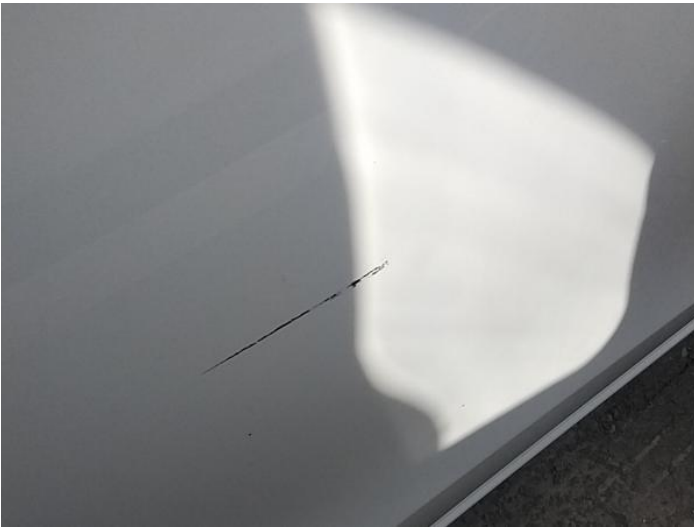
11: Panel Front
Scratched
Over 25mm Thru Paint

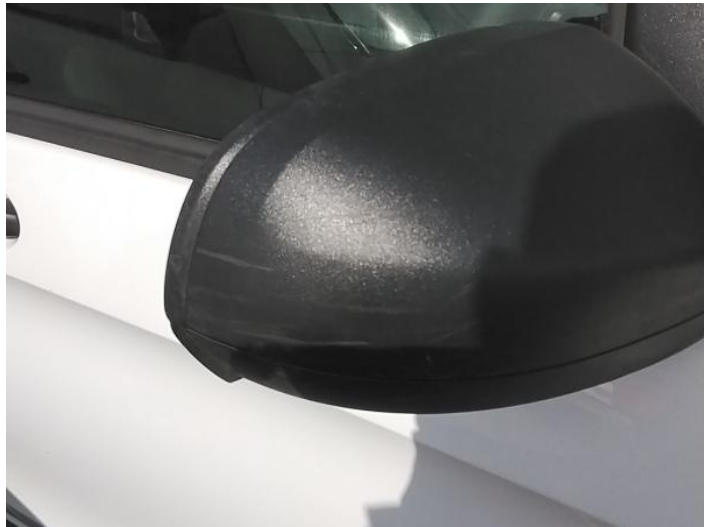
12: Door Mirror Assy nsf
Scuffed (Unpainted)
Over 100mm

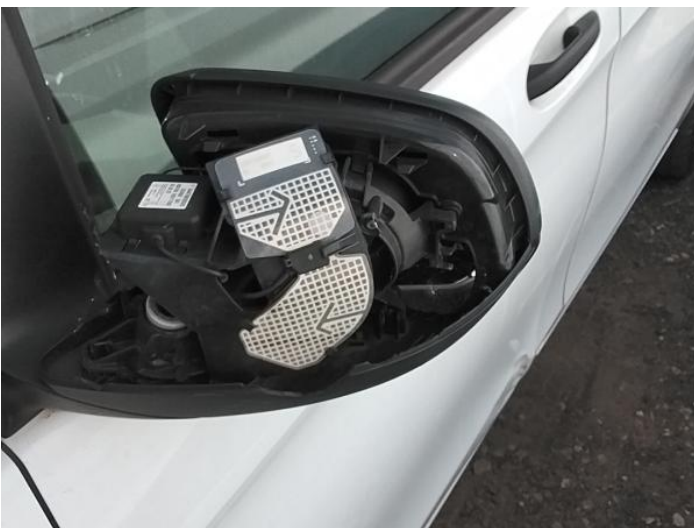
13: Door Mirror Assy osf
Broken
Replace
