VEHICLE INSPECTION REPORT

PK67VCM

Daf LF 150

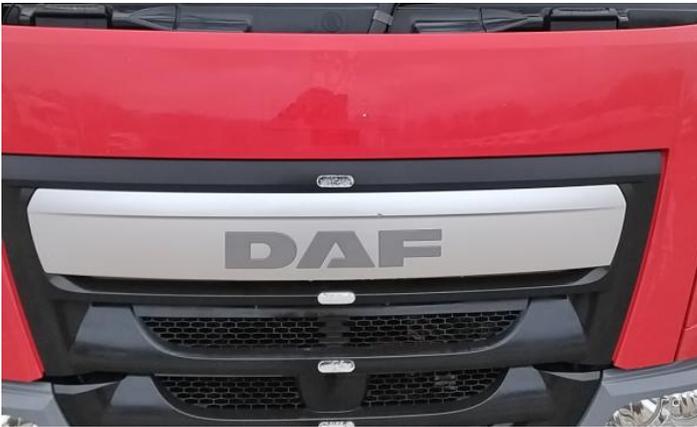
1: Bonnet
Chipped
Multiple Chips

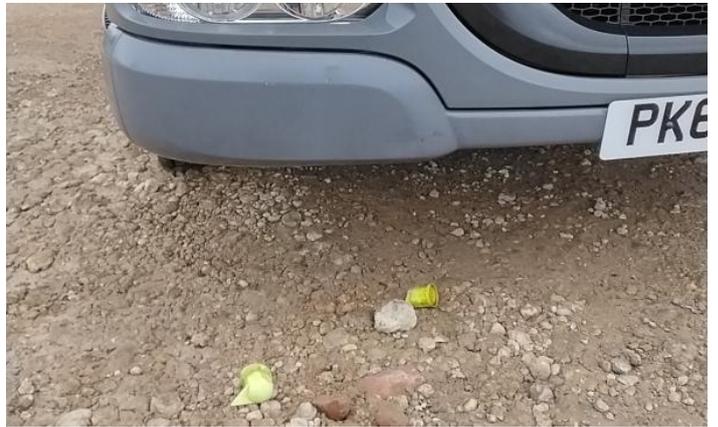
2: Bumper Front
Chipped
Multiple Chips

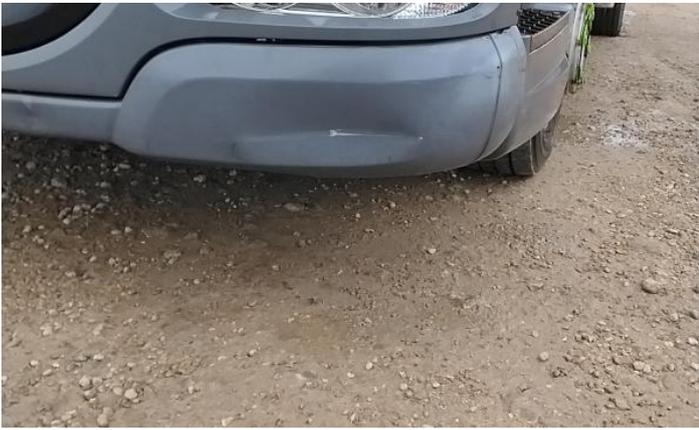
3: Bumper Front
Dented
With Paint Damage

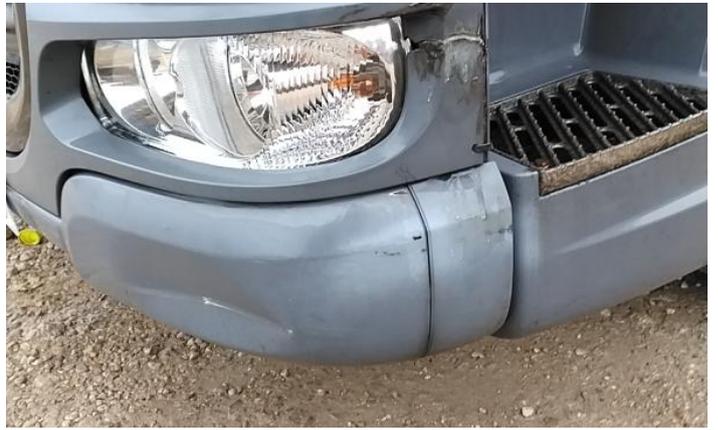
4: Fog Lamp Surround ns
Broken
Replace

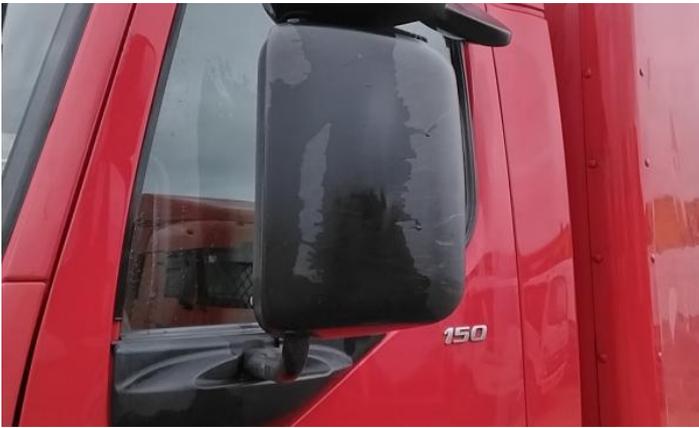
5: Door Mirror Assy nsf
Scuffed (Unpainted)
Over 100mm

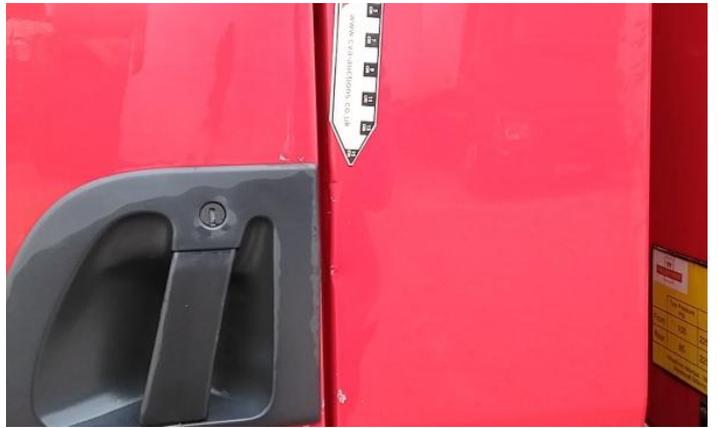
6: B Post ns
Dented
With Paint Damage

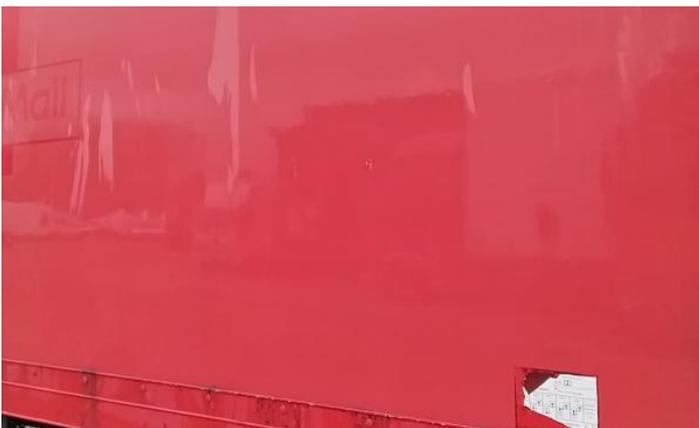
7: Qtr Panel nsr
Scratched
Over 25mm Thru Paint

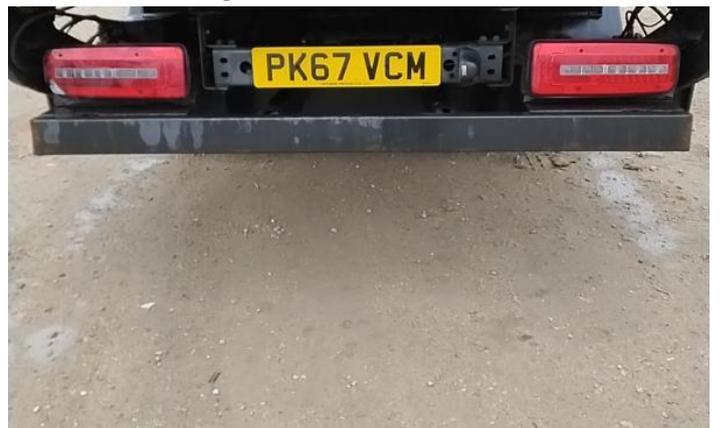
8: Bumper Rear
Rusted
Over 5mm

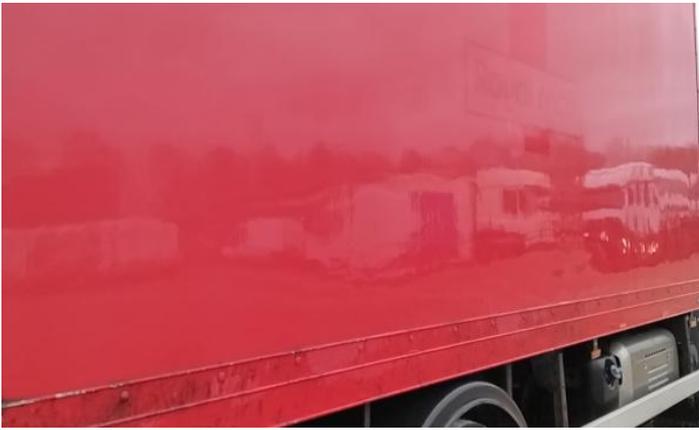
9: Qtr Panel osr
Scratched
Over 25mm Not Thru Paint

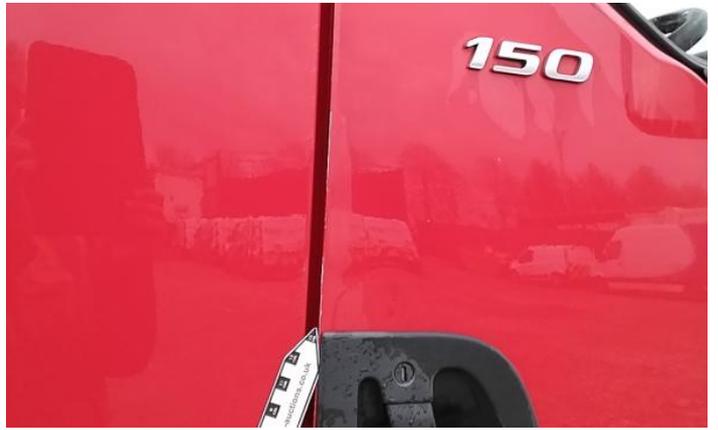
10: Door osf
Chipped
Edge Chip

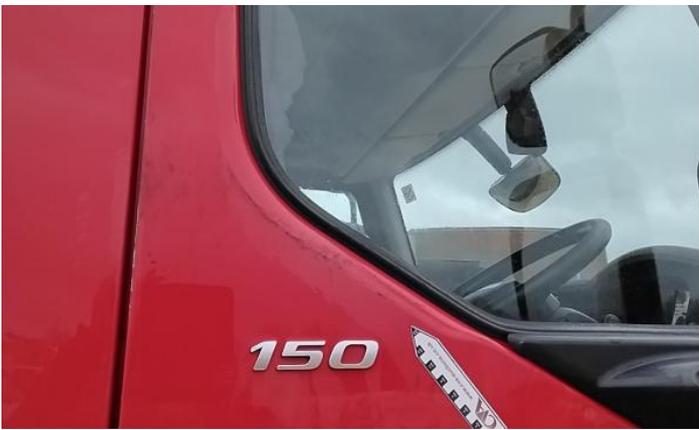
11: Door osf
Scratched
Over 25mm Not Thru Paint

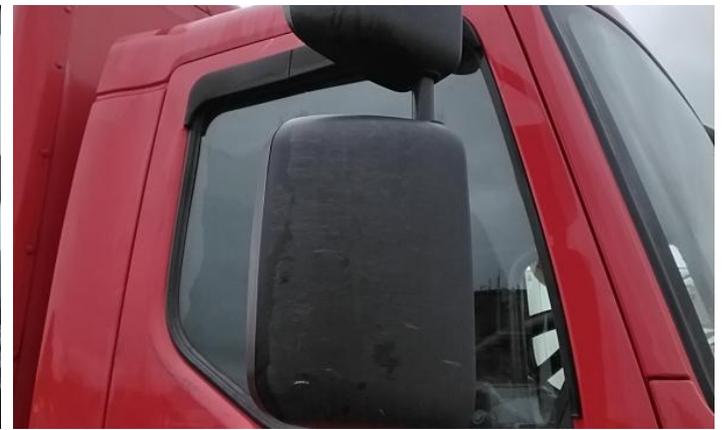
12: Door Mirror Assy osf
Scuffed (Unpainted)
Over 100mm

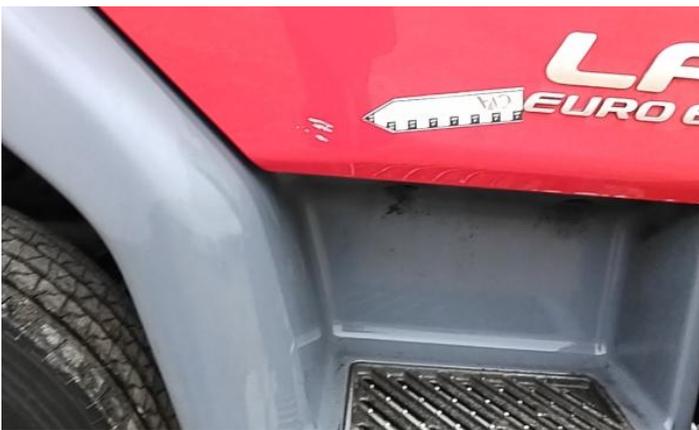
13: Door osf
Scratched
Over 25mm Thru Paint

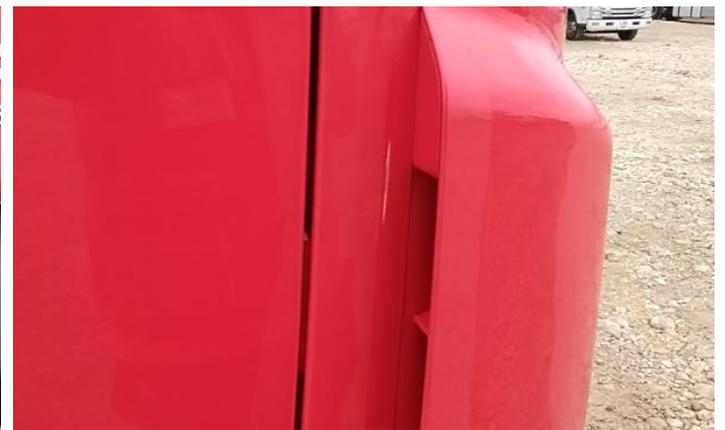
14: Wing osf
Scratched
Over 25mm Thru Paint

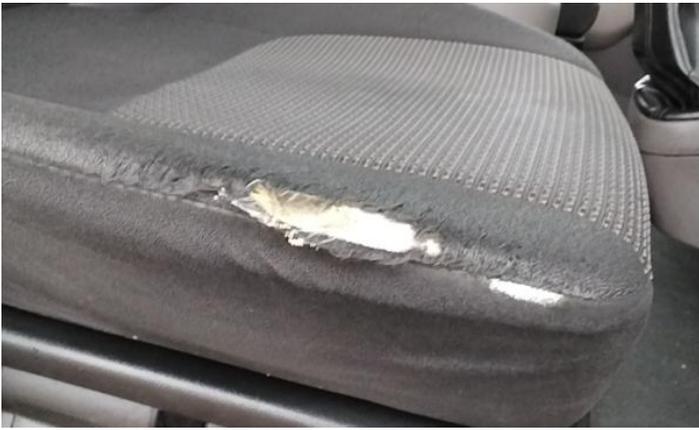
15: Seat Base Cover osf
 Holed
 Over 3mm
