# VEHICLE INSPECTION REPORT

**DY16TXJ**

## Daf LF 220

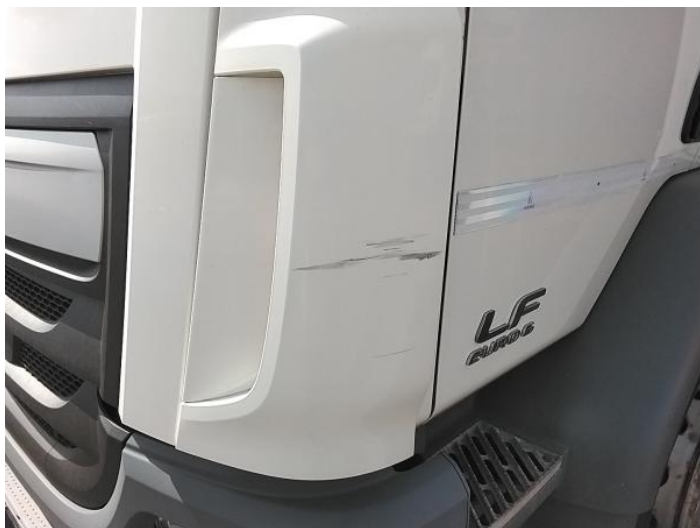
1: Panel Front  
Scratched  
Over 25mm Thru Paint

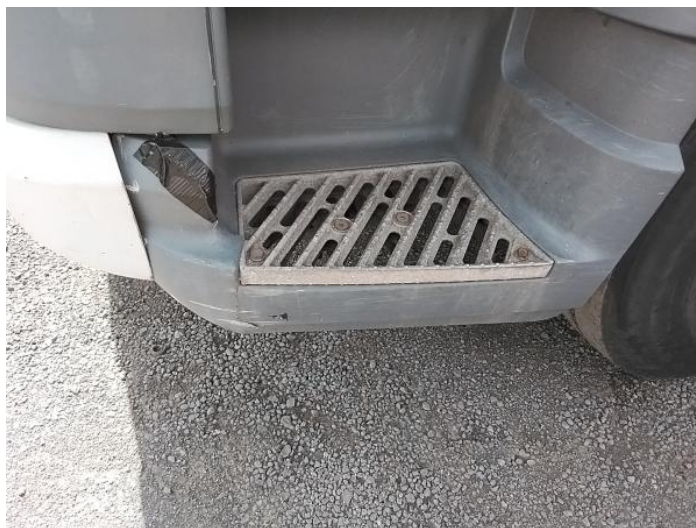
2: Bumper Front Moulding  
Broken  
Replace

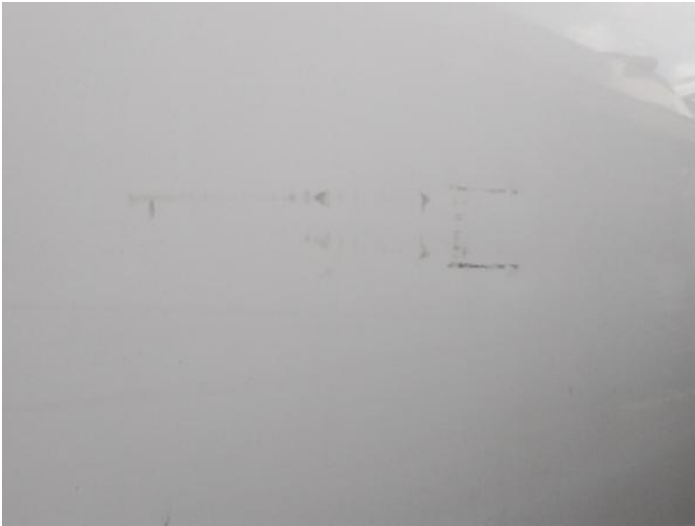
3: Qtr Panel nsr  
Scratched  
Over 25mm Thru Paint

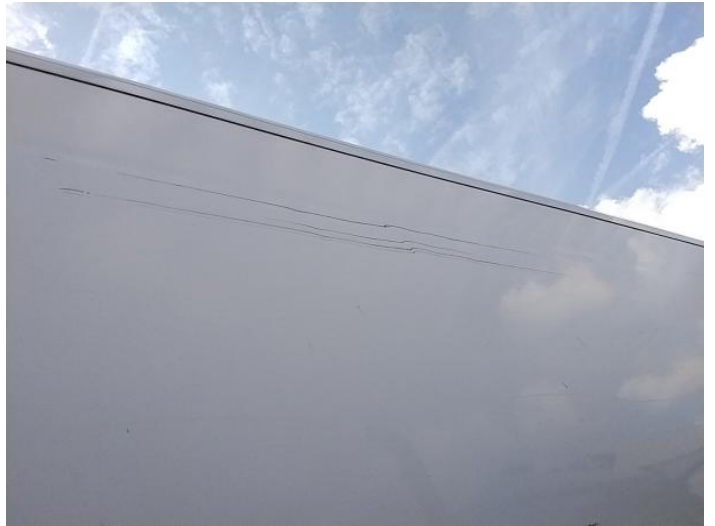
4: Qtr Panel nsr  
Dented  
With Paint Damage

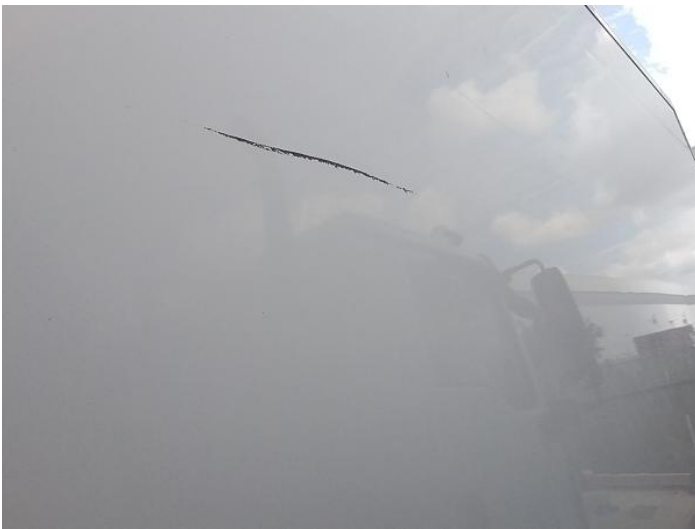
5: Qtr Panel nsr  
Scratched  
Over 25mm Thru Paint

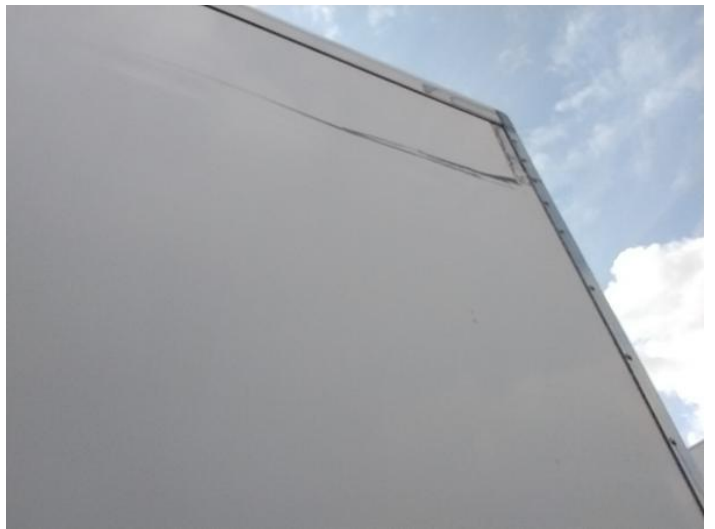
6: Qtr Panel nsr  
Cracked  
Replace

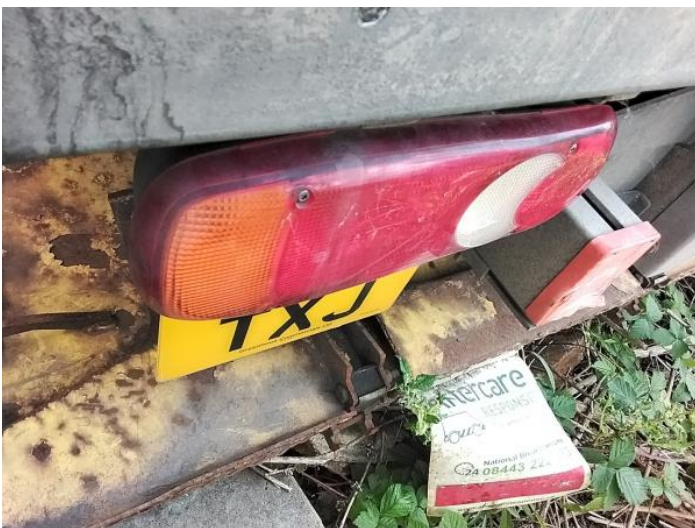
7: Lamp nsr  
Broken  
Replace

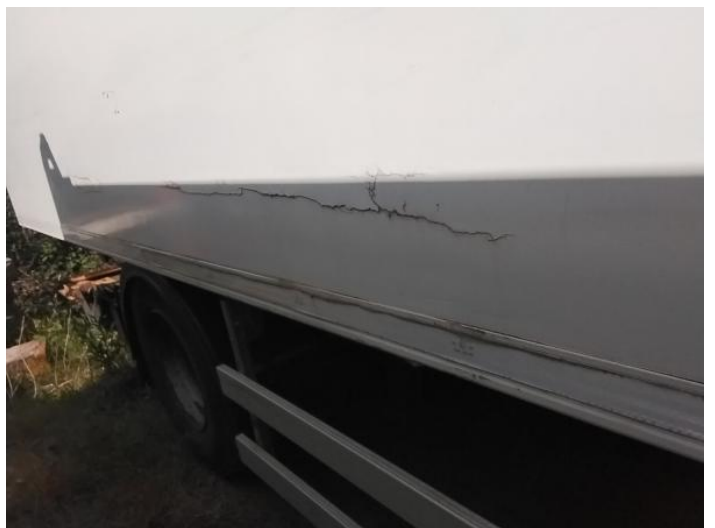
8: Qtr Panel osr  
Cracked  
Replace

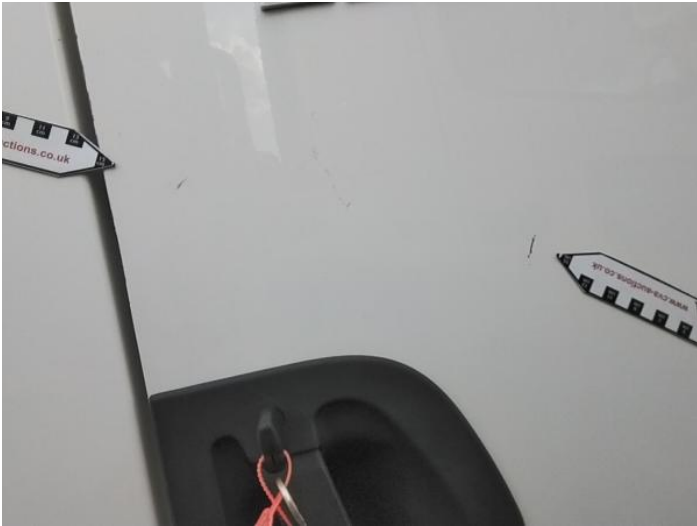
9: Door osf  
 Scratched  
 Over 25mm Thru Paint

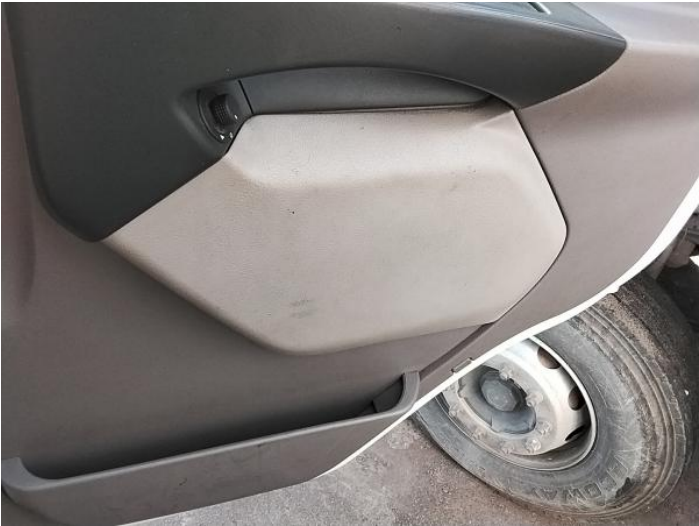
10: Door Pad osf  
 Soiled  
 Heavy

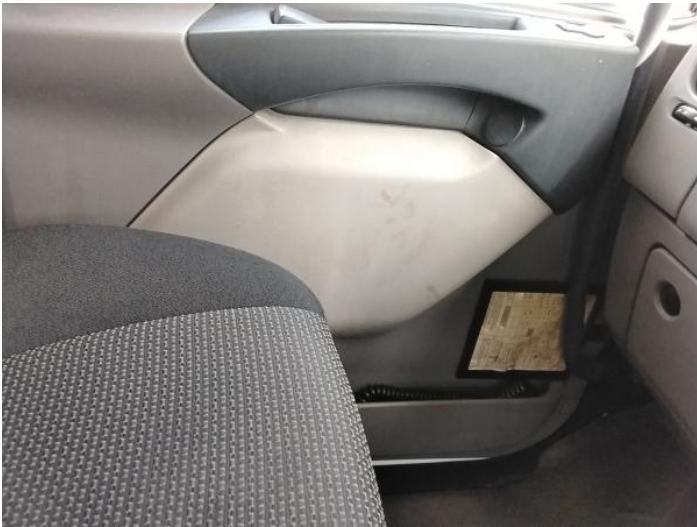
11: Door Pad nsf  
 Soiled  
 Heavy
