VEHICLE INSPECTION REPORT

WX67JUW

ISUZU D-MAX 1.9 EXTENDED

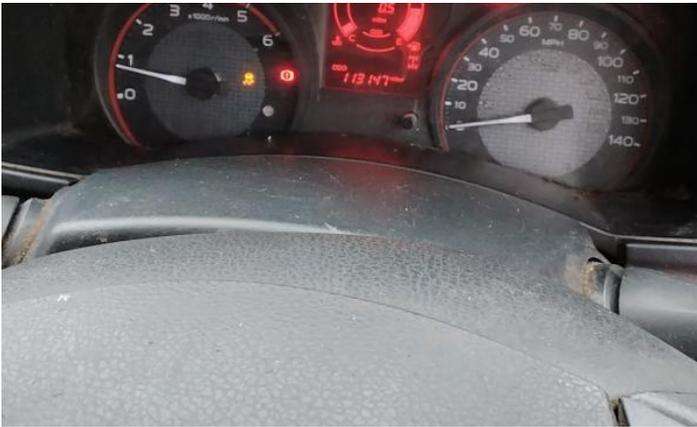
1: Dash Warning Lights
Displayed
No Action

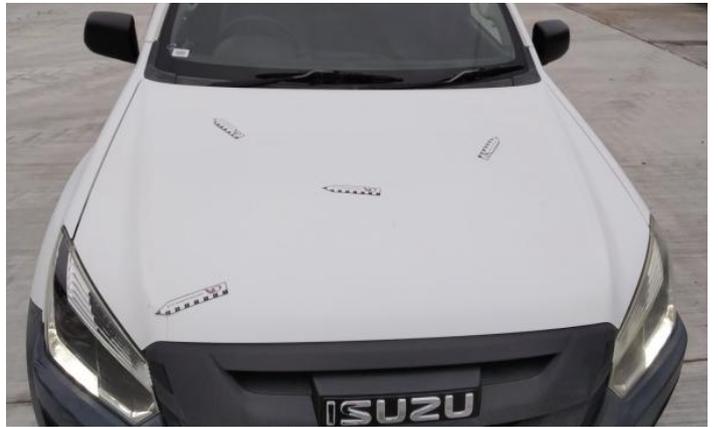
2: Bonnet
Scratched
Over 25mm Thru Paint

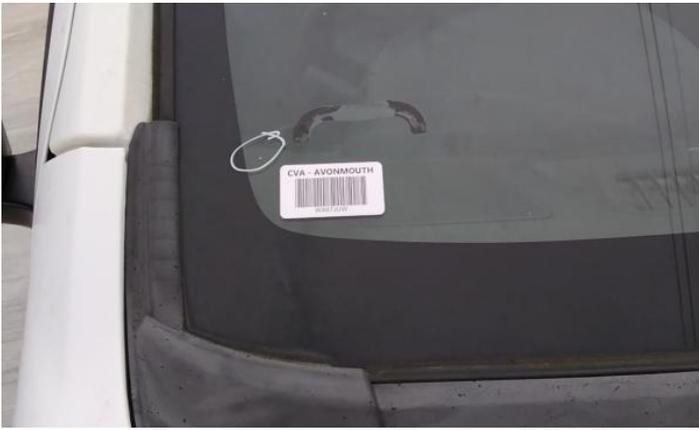
3: Screen Front
Chipped
Over 10mm

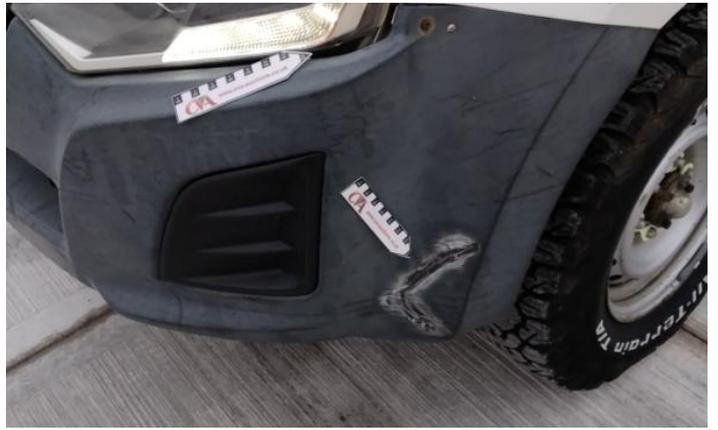
4: Bumper Front
Insecure
Action Required

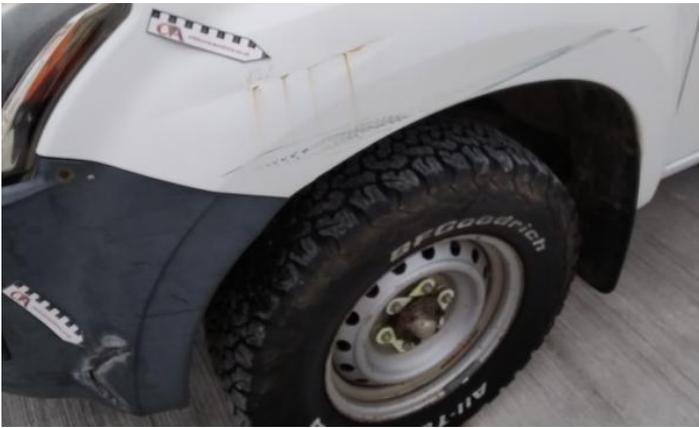
5: Wing nsf
Dented
With Paint Damage

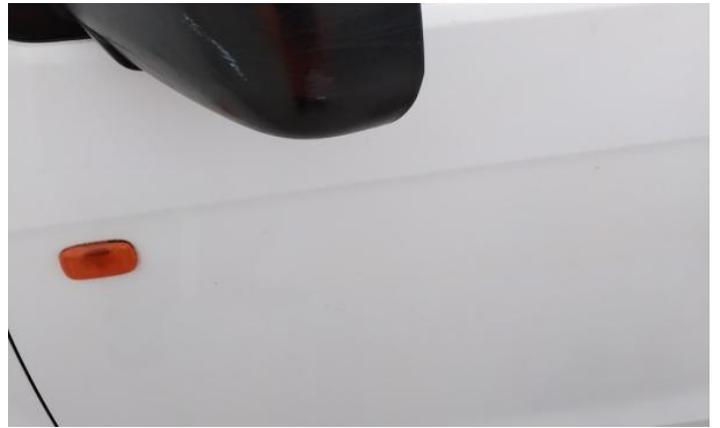
6: Door Mirror Assy nsf
Scuffed (Unpainted)
Over 100mm

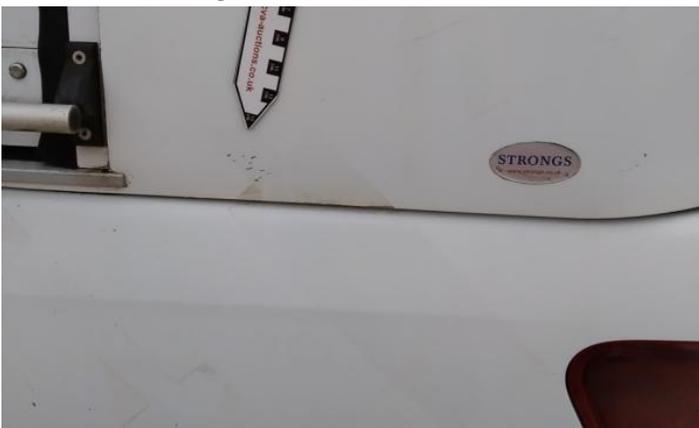
7: Qtr Panel nsr
Cracked
Replace

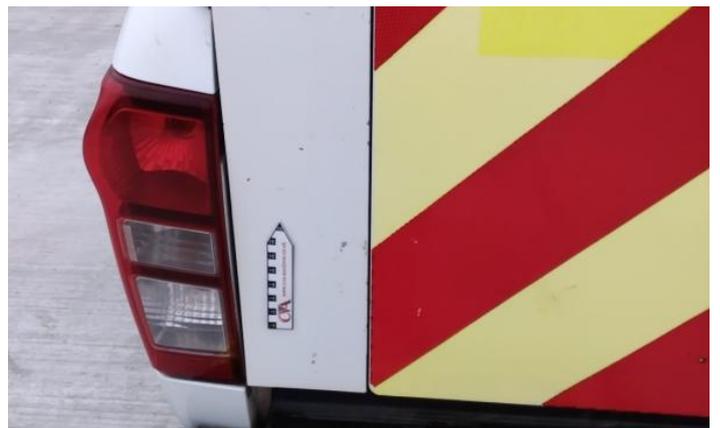
8: Panel Rear
Scratched
Over 25mm Thru Paint

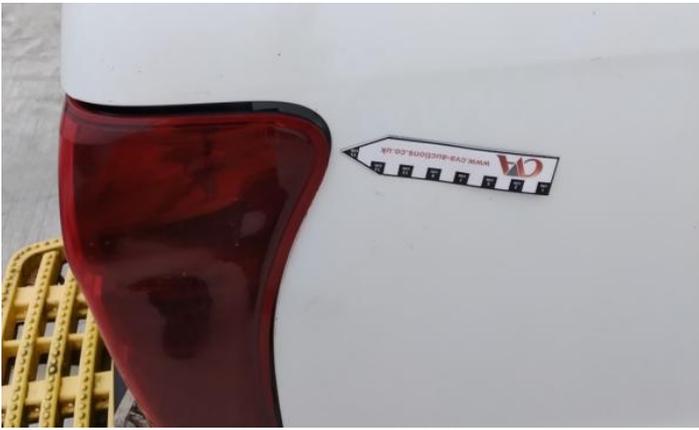
9: Lamp osf
Broken
Replace

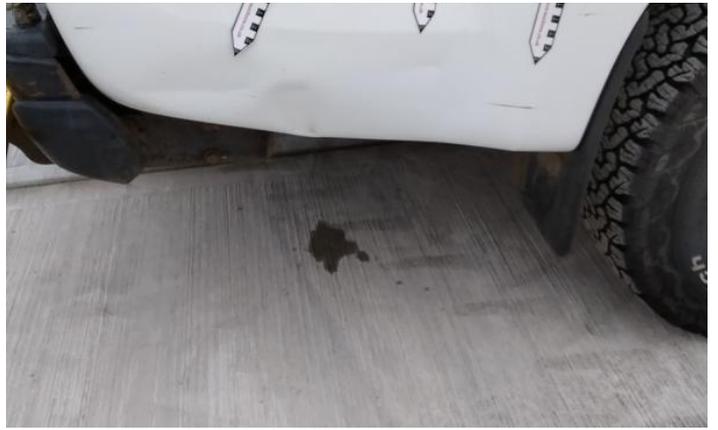
10: Qtr Panel osf
Dented
With Paint Damage

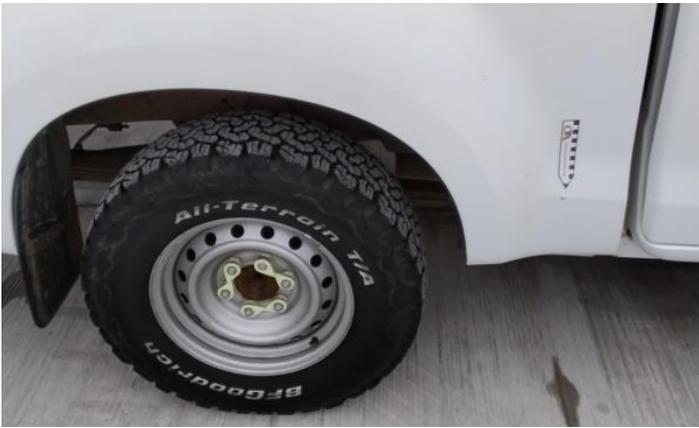
11: Qtr Panel osf
Scratched
Over 25mm Thru Paint

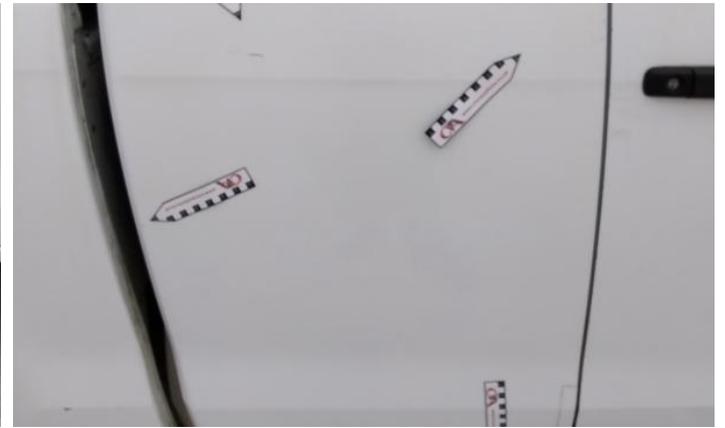
12: Wing osf
Scratched
Over 25mm Thru Paint

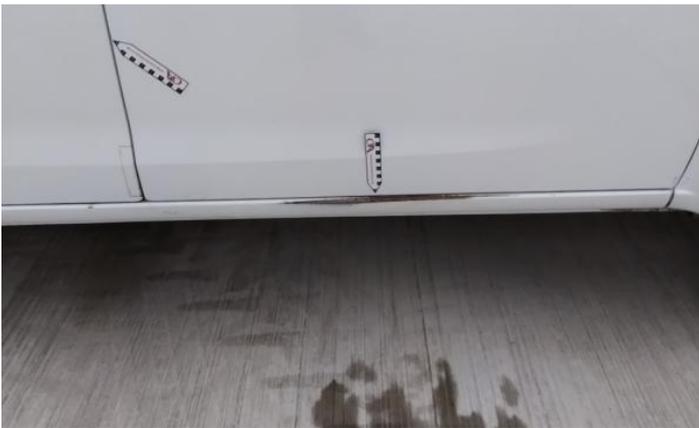
13: Door osf
Scratched
Rusted

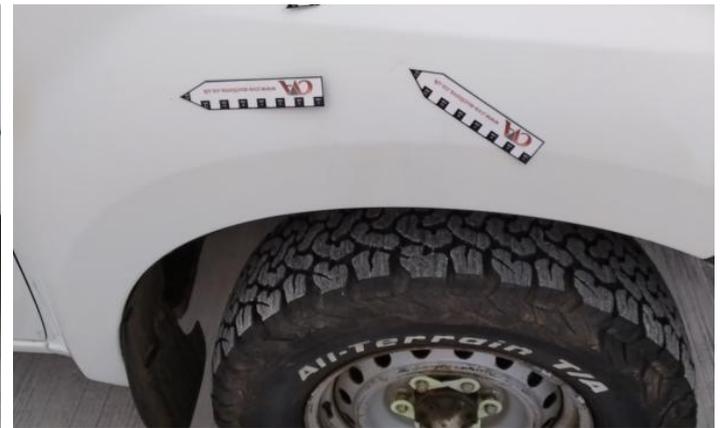
14: Wing osf
Scratched
Rusted

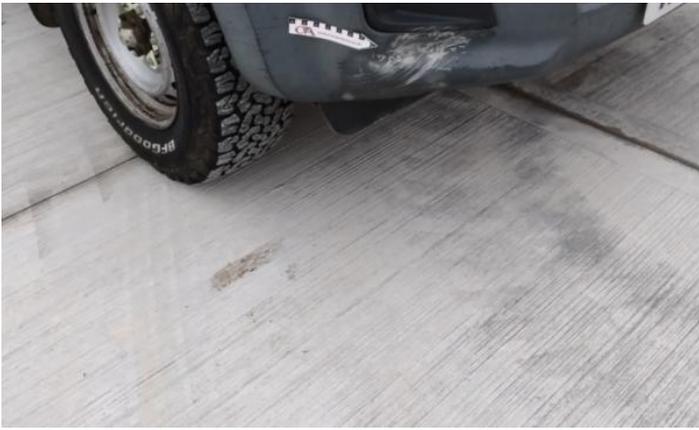
15: Bumper Front
Cracked
Over 25mm
