VEHICLE INSPECTION REPORT

YF66UTY

Ford Transit 350 2.0 TDCI 130PS

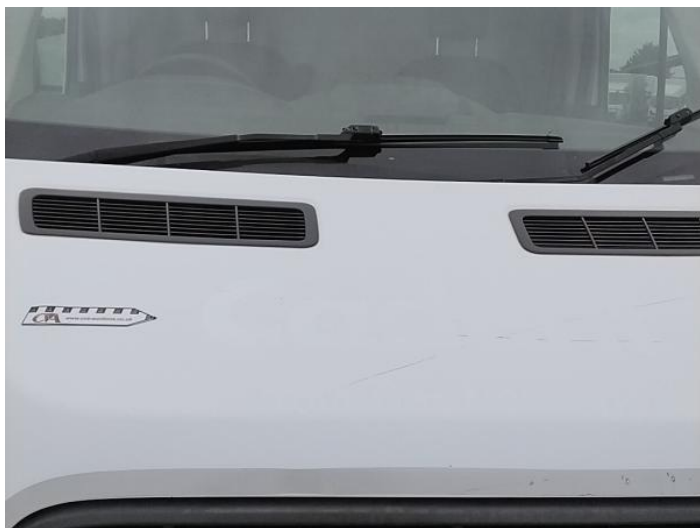
1: Bonnet
Scratched
Over 25mm Thru Paint

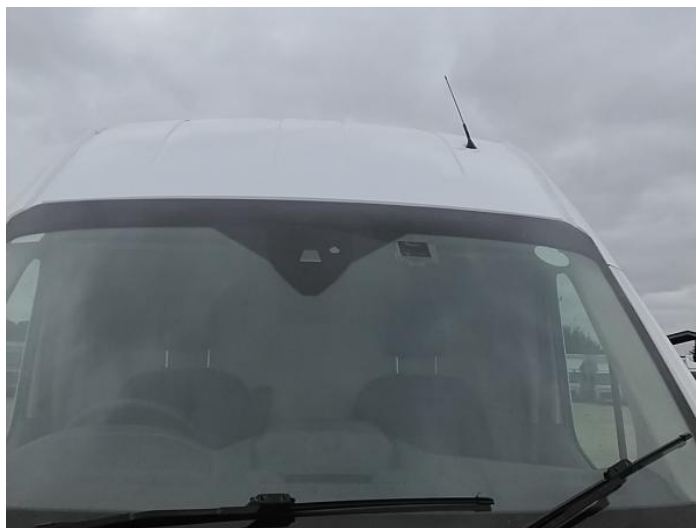
2: Screen Front
Cracked
Replace

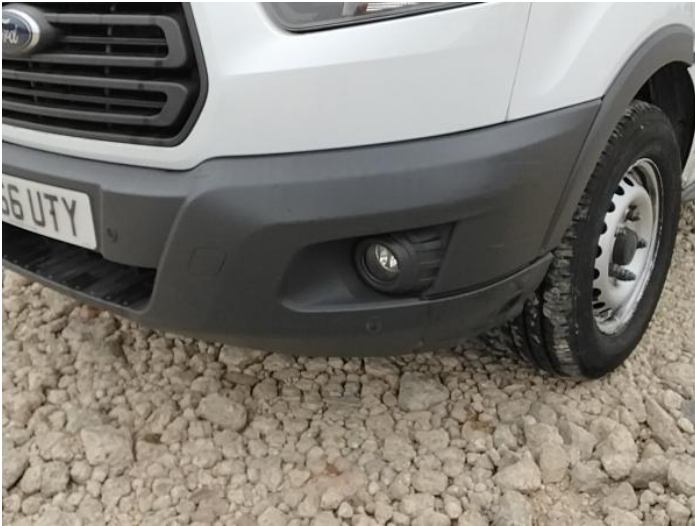
3: Bumper Front Moulding
Scuffed (Unpainted)
UpTo 100mm

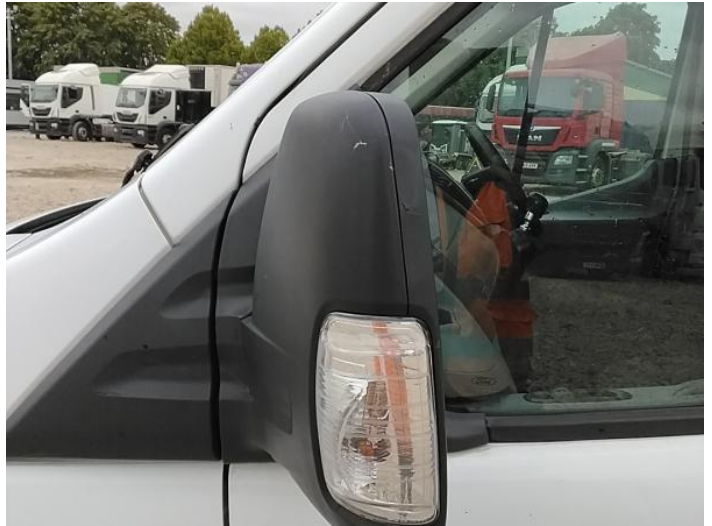
4: Door Mirror Assy nsf
Scuffed (Unpainted)
UpTo 100mm

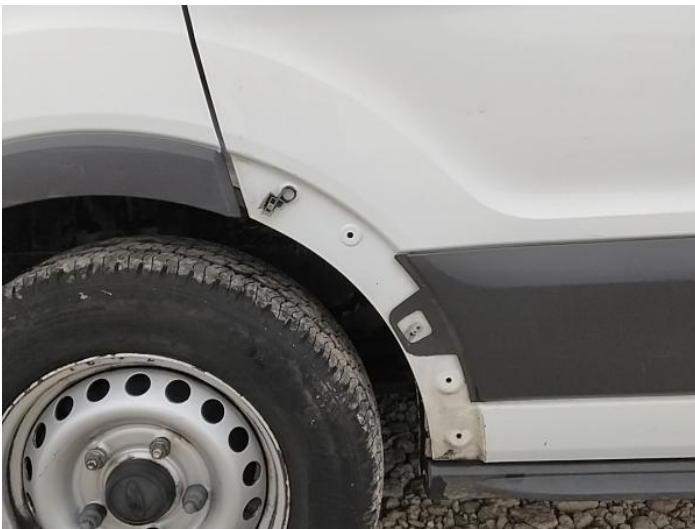
5: Moulding nsf Wing
Missing
Replace

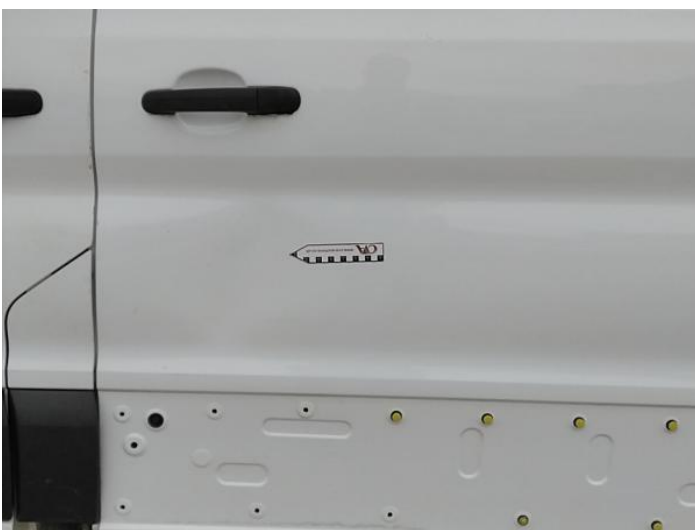
7: Door nsr
Dented
Between 10mm + 30mm

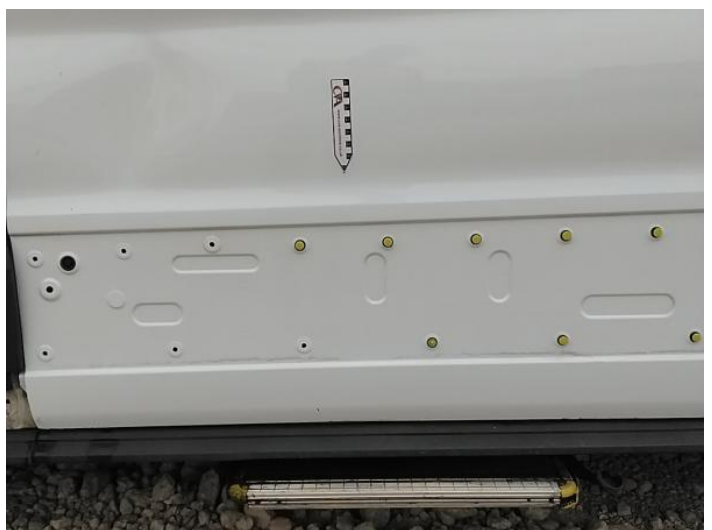
8: Door Moulding nsr
Missing
Replace

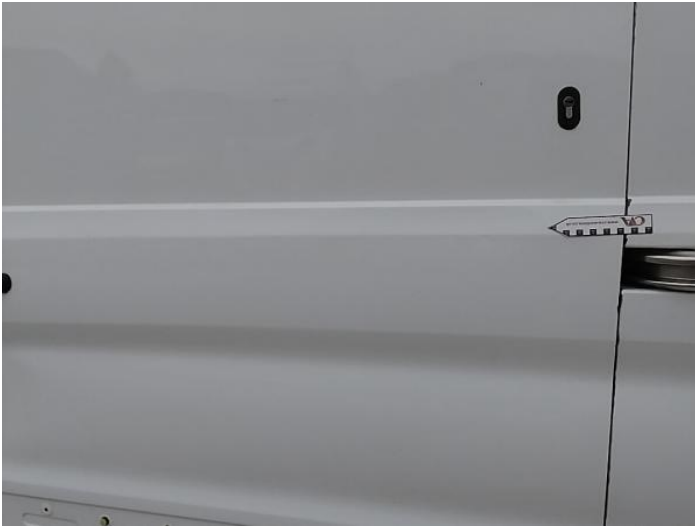
9: Door nsr
Dented
Between 10mm + 30mm

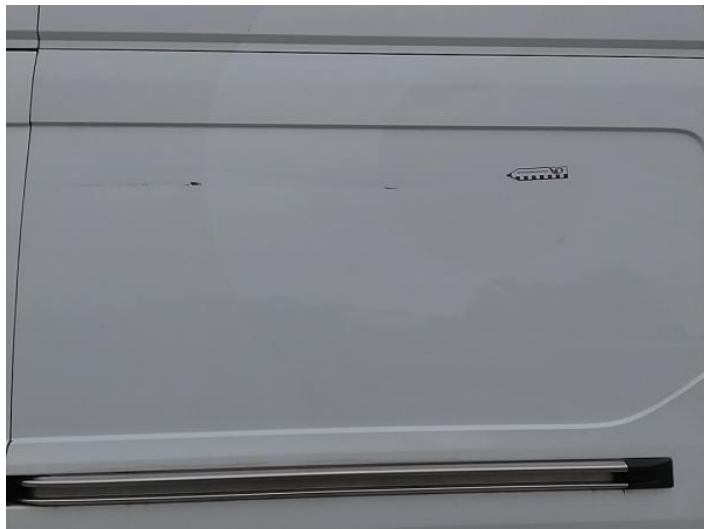
12: Qtr Panel nsr
Dented
Between 10mm + 30mm

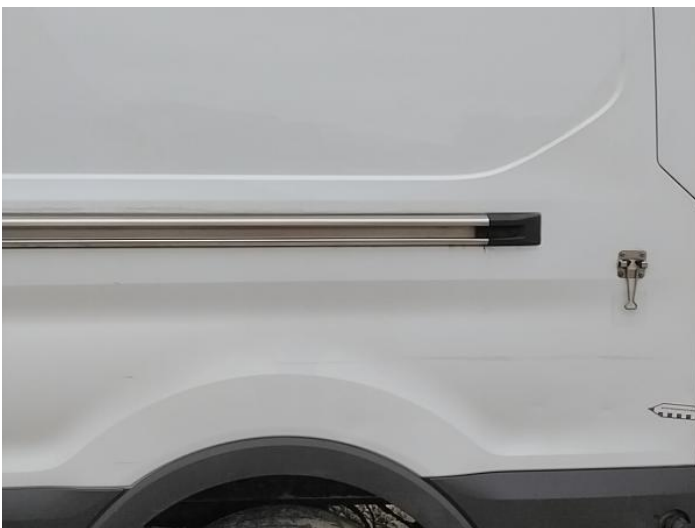
13: Qtr Panel nsr
Dented
Over 2 UpTo 10mm

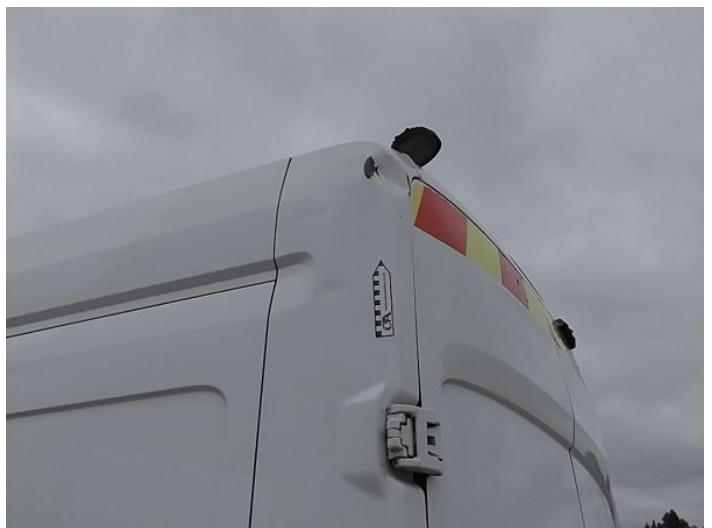
14: Qtr Panel nsr
Dented
With Paint Damage

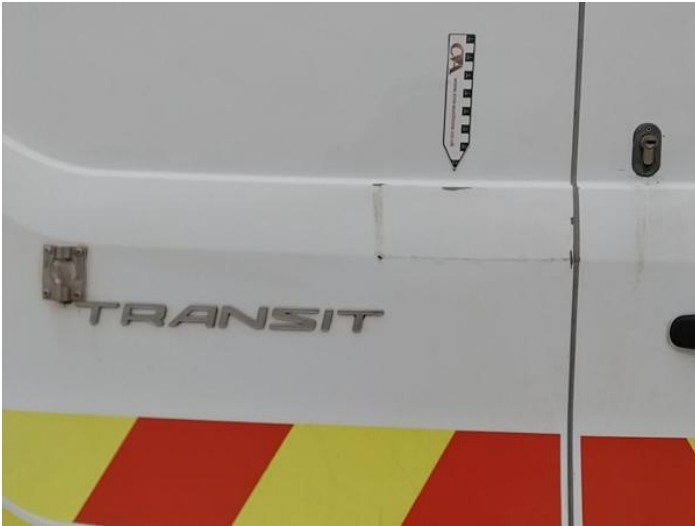
15: Door nsr
Scratched
UpTo 25mm Thru Paint

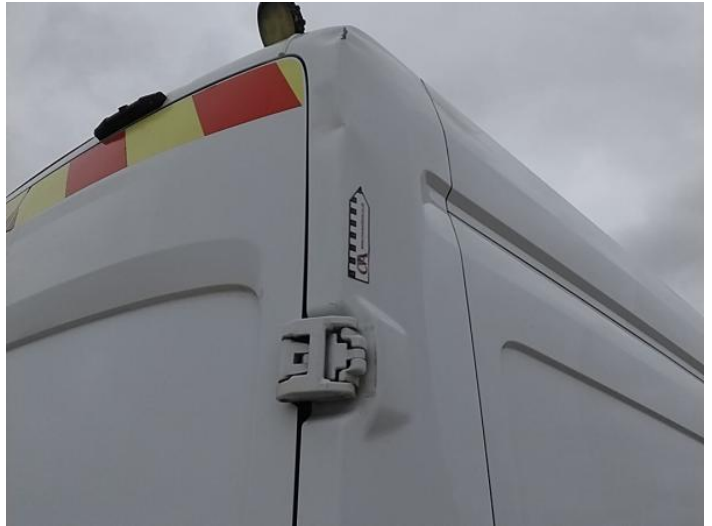
16: Qtr Panel osr
Dented
With Paint Damage

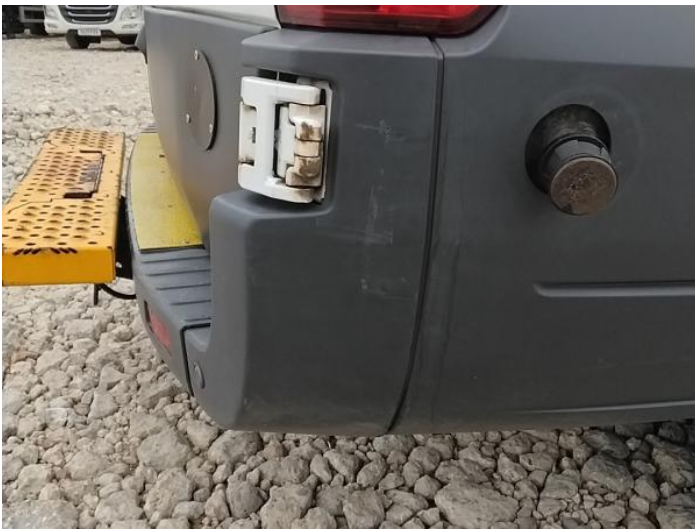
17: Bumper Rear Moulding
Scuffed (Unpainted)
UpTo 100mm

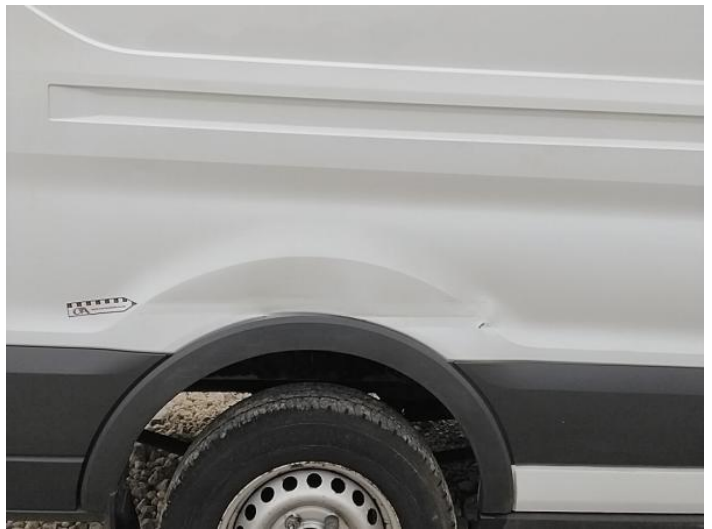
18: Qtr Panel osr
Dented
With Paint Damage

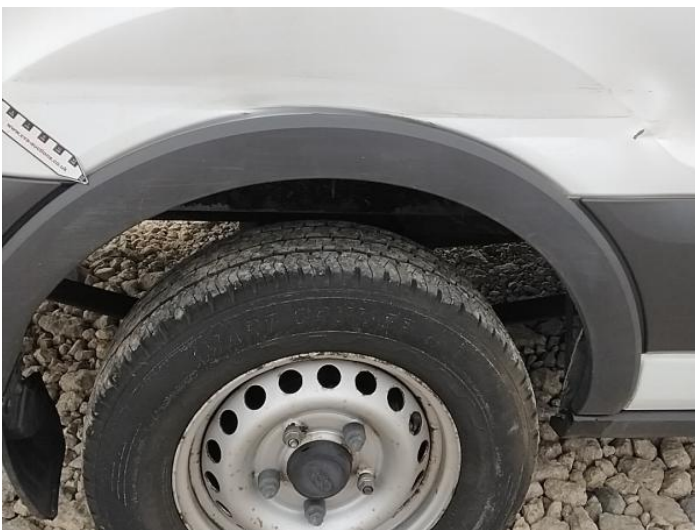
19: Qtr Panel Arch Extension os
Scuffed (Unpainted)
UpTo 100mm

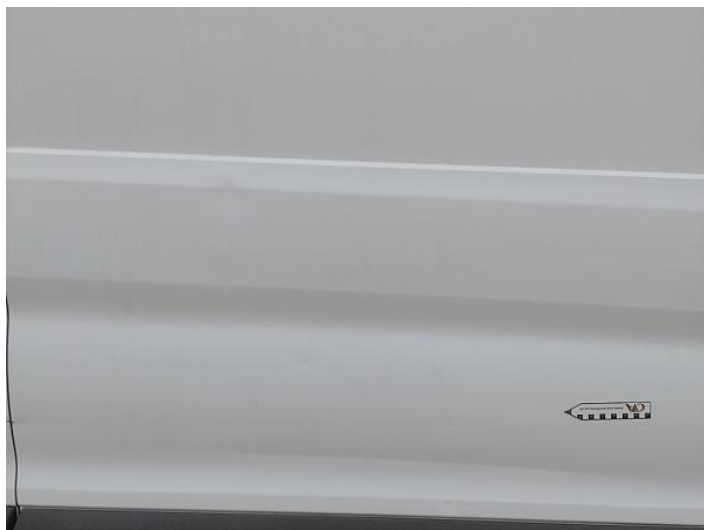
20: Qtr Panel osr
Dented
Over 2 UpTo 10mm

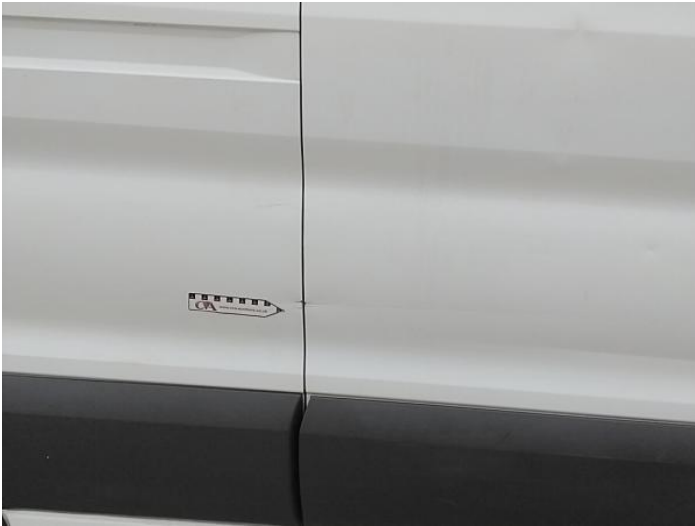
21: Qtr Panel osr
Dented
With Paint Damage

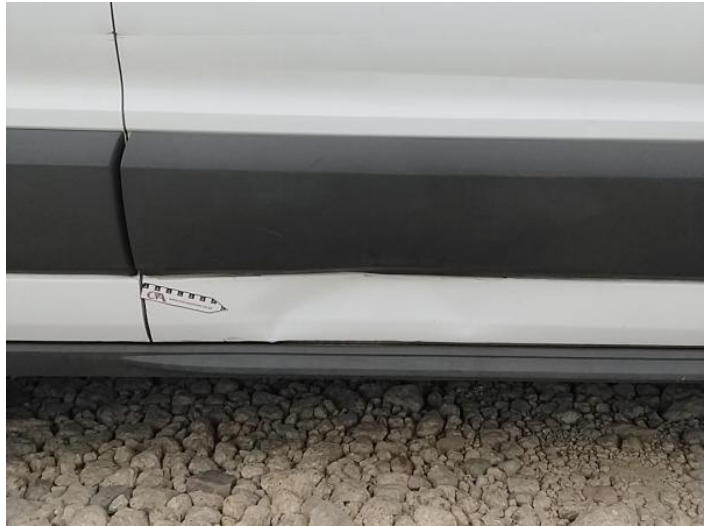
22: Qtr Panel osr
Dented
Between 10mm + 30mm

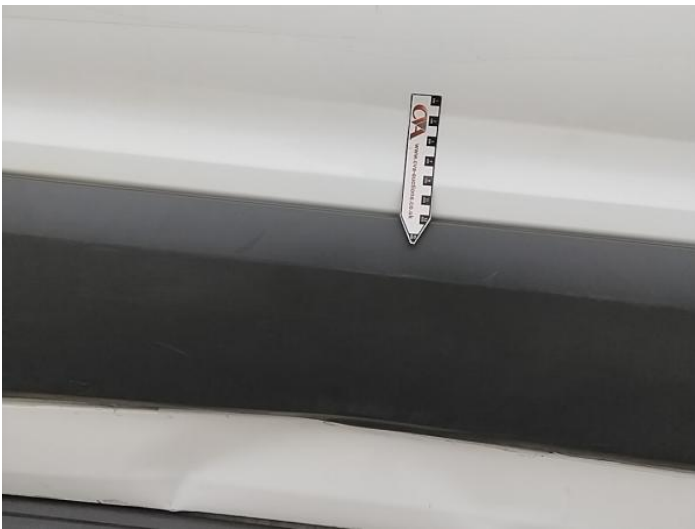
23: Qtr Panel Moulding os
Broken
Replace

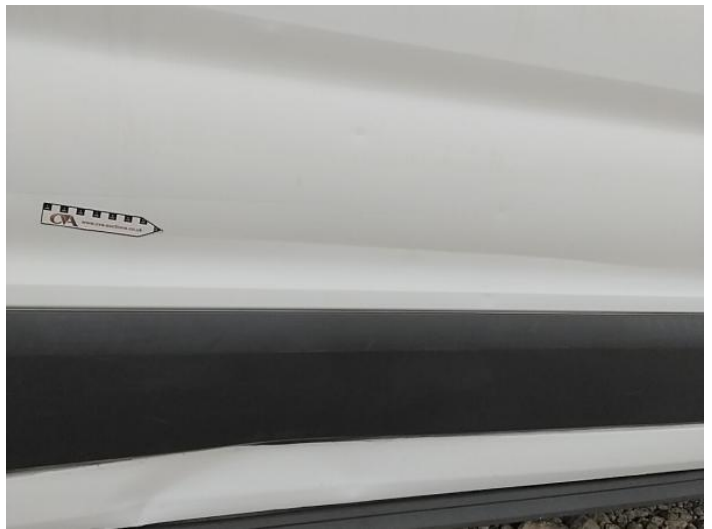
24: Qtr Panel osr
Dented
Over 30mm

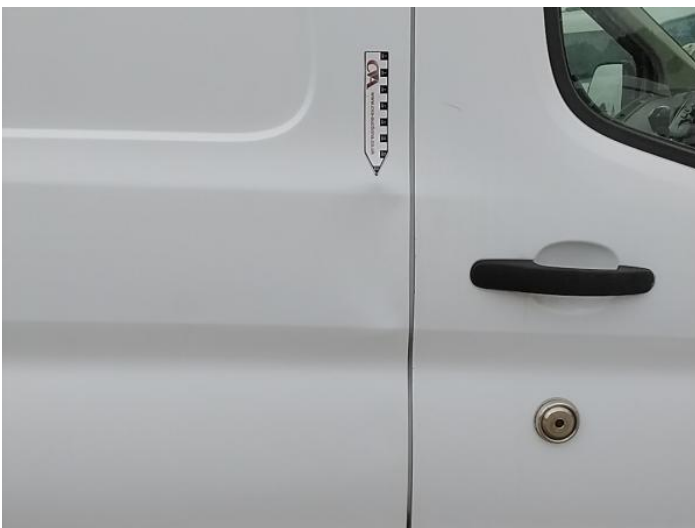
25: Qtr Panel nsr
Dented
Over 2 UpTo 10mm

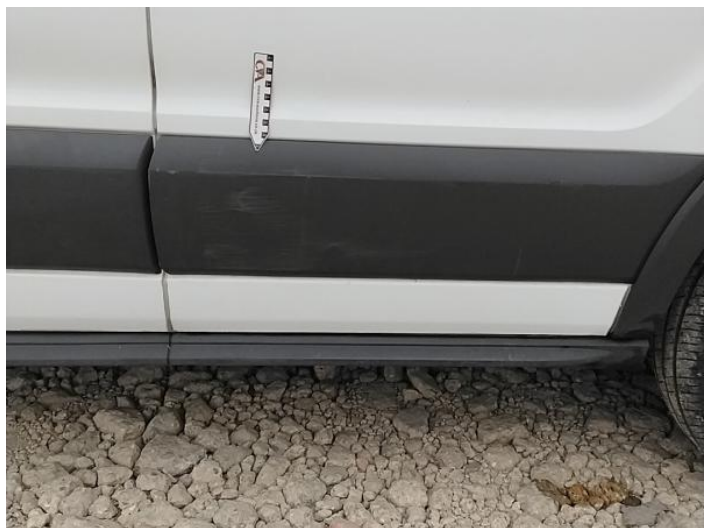
26: Door Moulding osf
Scuffed (Unpainted)
UpTo 100mm

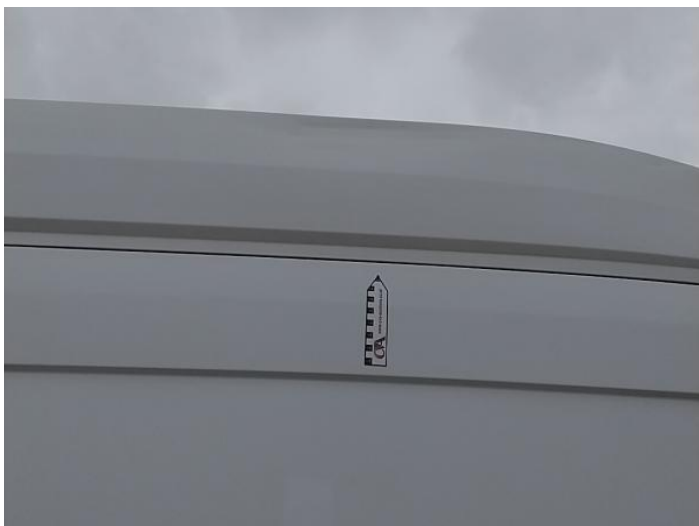
27: Qtr Panel osr
Dented
Over 30mm

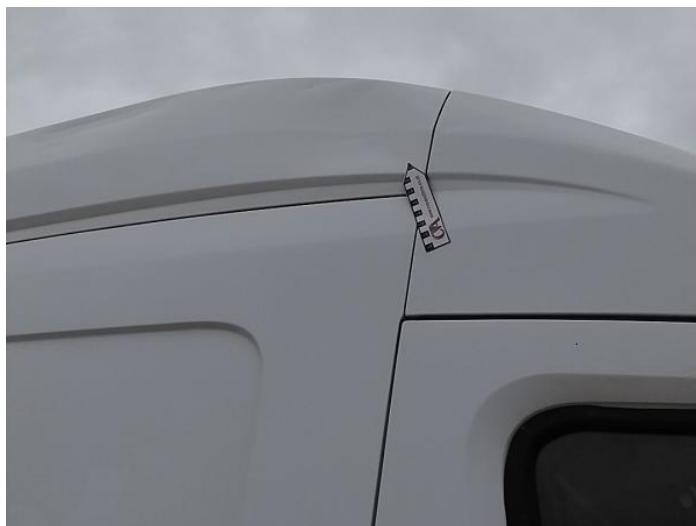
28: Qtr Panel osr
Dented
Between 10mm + 30mm

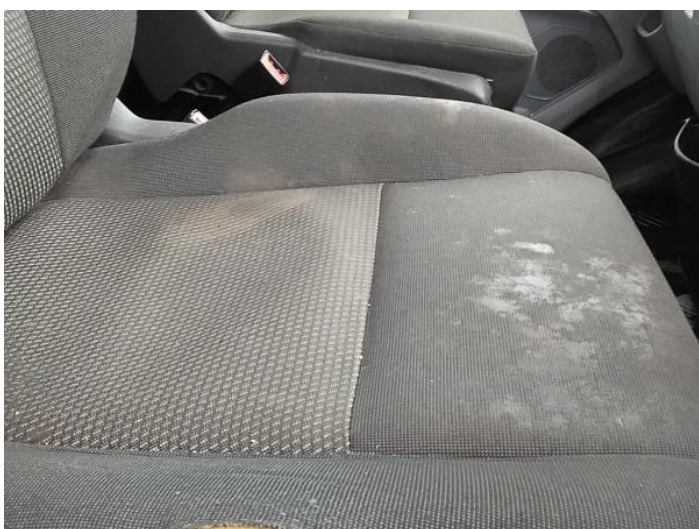
29: Seat Base Cover osf
Holed
Over 3mm
