# VEHICLE INSPECTION REPORT

**WN14VGZ**

## Fiat Doblo 1.3 Multijet 16V

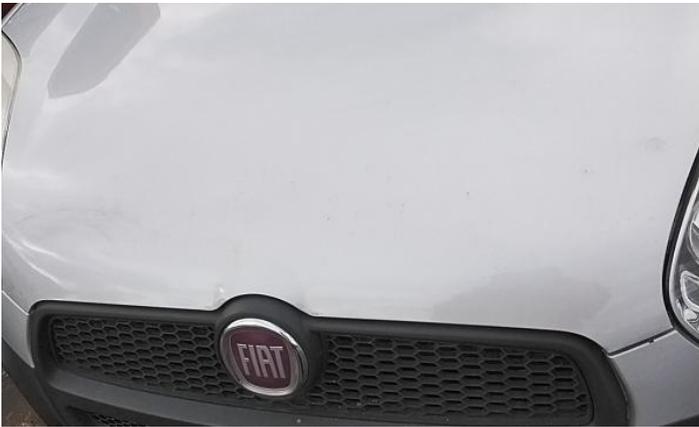
1: Bonnet  
Chipped  
Multiple Chips

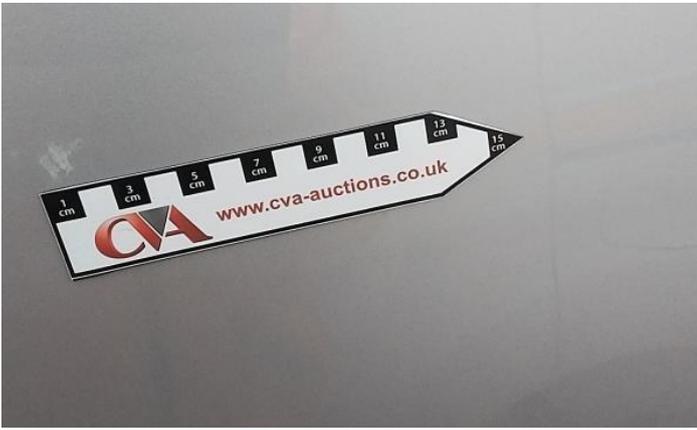
3: Qtr Panel nsr  
Scratched  
Over 25mm Thru Paint

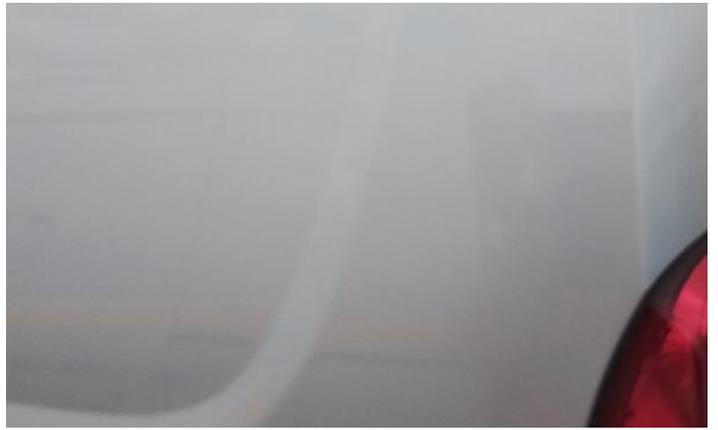
4: Qtr Panel nsr  
Chipped  
Multiple Chips

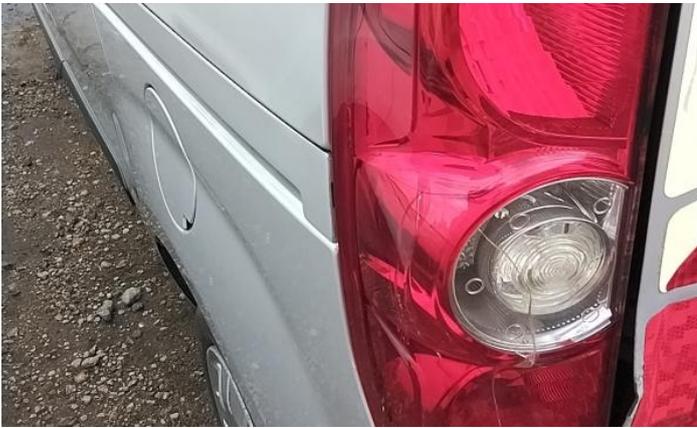
5: Lamp nsr  
Broken  
Replace

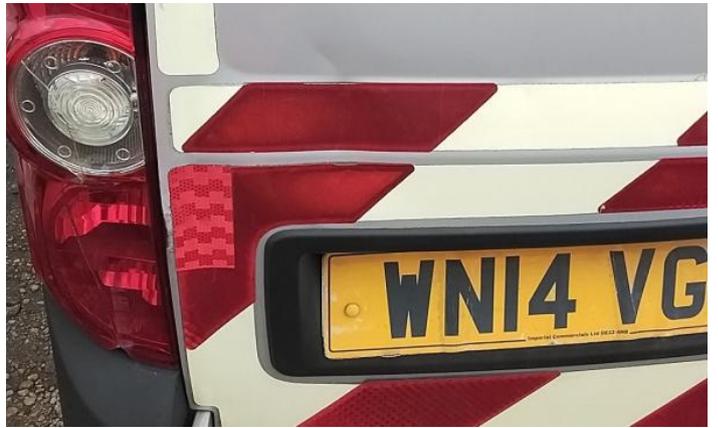
6: Door nsr  
Dented  
With Paint Damage

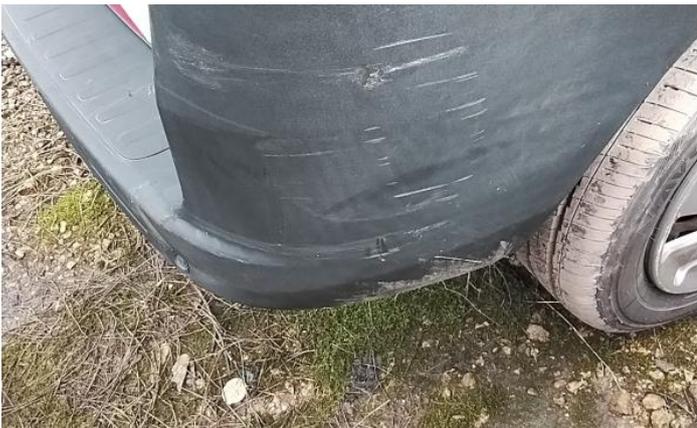
7: Bumper Rear  
Scratched  
Over 100mm Thru Paint

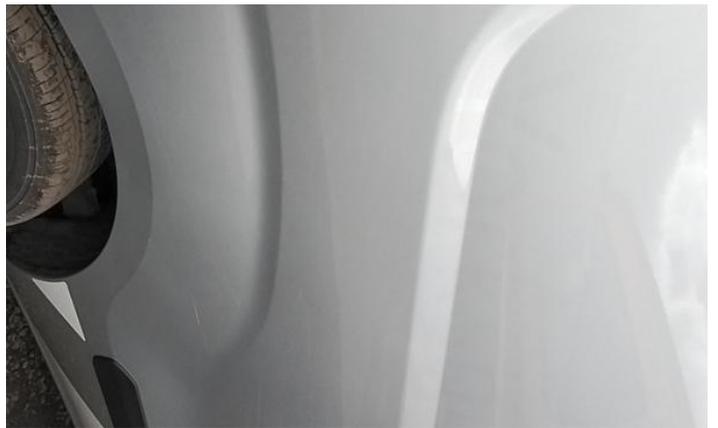
8: Qtr Panel osr  
Scratched  
Over 25mm Thru Paint

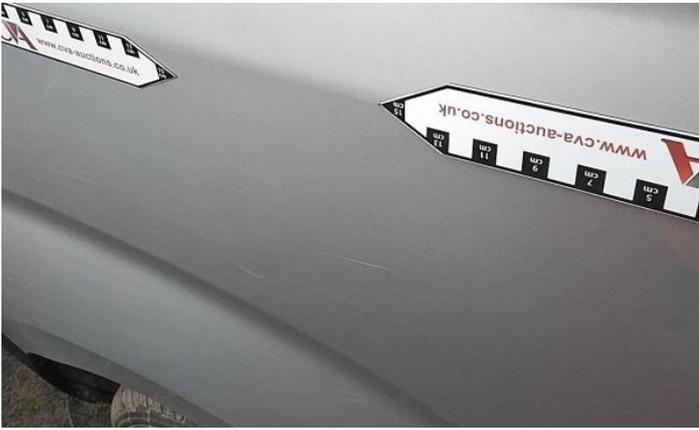
9: Qtr Panel osr  
Dented  
Over 30mm

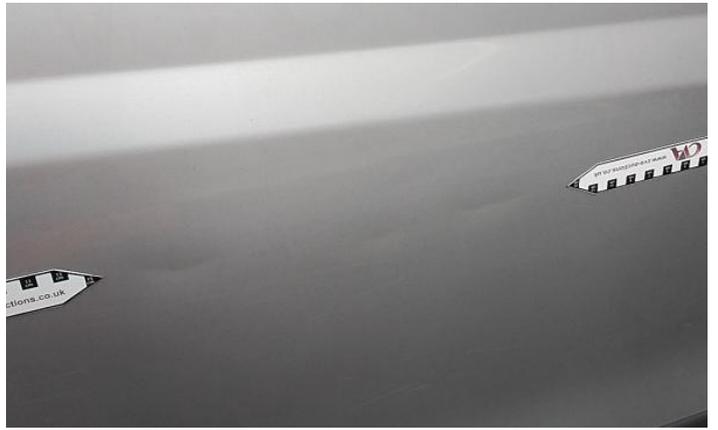
10: Qtr Panel osr  
Dented  
Over 30mm

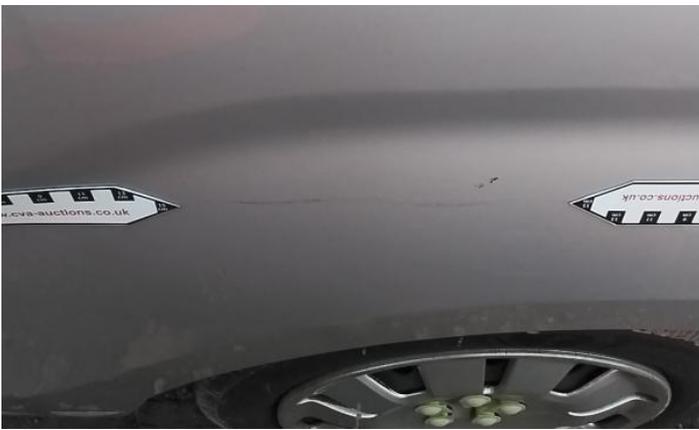
11: Wing osf  
Scratched  
Over 25mm Not Thru Paint

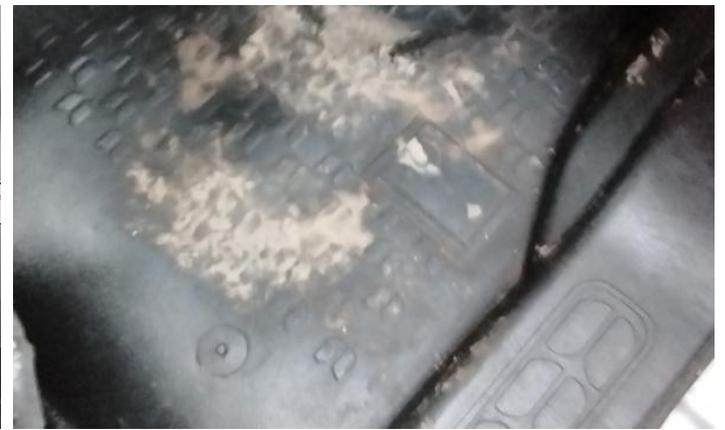
12: Carpets Front  
Holed  
Over 3mm

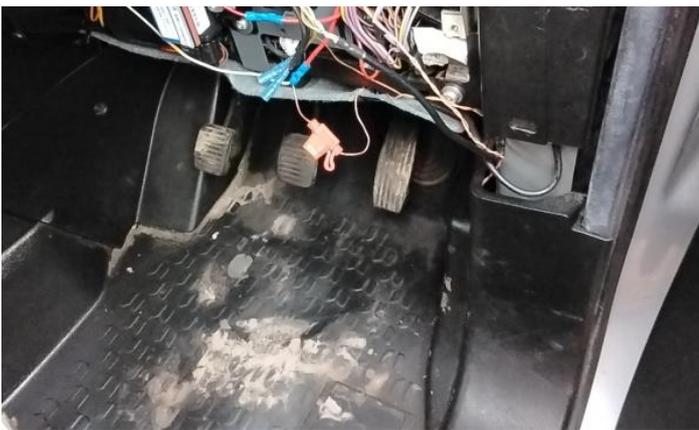
13: Fascia Panel  
Missing  
Replace

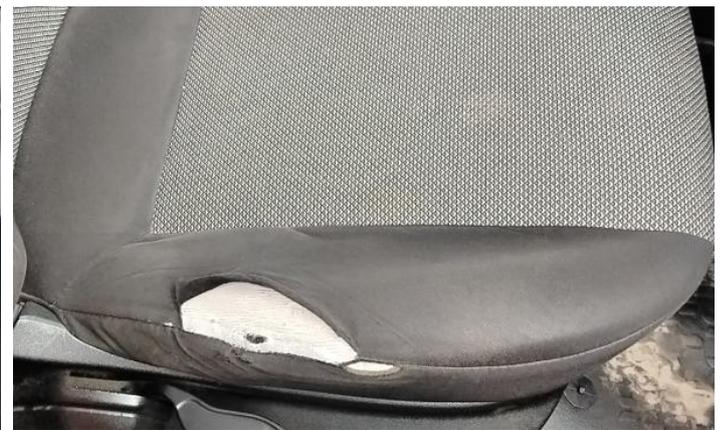
14: Seat Base Cover osf  
Holed  
Over 3mm

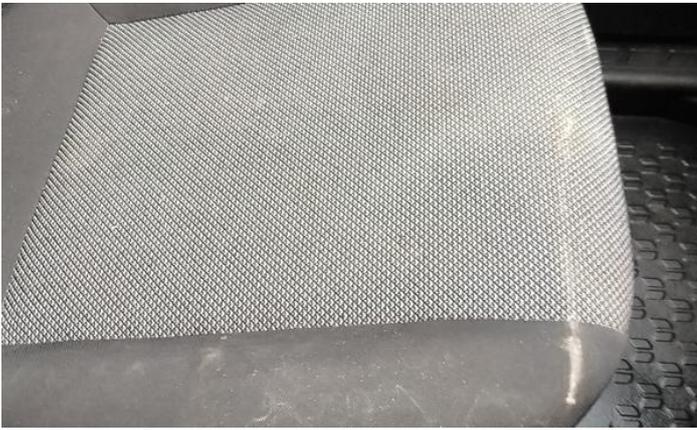
15: Seat Base Cover nsf  
Soiled  
Heavy

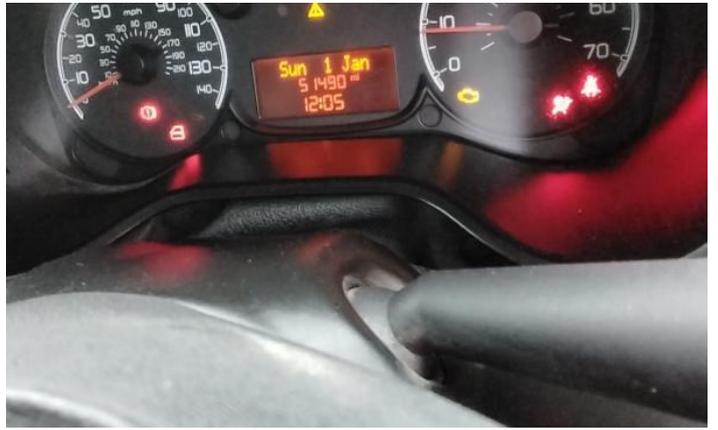
\*ONLY RUNS WITH A BOOST PACK, WARNING LIGHT ON DASH\*

16: Dash Warning Lights  
Displayed  
No Action

Engine Runs	Fault		
EML light illuminated	Fault	DPF light illuminated	OK
ABS light illuminated	OK
