VEHICLE INSPECTION REPORT

KX66YGR

Mercedes-Benz Sprinter 313 CDI

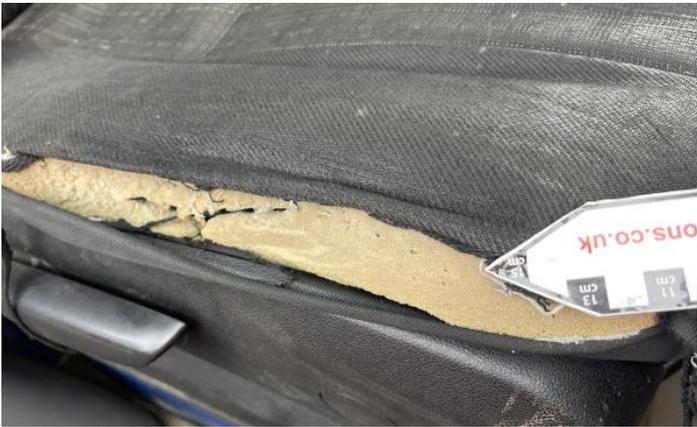
1: Seat Base Cover osf
Torn
Over 3mm

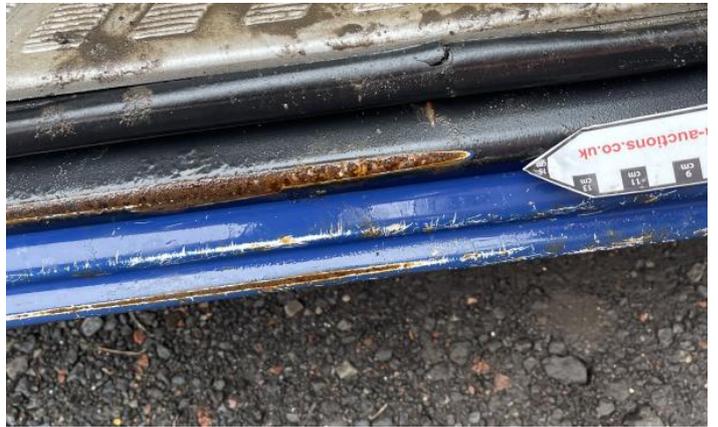
2: Sill os
Rusted
Over 5mm

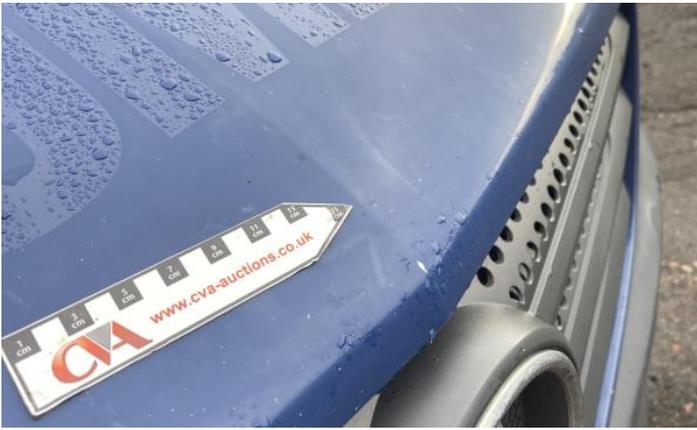
3: Bonnet
Dented
Over 30mm

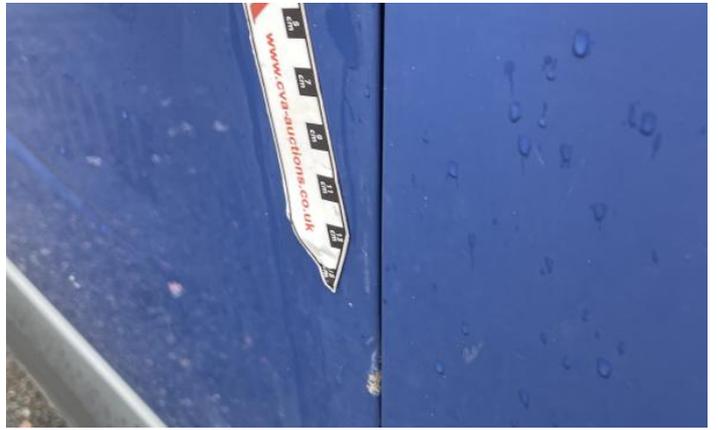
4: Door osf
Rusted
Over 5mm

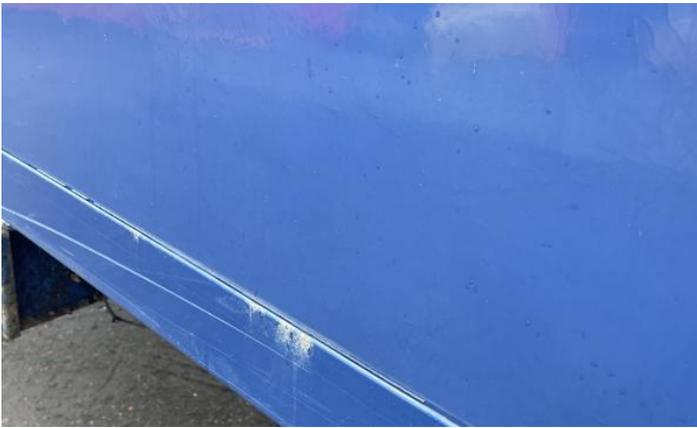
5: Qtr Panel osr
Rusted
UpTo 5mm

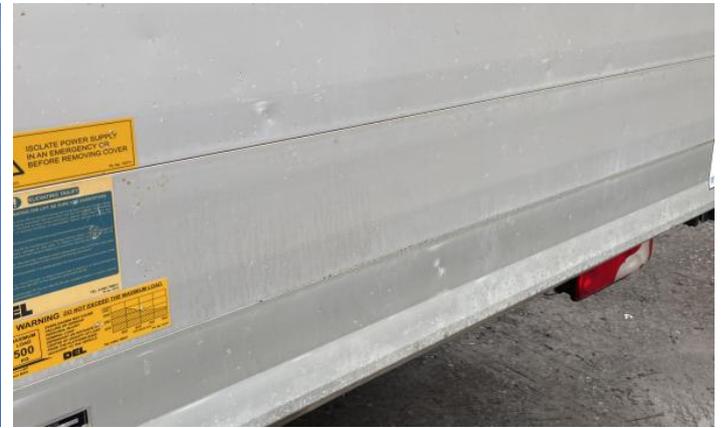
6: Tailgate
Rusted
Over 5mm

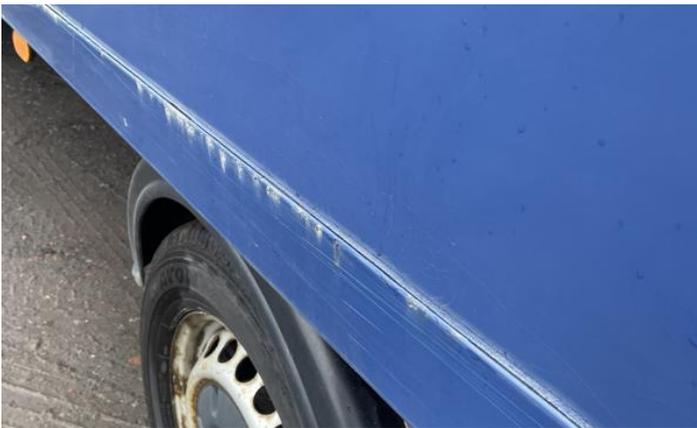
7: Qtr Panel nsr
Dented
Over 30mm

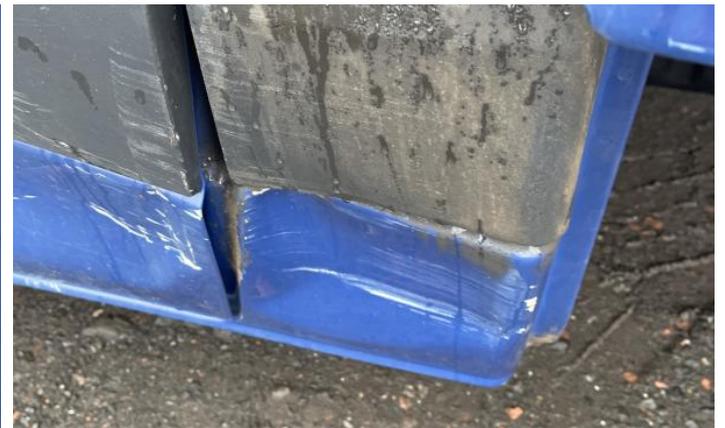
8: B Post ns
Dented
Over 30mm

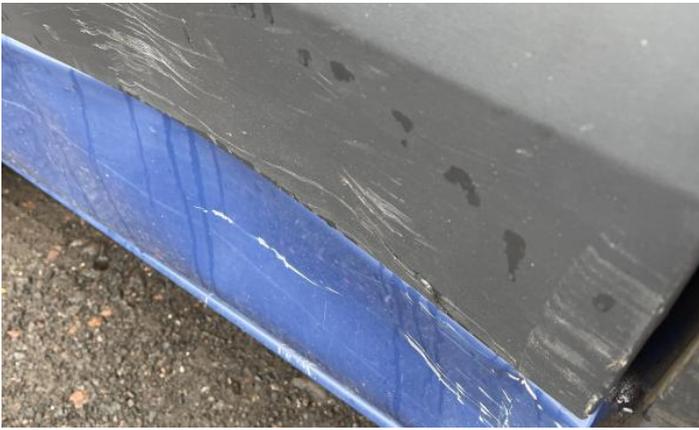
9: Door nsf
 Dented
 With Paint Damage
