# VEHICLE INSPECTION REPORT

**GL21YJC**

## Volkswagen Crafter CR35 2.0 TDI 140PS

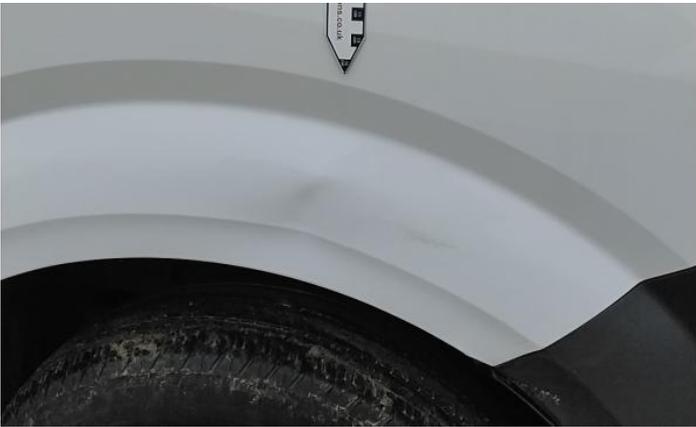
1: Wing of  
Dented  
Over 30mm

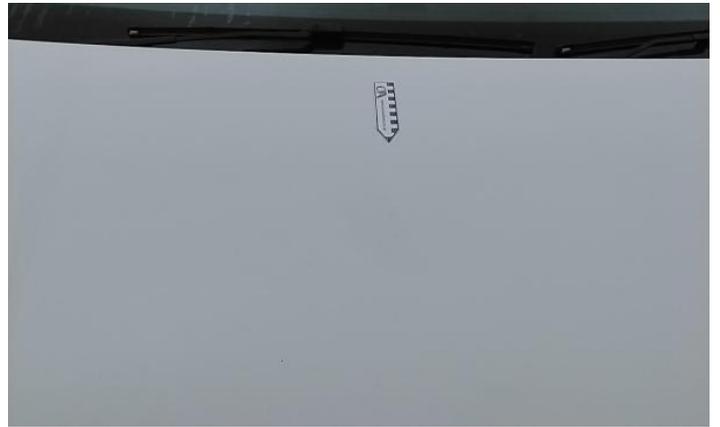
2: Bonnet  
Chipped  
Multiple Chips

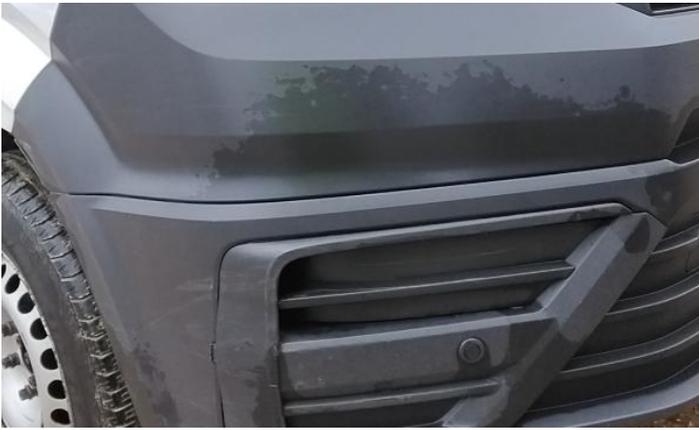
3: Bumper Front Moulding  
Scuffed (Unpainted)  
Over 100mm

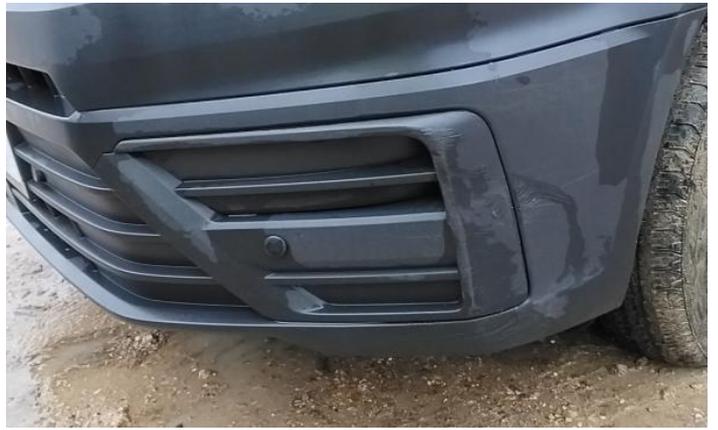
4: Bumper Front Moulding  
Scuffed (Unpainted)  
Over 100mm

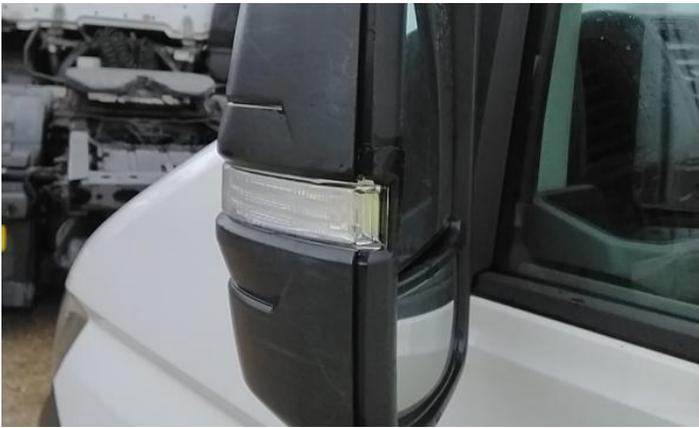
5: Door Mirror Assy nsf  
Broken  
Replace

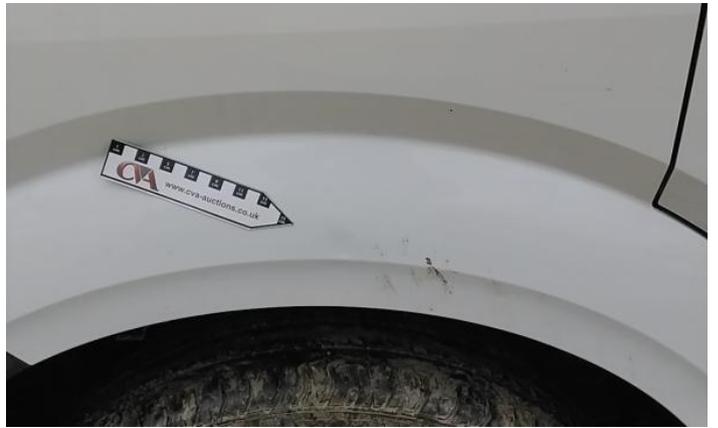
6: Wing nsf  
Dented  
Between 10mm + 30mm

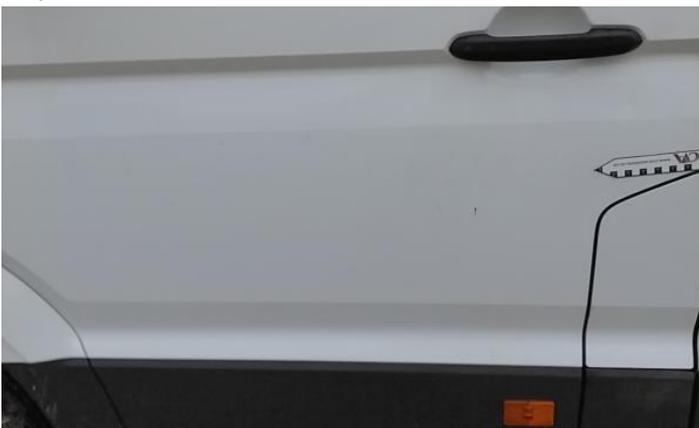
7: Door nsf  
Scratched  
Over 25mm Not Thru Paint

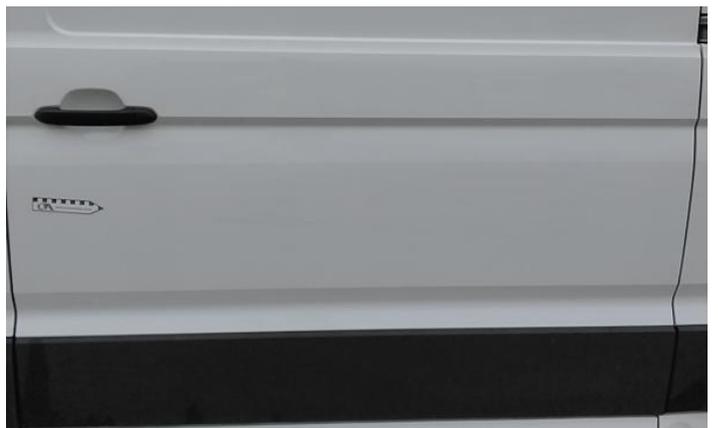
8: Door nsr  
Scratched  
Over 25mm Not Thru Paint

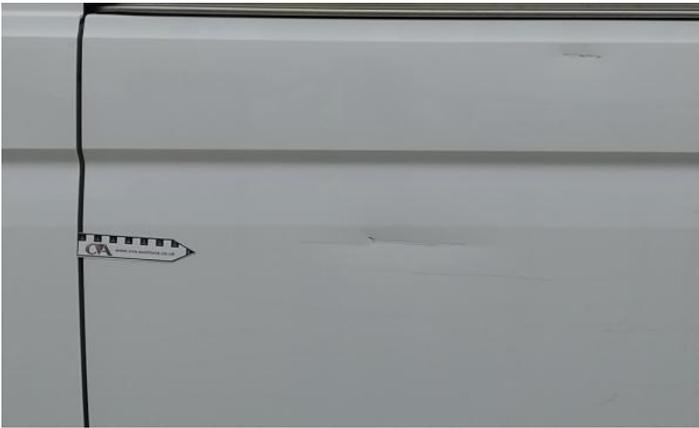
9: Qtr Panel nsr  
Dented  
With Paint Damage

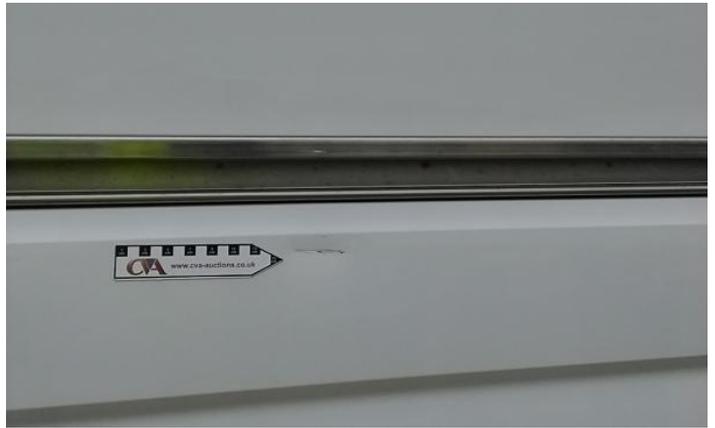
10: Qtr Panel nsr  
Dented  
With Paint Damage

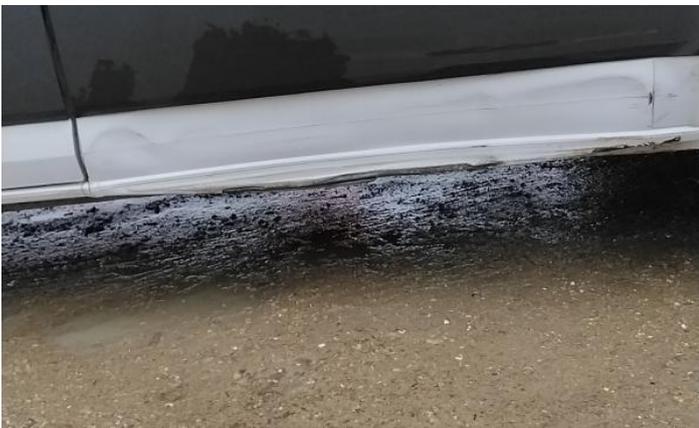
11: Sill ns  
Dented  
With Paint Damage

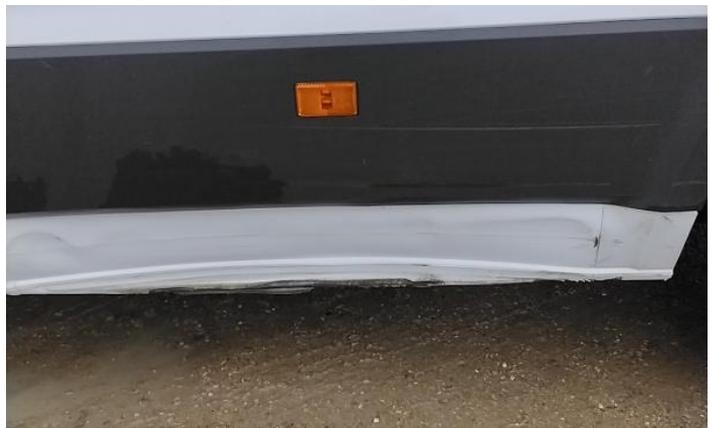
12: Qtr Panel Moulding ns  
Scuffed (Unpainted)  
Over 100mm

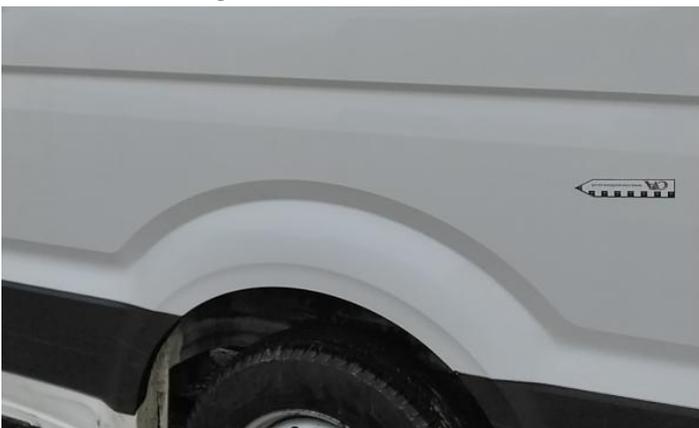
13: Qtr Panel nsr  
Scratched  
Over 25mm Not Thru Paint

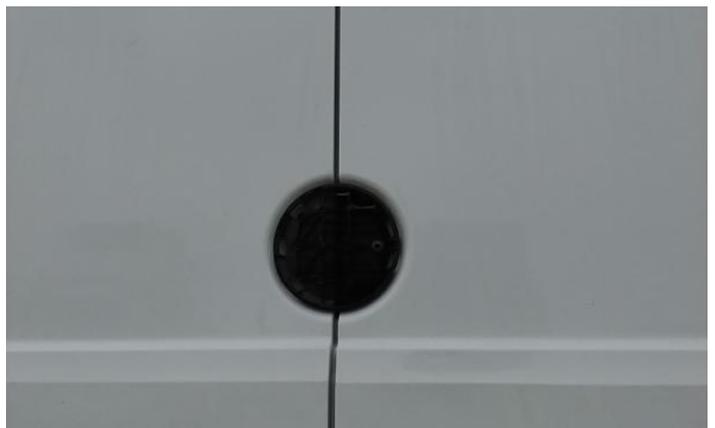
14: Badgedecal Rear  
Missing  
Replace

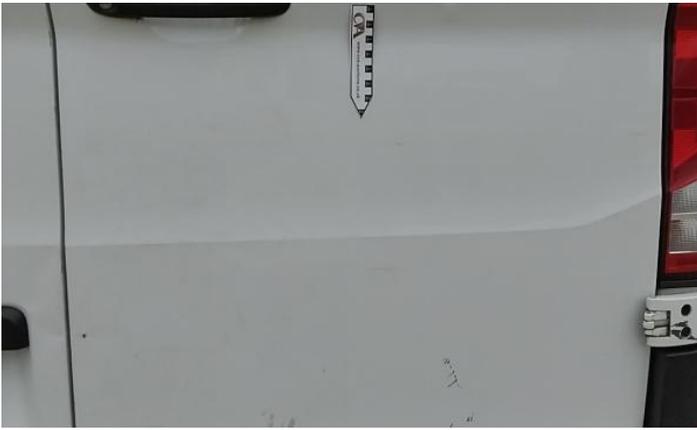
15: Door osr  
Scratched  
Over 25mm Not Thru Paint

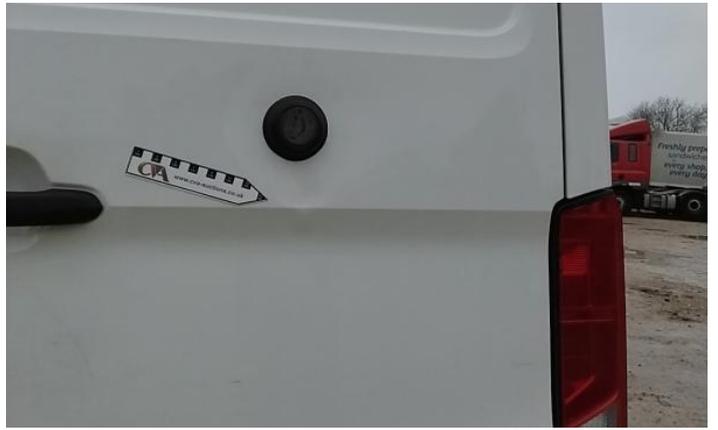
16: Door osr  
Dented  
Between 10mm + 30mm

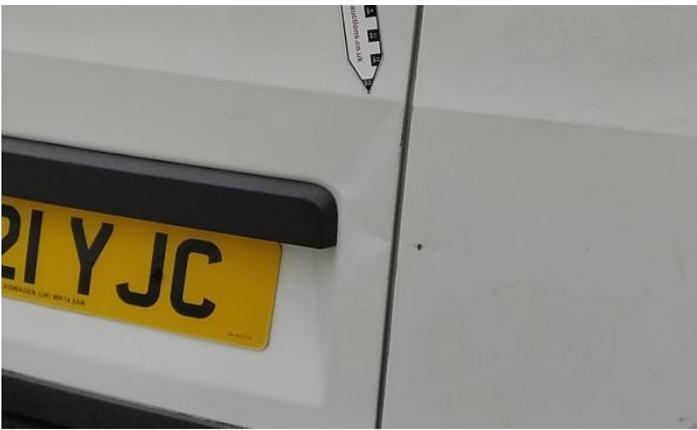
17: Door nsr  
Dented  
Between 10mm + 30mm

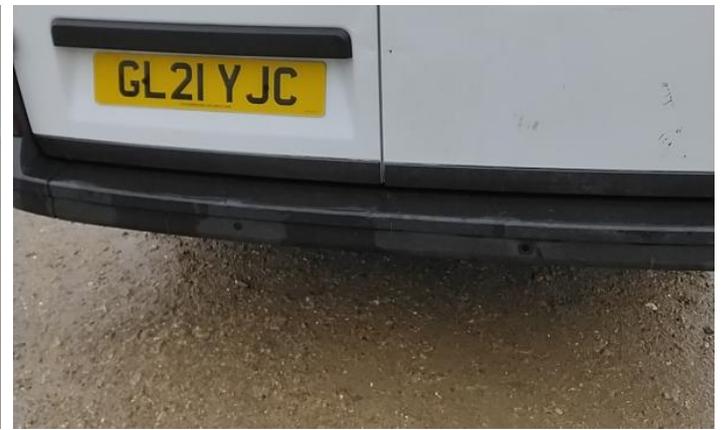
18: Bumper Rear  
Scratched  
Over 25mm Not Thru Paint

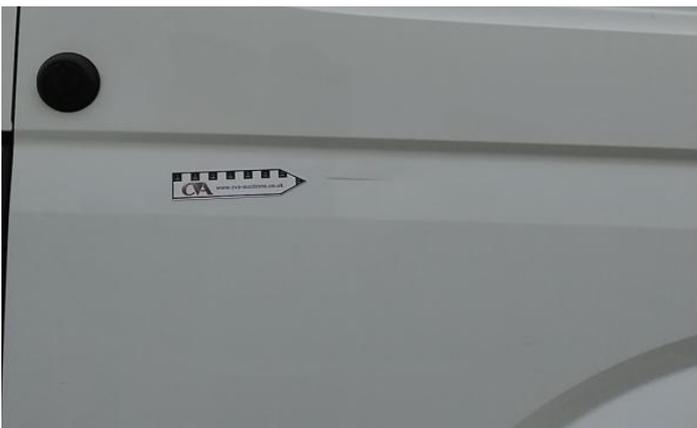
19: Qtr Panel osr  
Dented  
Between 10mm + 30mm

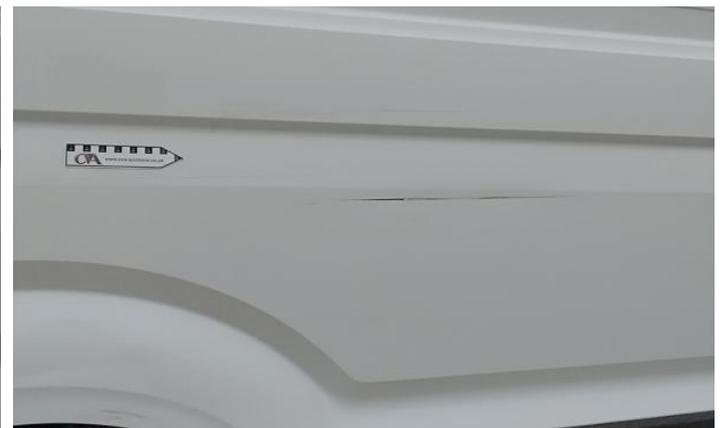
20: Qtr Panel osr  
Dented  
Between 10mm + 30mm

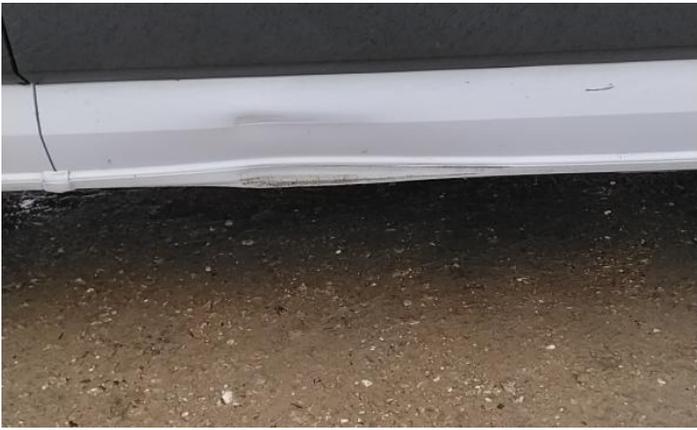
21: Sill os  
Dented  
With Paint Damage

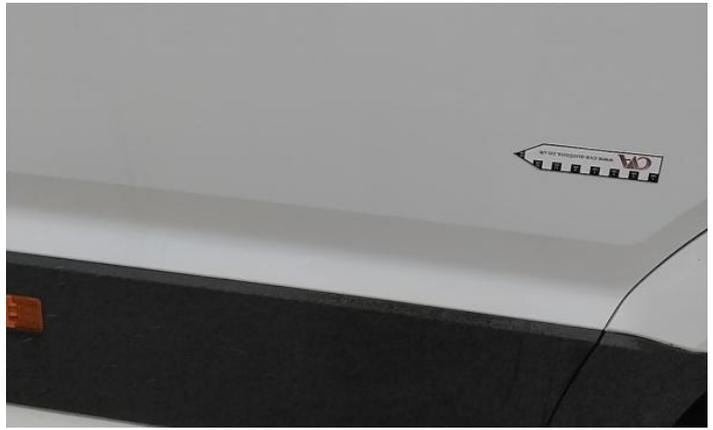
22: Door osf  
Scratched  
Over 25mm Not Thru Paint

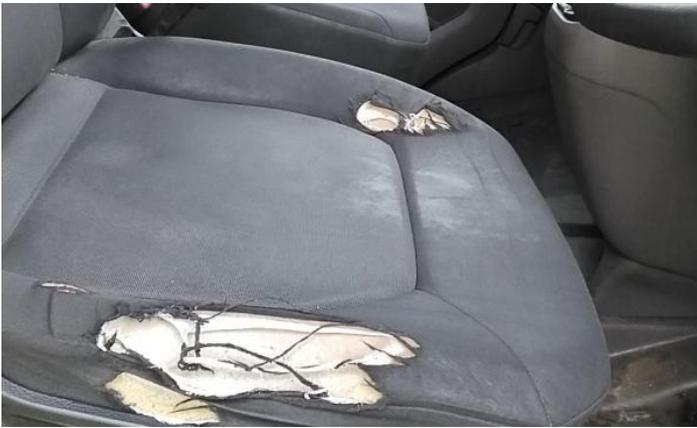
23: Seat Base Cover osf  
Holed  
Over 3mm
