VEHICLE INSPECTION REPORT

YH20LRJ

Ford Transit Connect 240 1.5 ECOBLUE 100PS

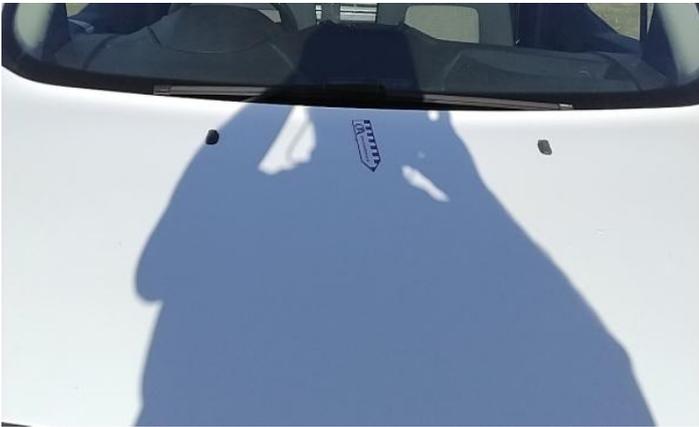
1: Bonnet
Chipped
Multiple Chips

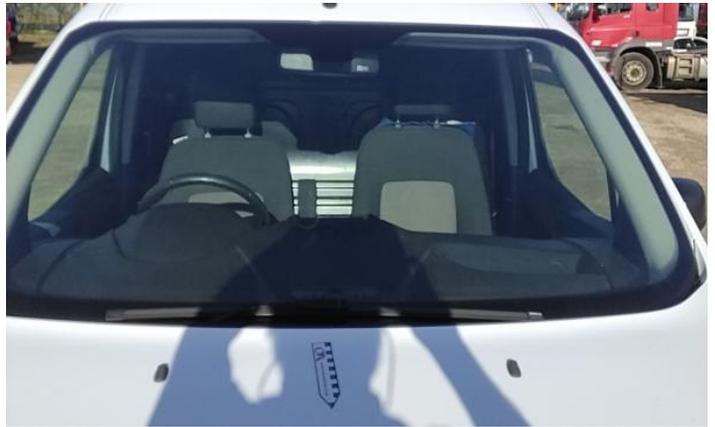
2: Screen Front
Chipped
Up To 10mm

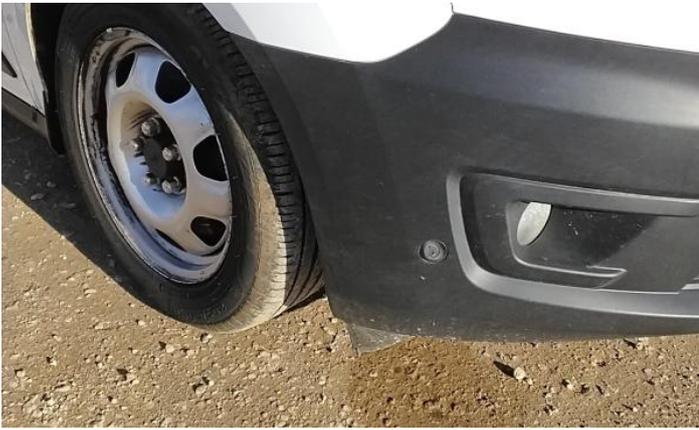
3: Bumper Front Moulding
Scuffed (Unpainted)
Over 100mm

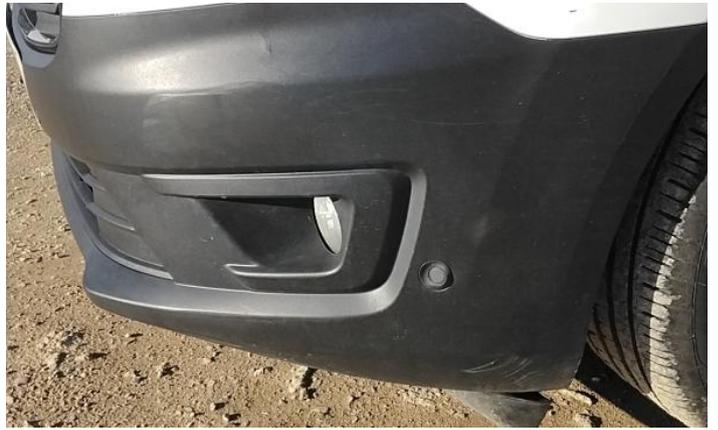
4: Bumper Front Moulding
Scuffed (Unpainted)
Over 100mm

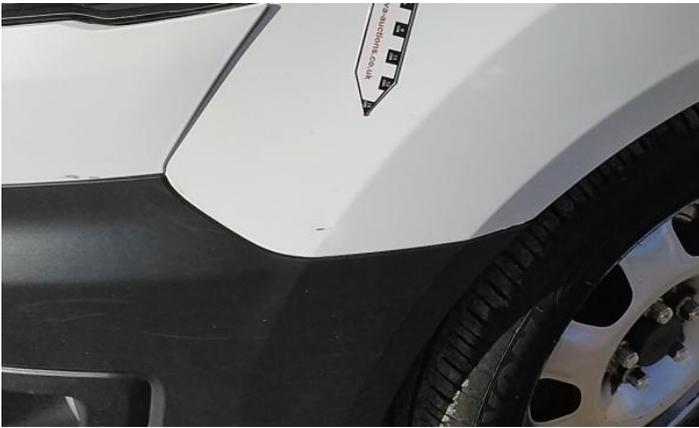
5: Wing nsf
Dented
With Paint Damage

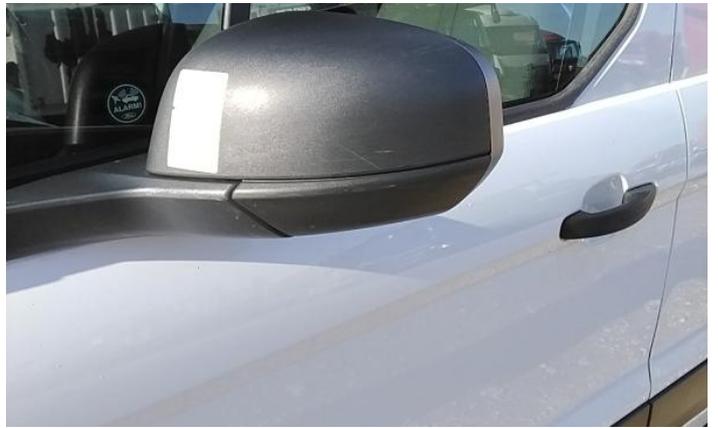
6: Door Mirror Assy nsf
Scuffed (Unpainted)
Over 100mm

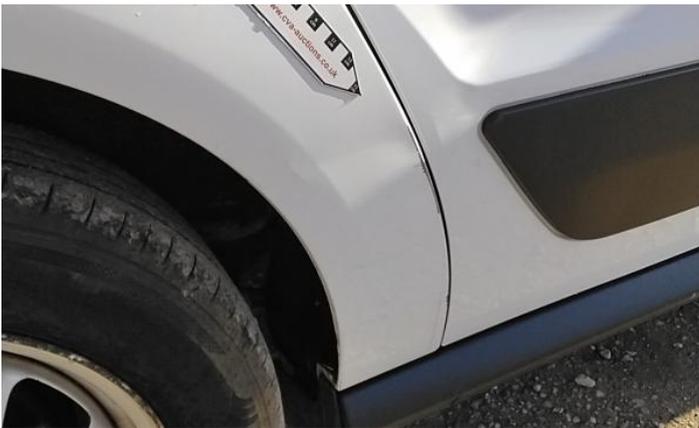
7: Qtr Panel osr
Dented
With Paint Damage

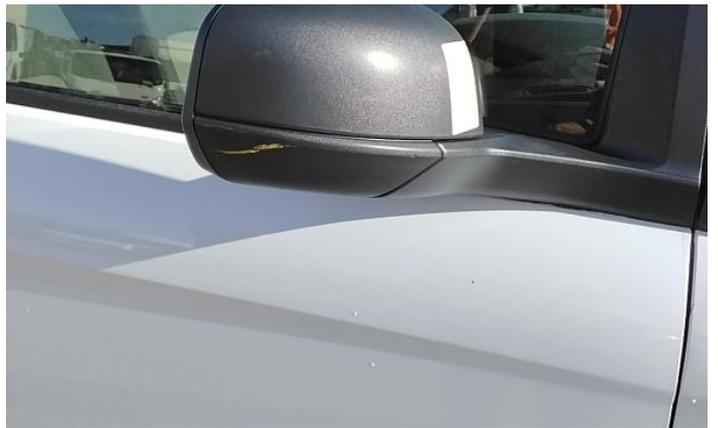
8: Door Mirror Assy osf
Scuffed (Unpainted)
Over 100mm
