VEHICLE INSPECTION REPORT

DA62PKY

MERCEDES-BENZ ACTROS 1842

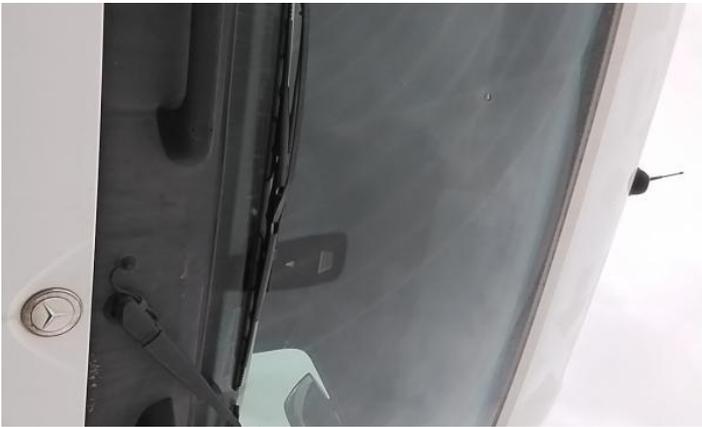
1: Panel Front
Scratched
Over 25mm Thru Paint

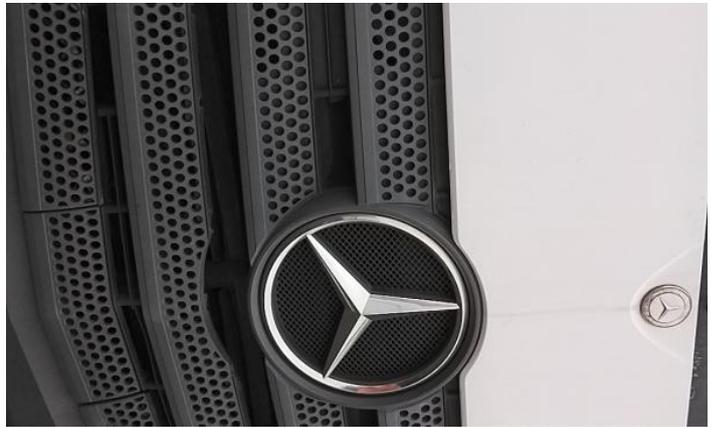
2: Bonnet
Chipped
Multiple Chips

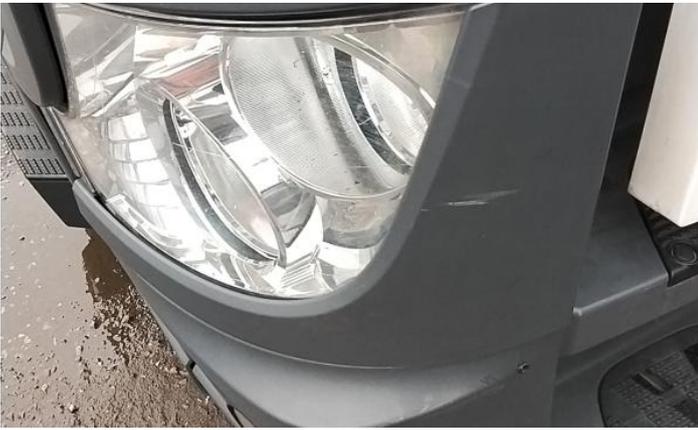
3: Panel Front
Scratched
Over 25mm Thru Paint

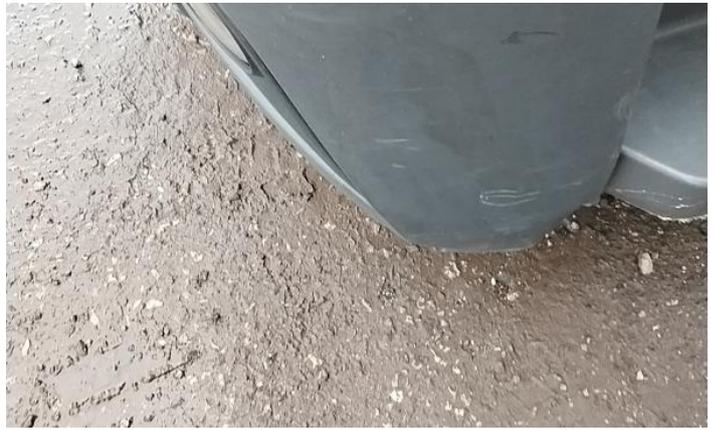
4: Bumper Front Moulding
Scuffed (Unpainted)
Over 100mm

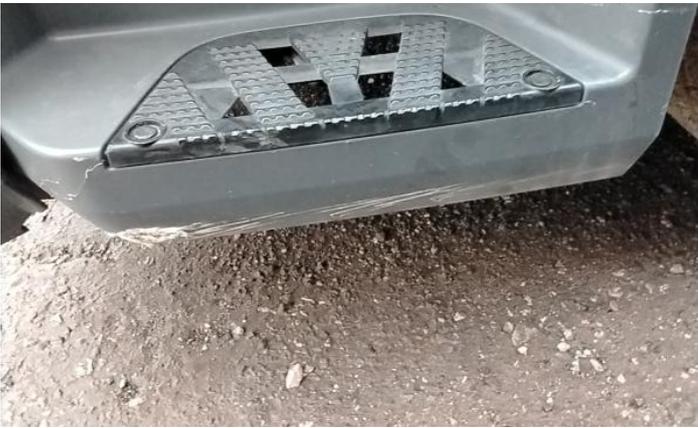
5: Bumper Front Moulding
Broken
Replace

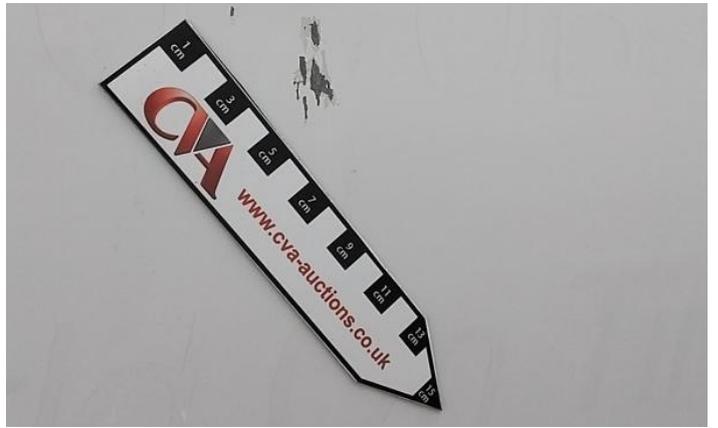
6: Door nsf
Scratched
Over 25mm Thru Paint

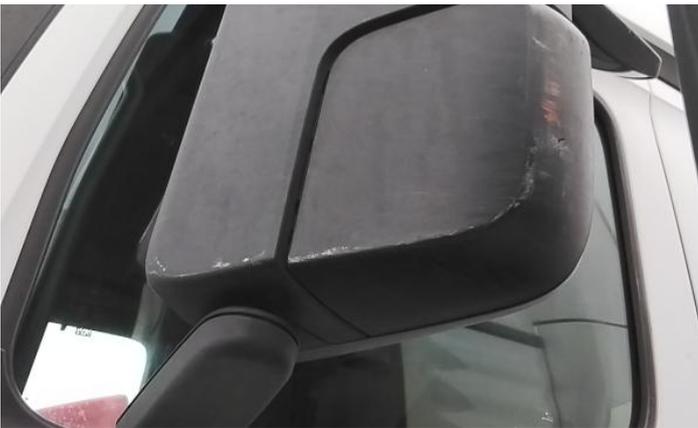
7: Door Mirror Assy nsf
Scuffed (Unpainted)
Over 100mm

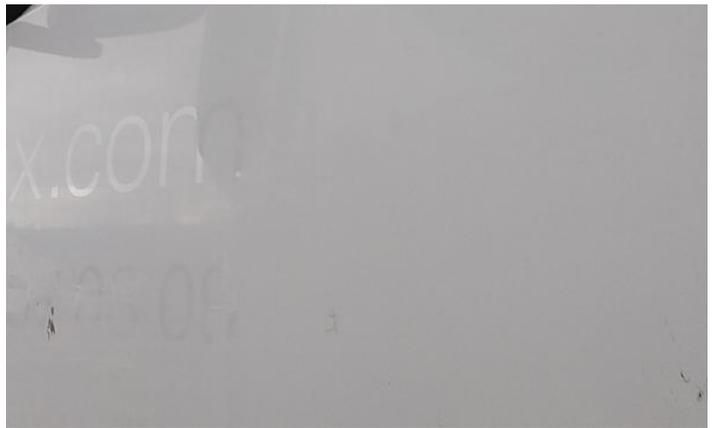
8: Door nsf
Chipped
Multiple Chips

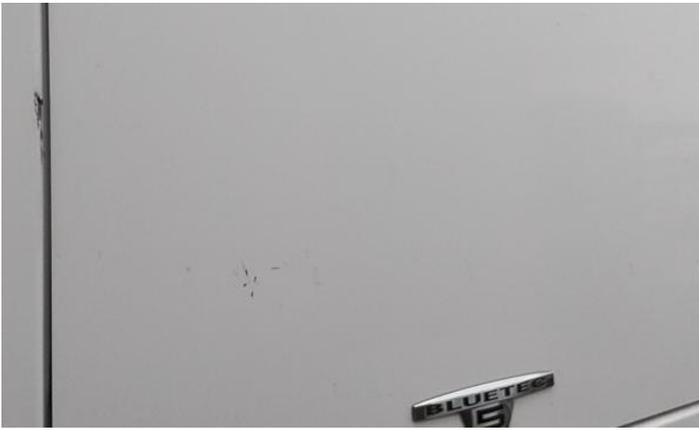
9: Qtr Panel nsr
Chipped
Multiple Chips

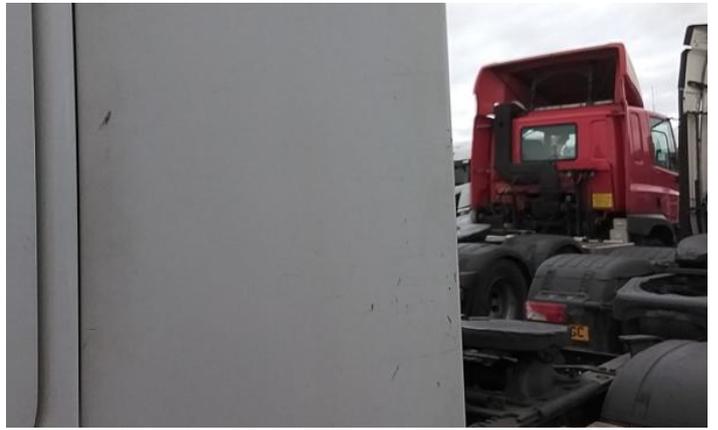
10: Qtr Panel Trim ns
Scuffed
Over 25mm

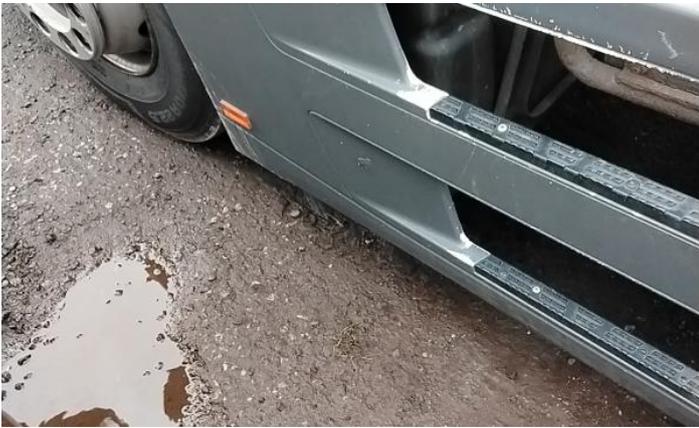
11: Qtr Panel Moulding ns
Scuffed (Unpainted)
Over 100mm

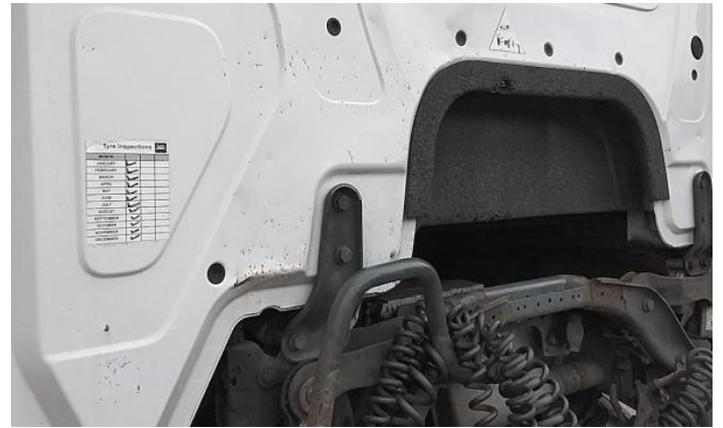
12: Panel Rear
Dented
With Paint Damage

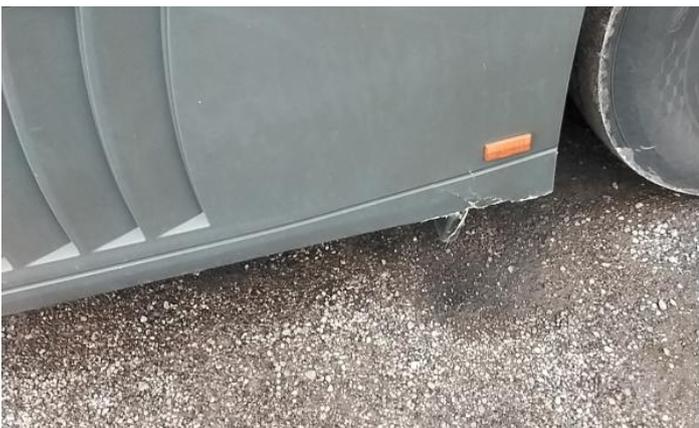
13: Qtr Panel Moulding os
Broken
Replace

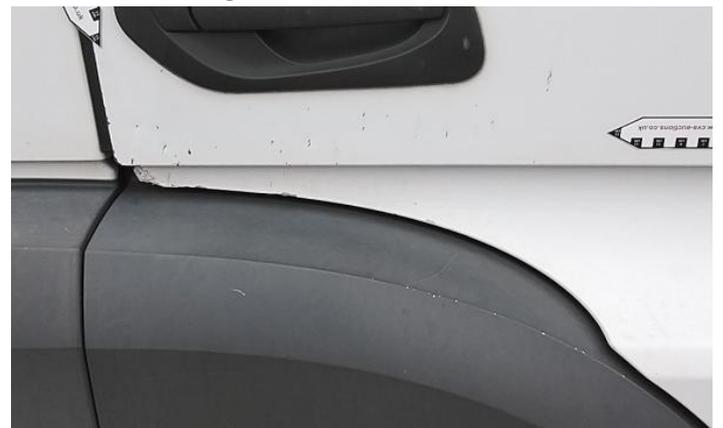
14: Door osf
Dented
With Paint Damage

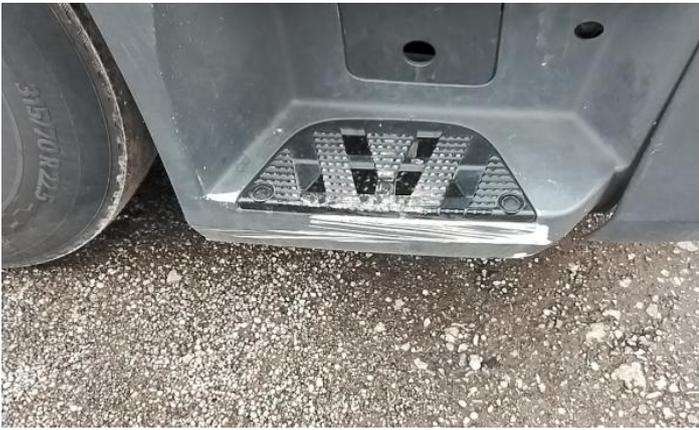
15: Bumper Front Moulding
Scuffed (Unpainted)
Over 100mm

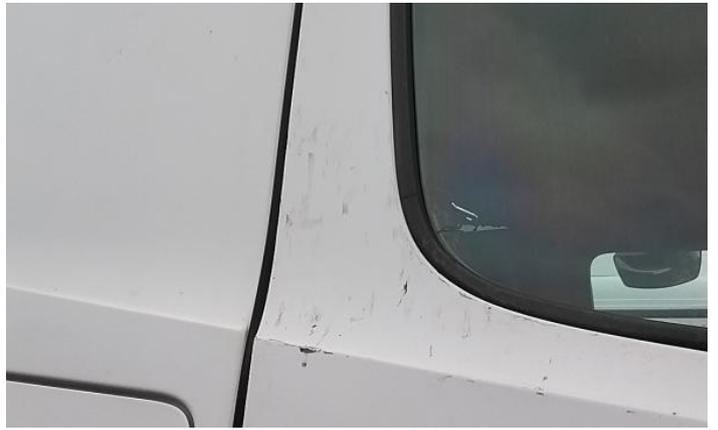
16: Door osf
Scratched
Over 25mm Thru Paint

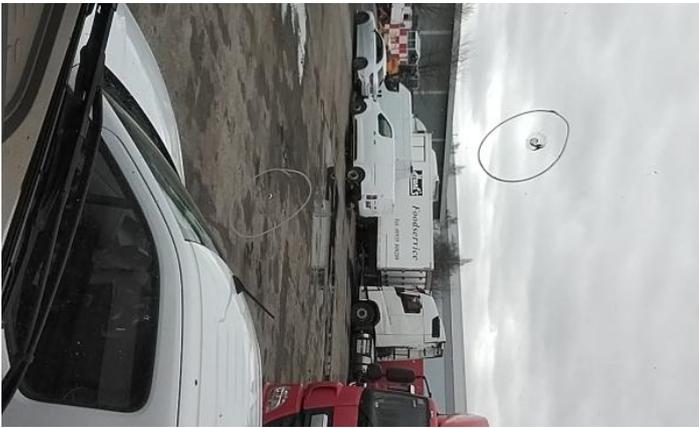
17: Screen Front
Chipped
Over 10mm
