VEHICLE INSPECTION REPORT

BX59DFE

DAF LF 45.160

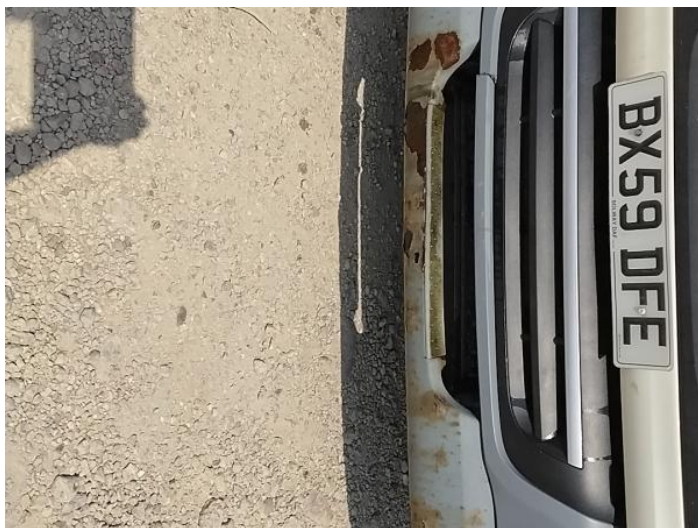
1: Bumper Front
Rusted
Over 5mm

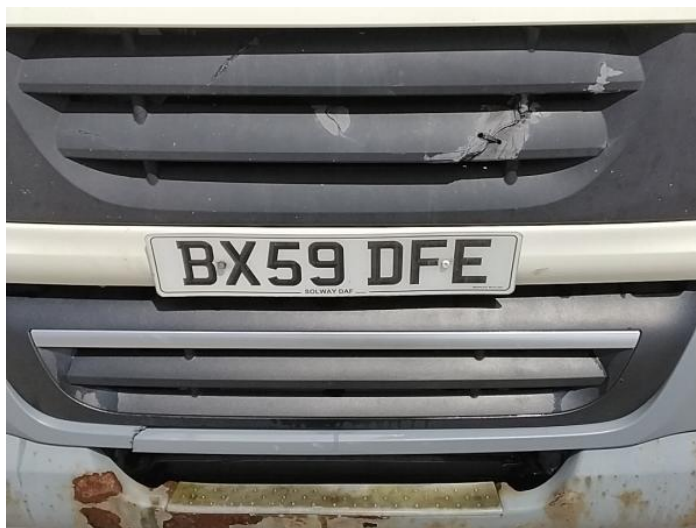
2: Bonnet
Cracked
Replace

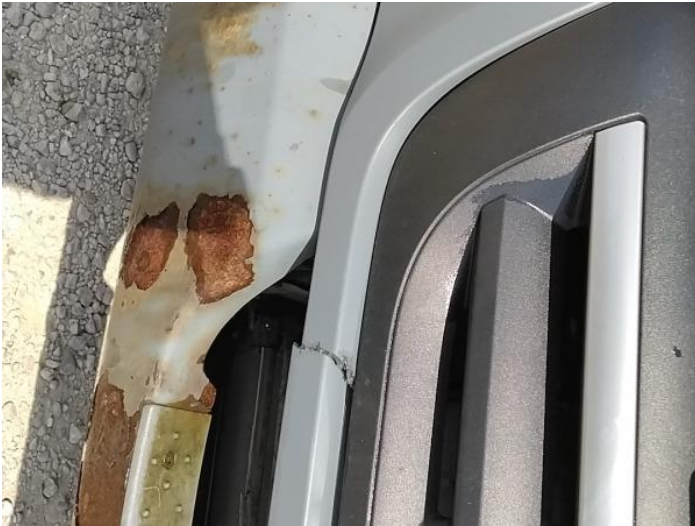
3: Panel Front
Cracked
Replace

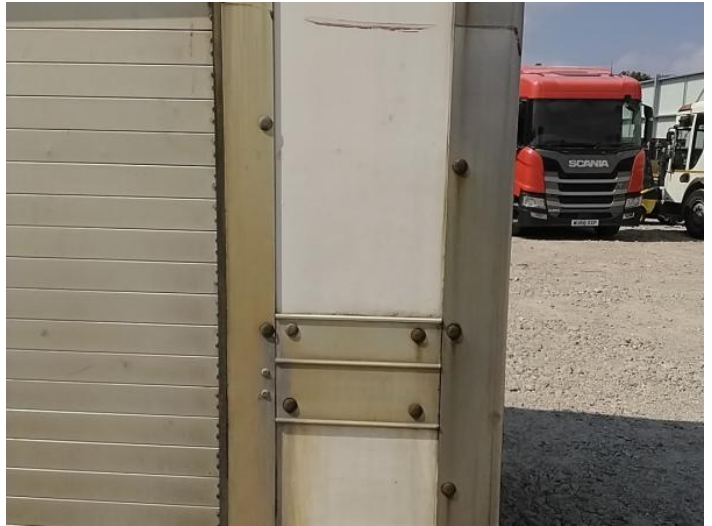
4: Qtr Panel nsr
Scratched
Over 25mm Thru Paint

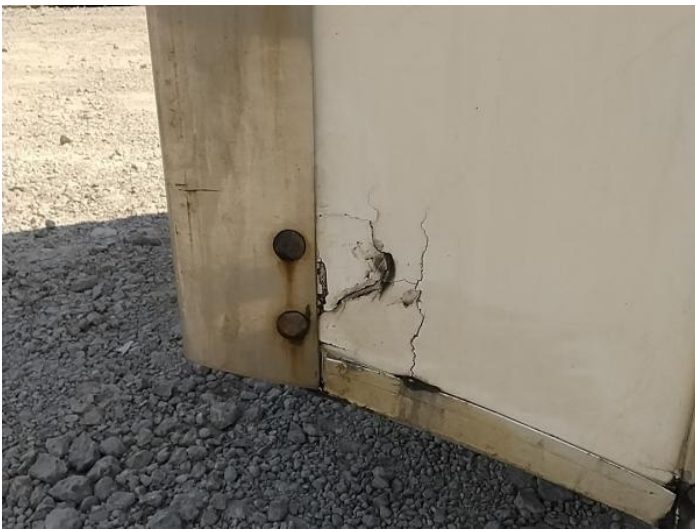
5: Qtr Panel osr
Cracked
Replace

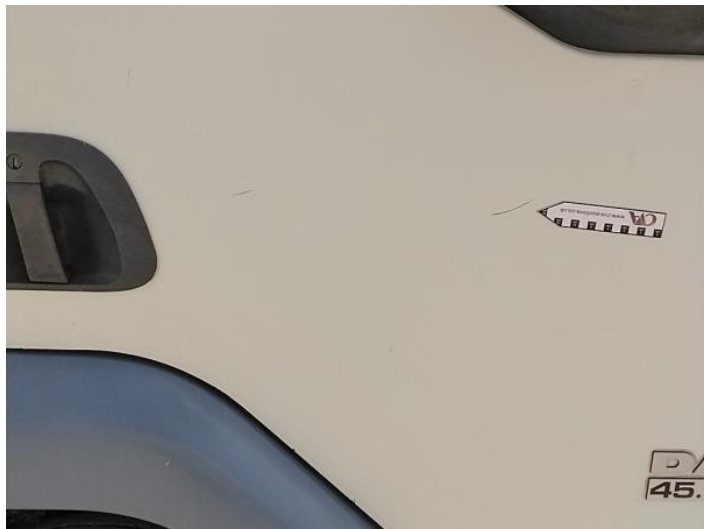
6: Door osf
Scratched
Over 25mm Not Thru Paint

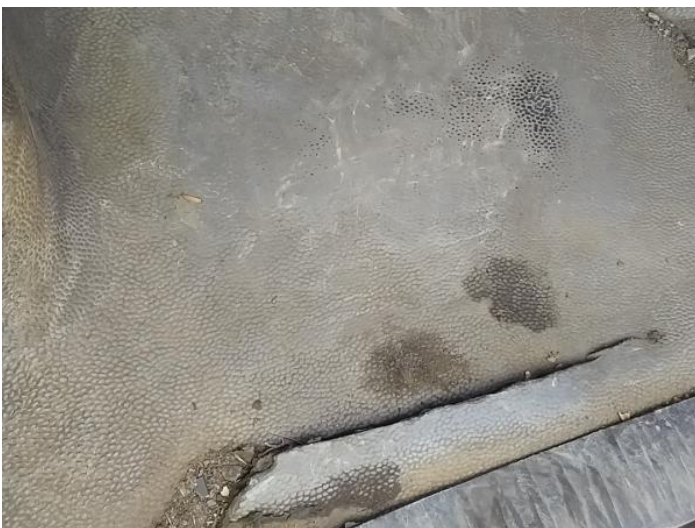
7: Carpets Front
Torn
Over 10mm

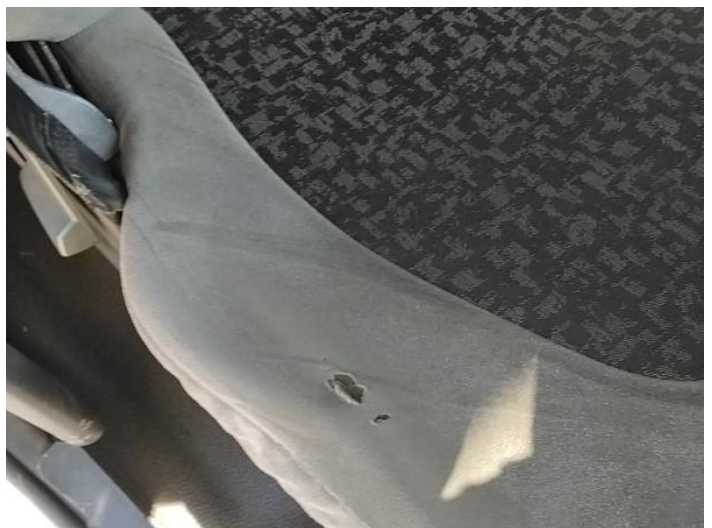
8: Seat Base Cover osf
Holed
Over 3mm
