VEHICLE INSPECTION REPORT

DG68MWX

Isuzu D-Max 1.9

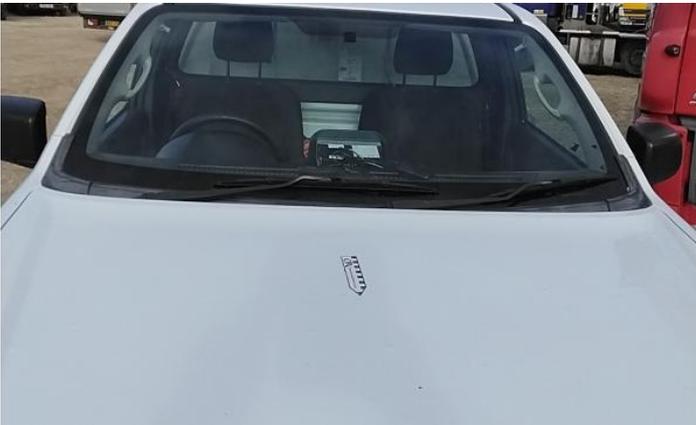
1: Bonnet
Chipped
Multiple Chips

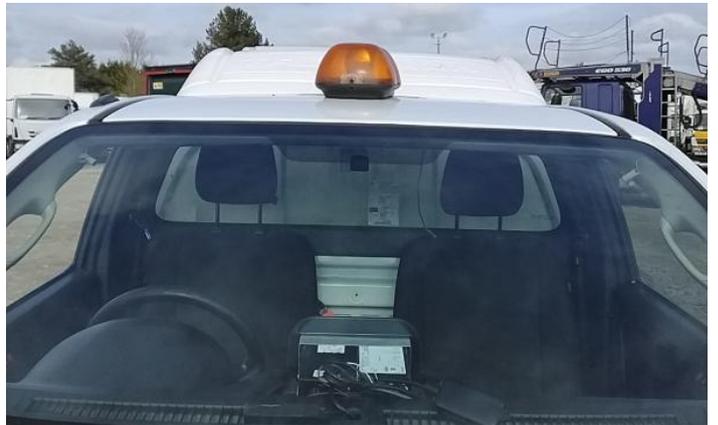
2: Screen Front
Chipped
UpTo 10mm

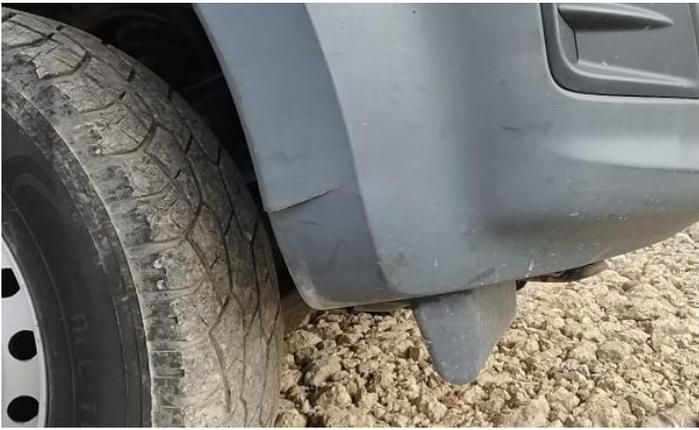
3: Bumper Front Moulding
Broken
Replace

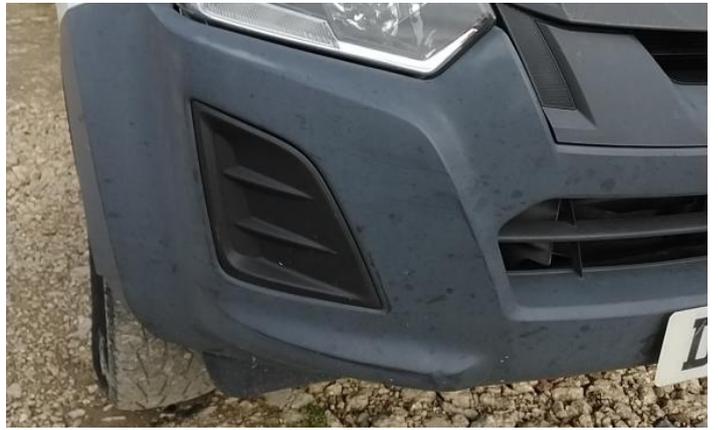
4: Bumper Front Moulding
Scuffed (Unpainted)
Over 100mm

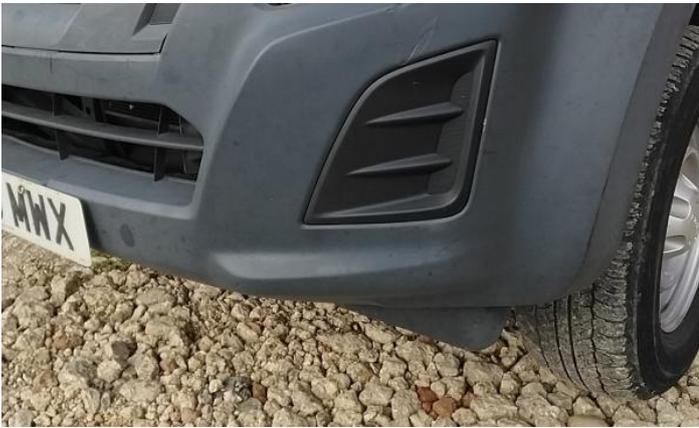
5: Bumper Front Moulding
Scuffed (Unpainted)
Over 100mm

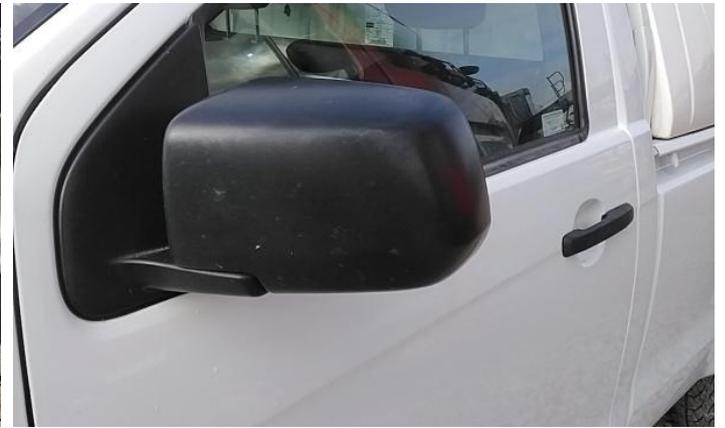
6: Door Mirror Assy nsf
Scuffed (Unpainted)
UpTo 100mm

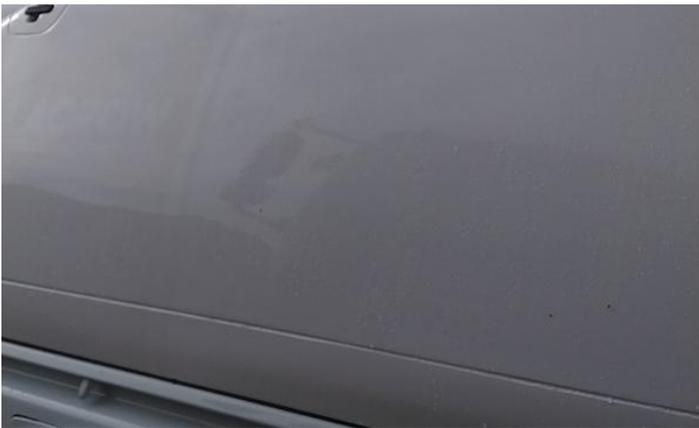
7: Qtr Panel nsr
Cracked
Replace

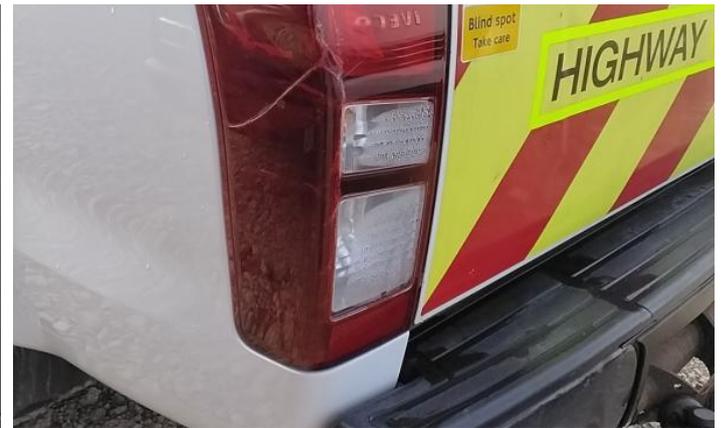
8: Lamp nsr
Broken
Replace

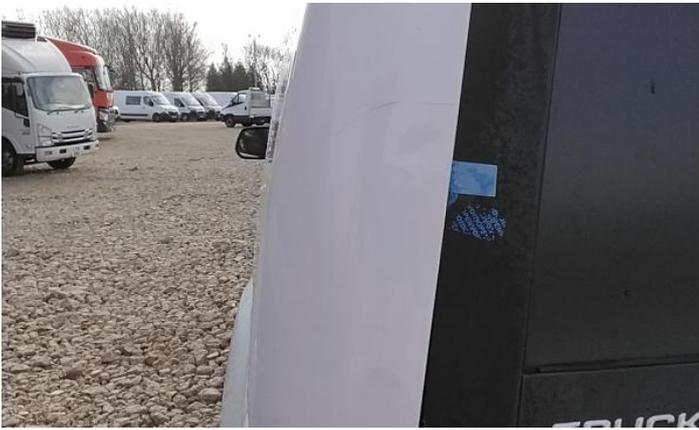
9: Qtr Panel nsr
Dented
Between 10mm + 30mm

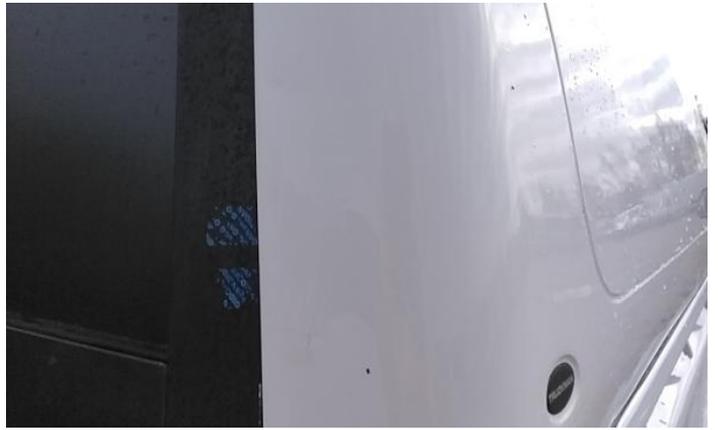
10: Qtr Panel osr
Cracked
Replace

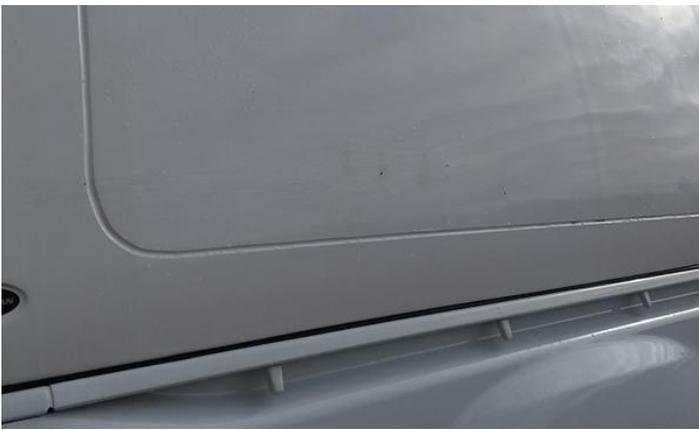
11: Qtr Panel osr
Cracked
Replace

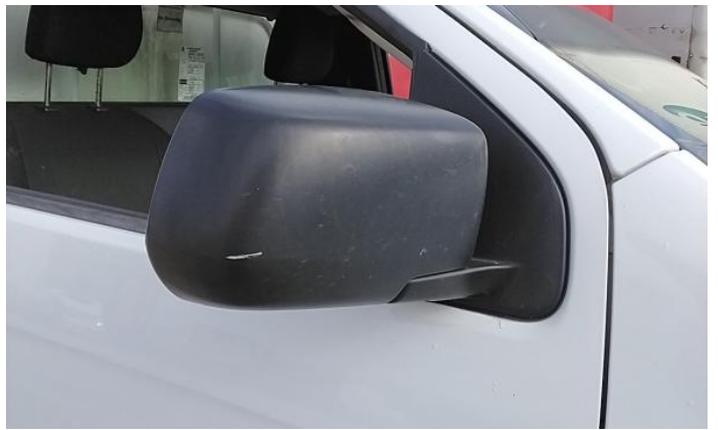
12: Door Mirror Assy osf
Scuffed (Unpainted)
Over 100mm

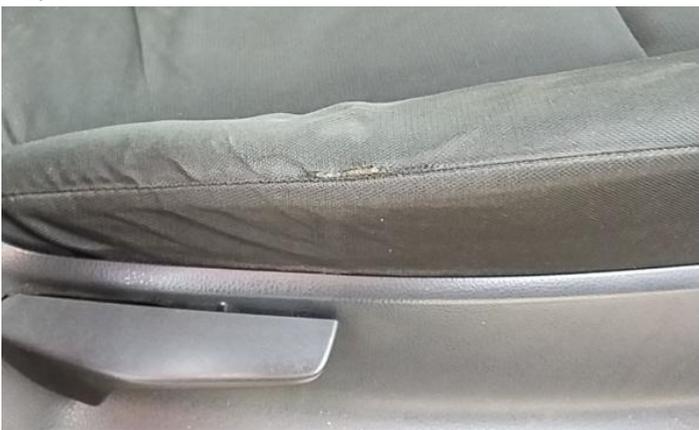
13: Seat Base Cover osf
Holed
Over 3mm
