**COMMERCIAL VEHICLE AUCTIONS LTD**  
THE UK'S MOST ESTABLISHED COMMERCIAL VEHICLE AUCTIONEERS

# VEHICLE INSPECTION REPORT

**CK16UCL**

## Mercedes-Benz Actros

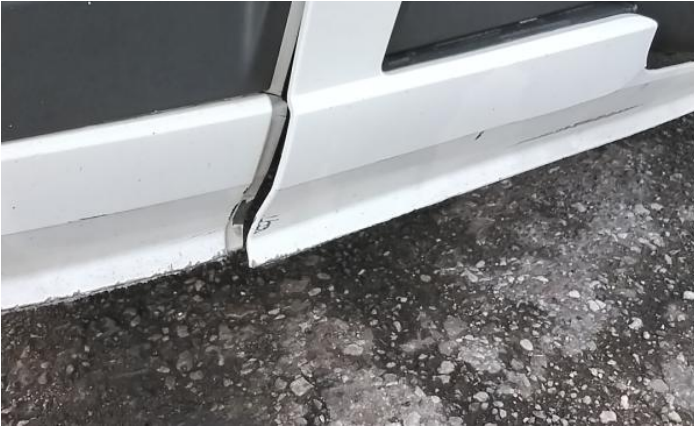
1: Bumper Front Moulding  
Broken  
Replace

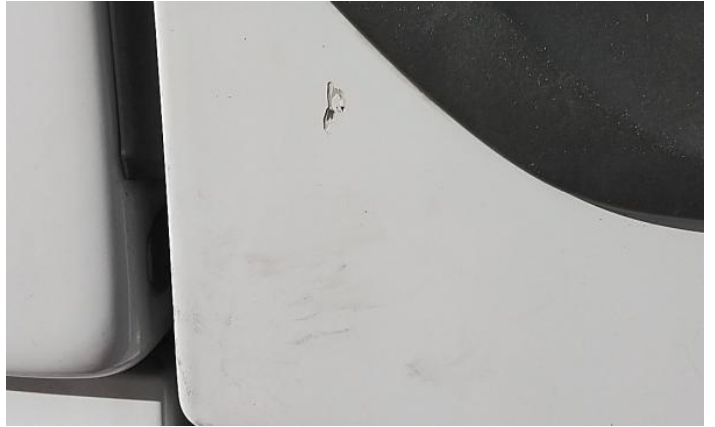
2: Door osf  
Chipped  
Over 5mm

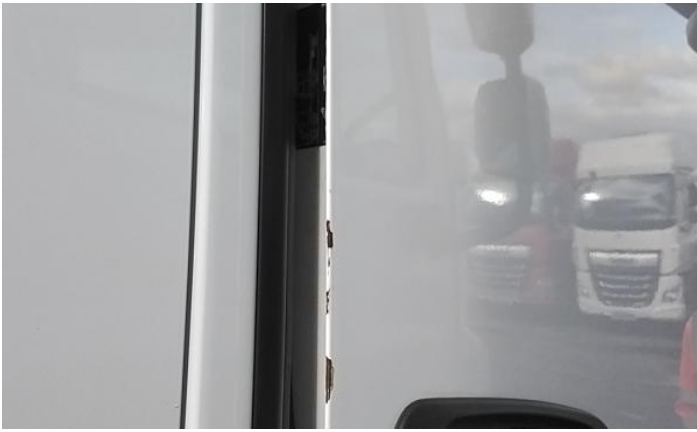
3: Door osf  
Chipped  
Edge Chip

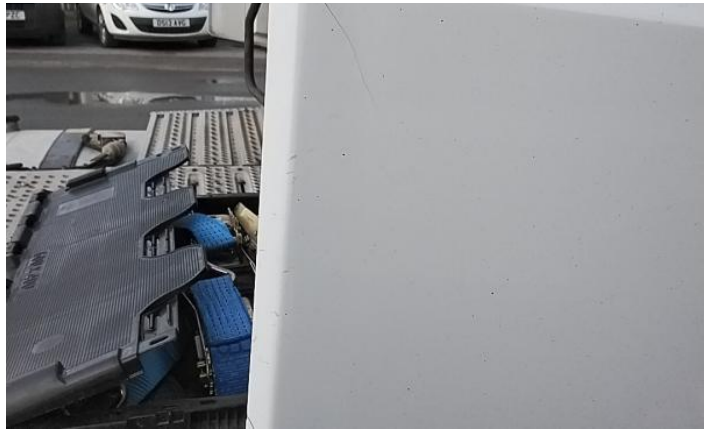
4: Panel Front  
Cracked  
Replace

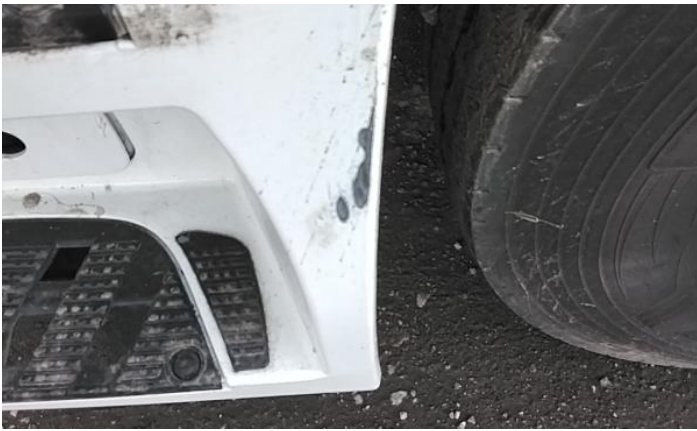
5: Moulding nsf Wing  
Scuffed (Unpainted)  
Over 100mm

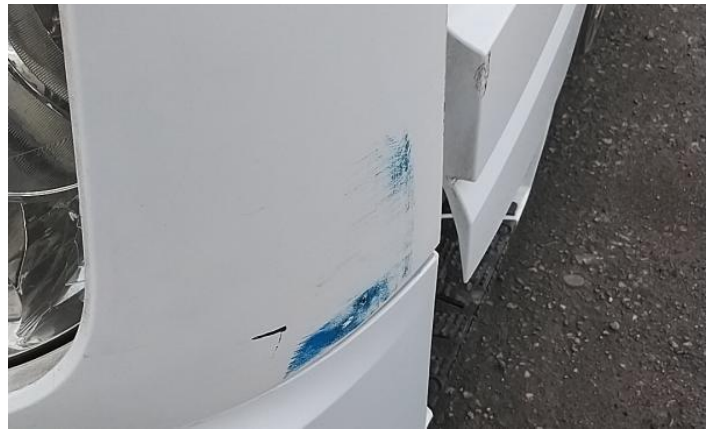
6: Bumper Front Moulding  
Scuffed (Unpainted)  
Over 100mm

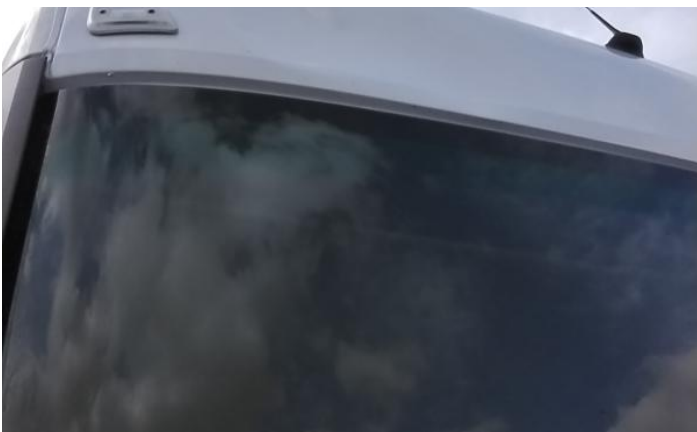
7: Roof  
Dented  
Over 30mm
