# VEHICLE INSPECTION REPORT

**AV69LUA**

## Volvo FM 330

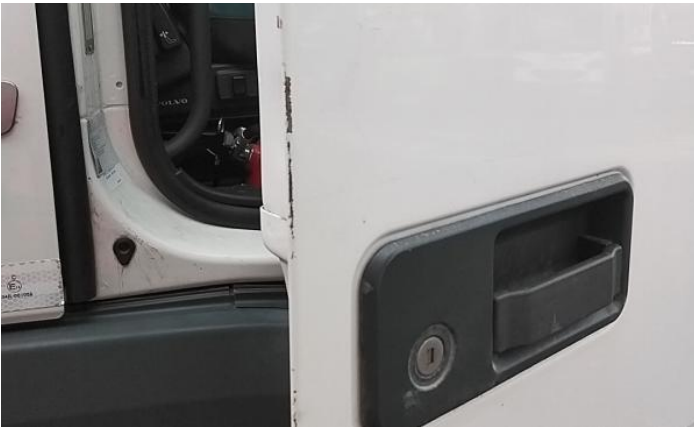
1: Door Lock osf  
Broken  
Replace

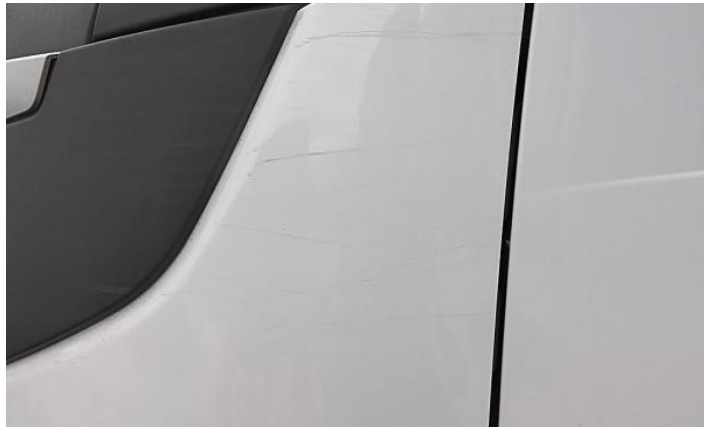
2: Panel Front  
Scratched  
Over 25mm Not Thru Paint

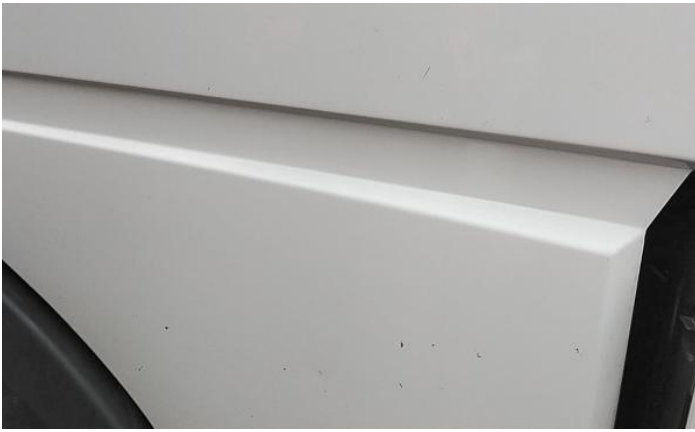
3: Door osf  
Chipped  
Multiple Chips

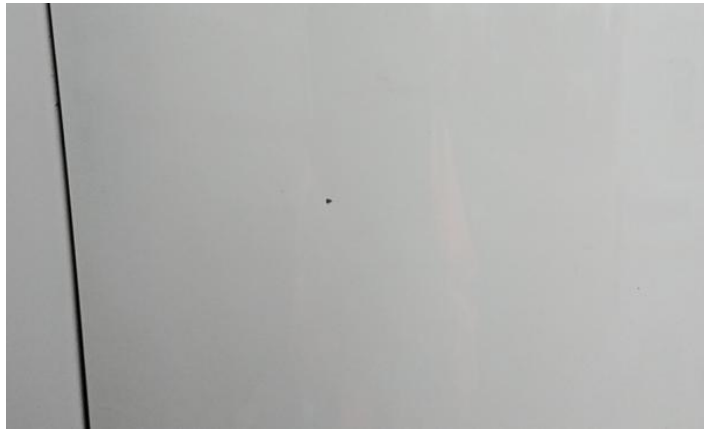
4: Panel Front  
Chipped  
Over 5mm

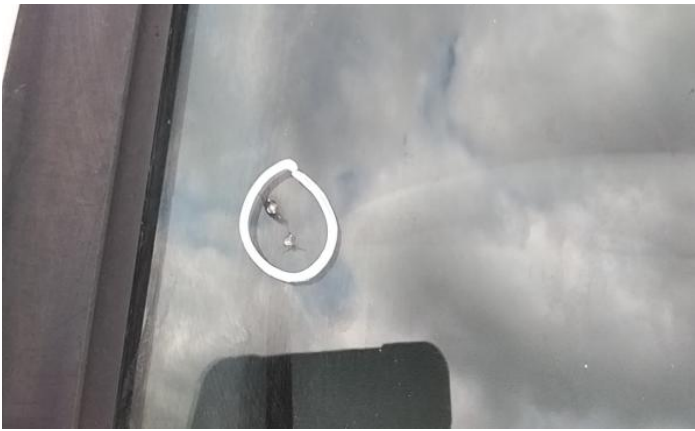
5: Screen Front  
Chipped  
UpTo 10mm

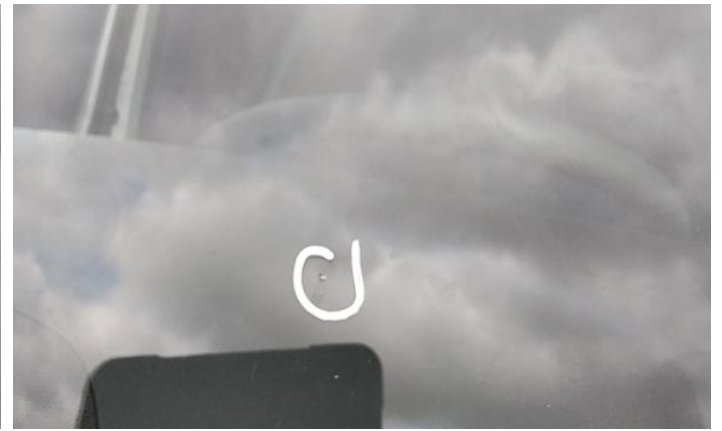
6: Screen Front  
Chipped  
UpTo 10mm
