# VEHICLE INSPECTION REPORT

**RA19GGZ**

## Fiat Doblo 1.4 CARGO

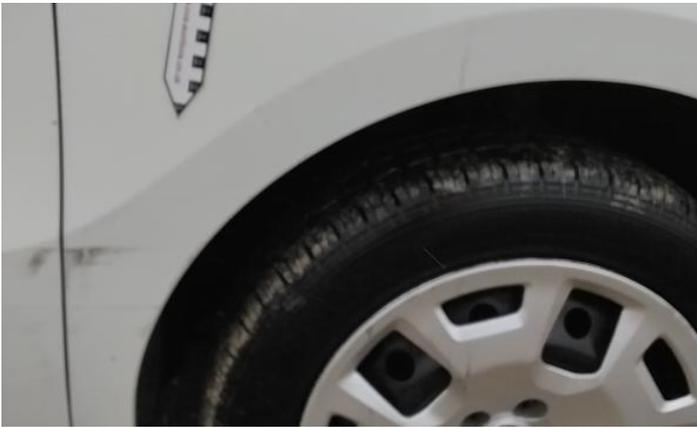
1: Wing of  
Scratched  
Over 25mm Not Thru Paint

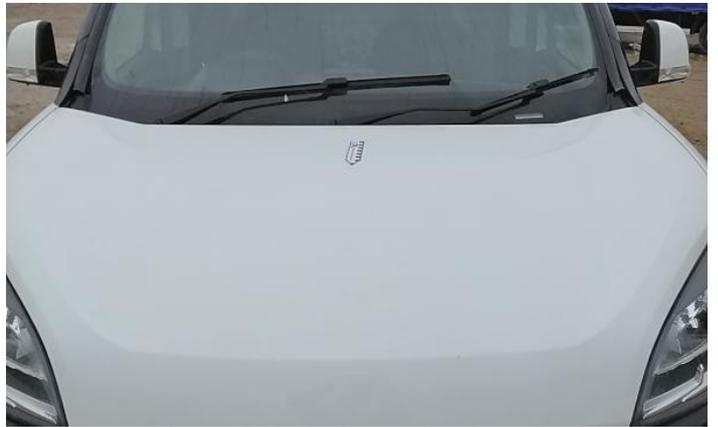
2: Bonnet  
Chipped  
Multiple Chips

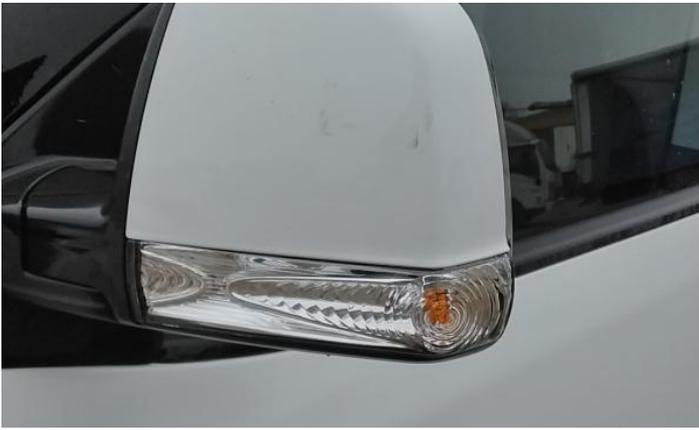
3: Door Mirror Assy nsf  
Scratched (Painted)  
Over 25mm Not Thru Paint

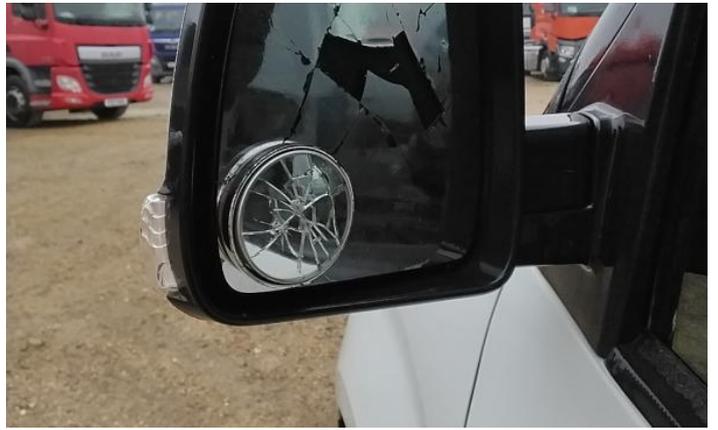
4: Door Mirror Glass ns  
Broken  
Replace

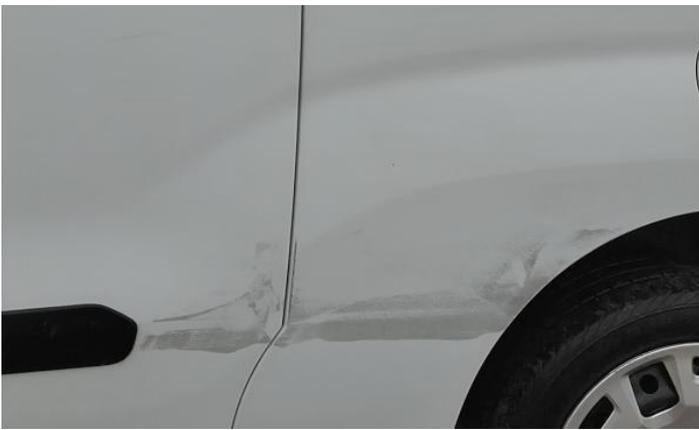
5: Qtr Panel nsr  
Scratched  
Over 25mm Not Thru Paint

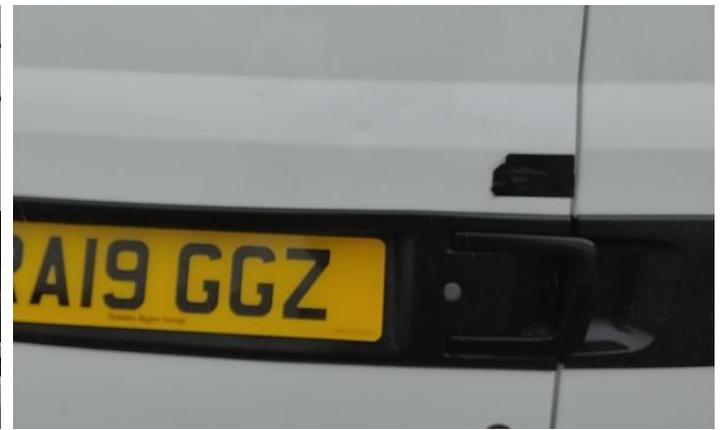
6: Door nsr  
Poor Previous Repair  
Poor Colour

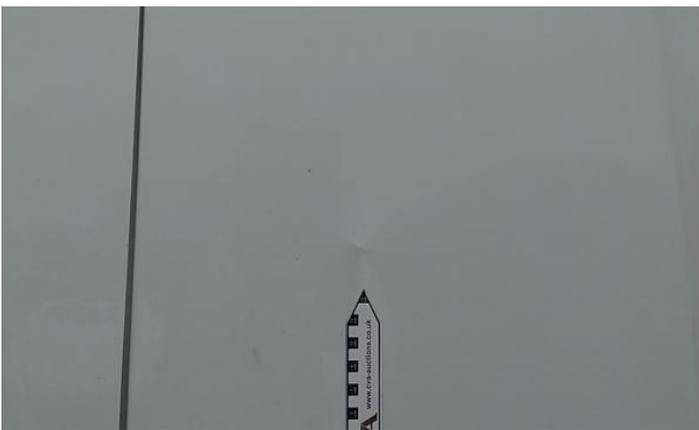
7: Door osr  
Dented  
With Paint Damage

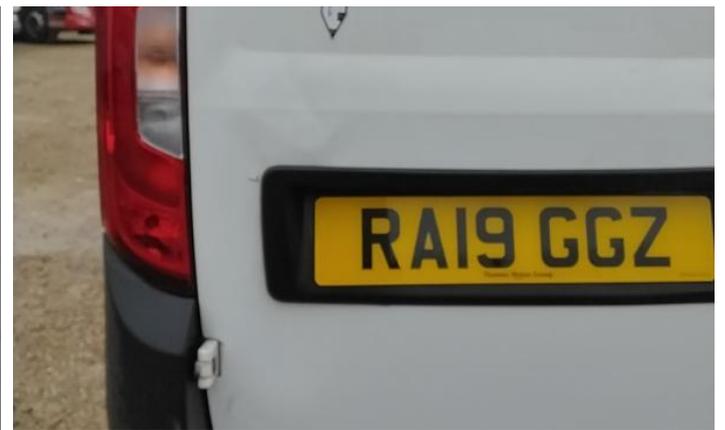
8: Door nsr  
Dented  
Over 30mm

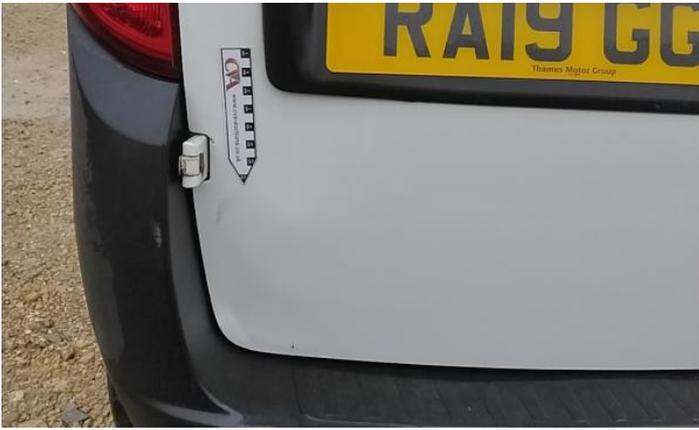
9: Door nsr  
Dented  
Over 30mm

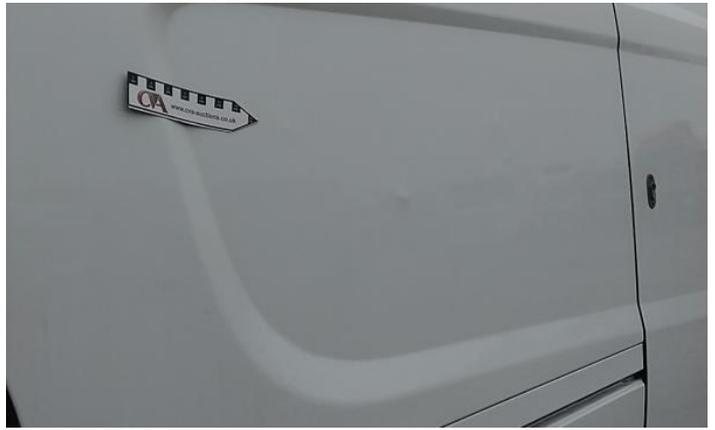
10: Qtr Panel osr  
Dented  
With Paint Damage

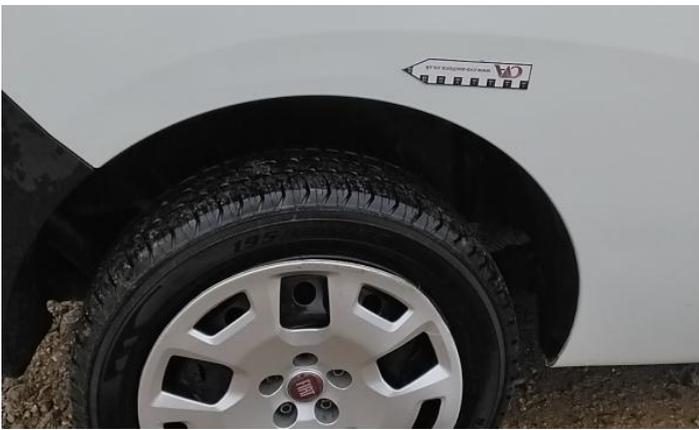
11: Qtr Panel osr  
Dented  
Over 30mm

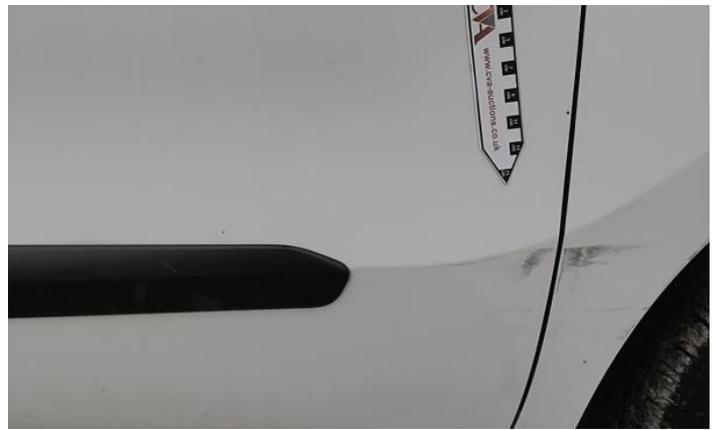
12: Door osf  
Scratched  
Up To 25mm Not Thru Paint

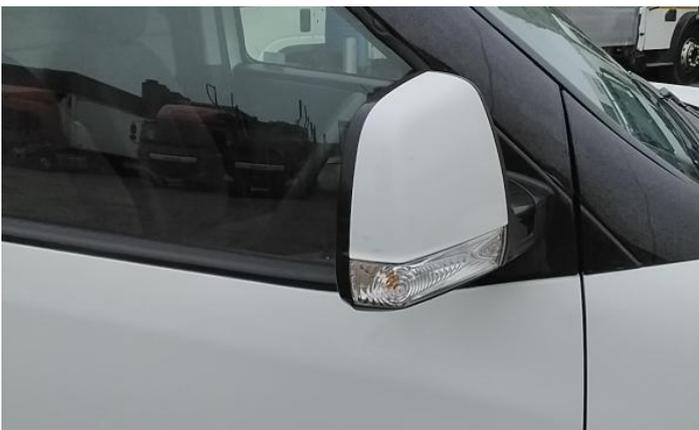
13: Door Mirror Assy osf  
Scratched (Painted)  
Over 25mm Thru Paint

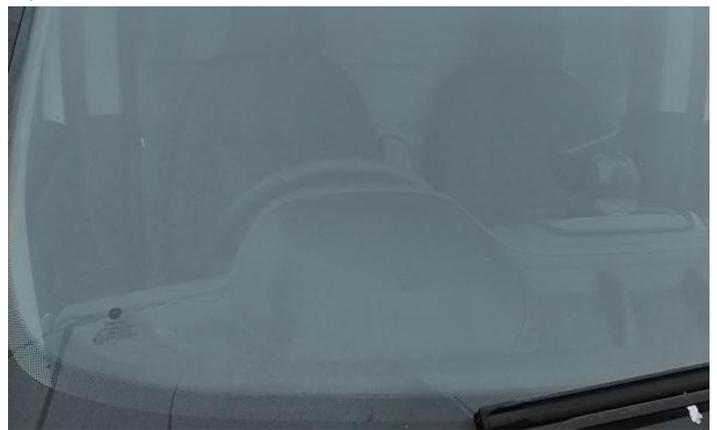
14: Screen Front  
Chipped  
Up To 10mm
