VEHICLE INSPECTION REPORT

PE72TLO

ISUZU N75 190

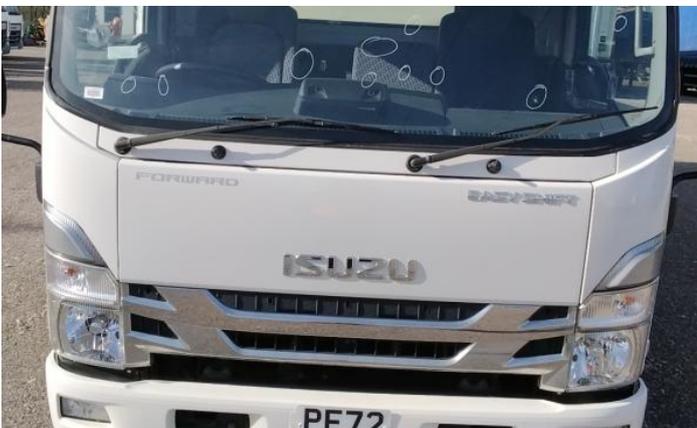
1: Screen Front
Chipped
Over 10mm

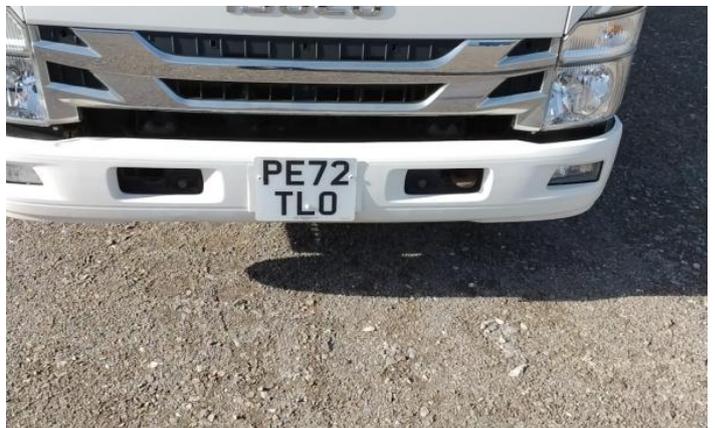
2: Bonnet
Chipped
Multiple Chips

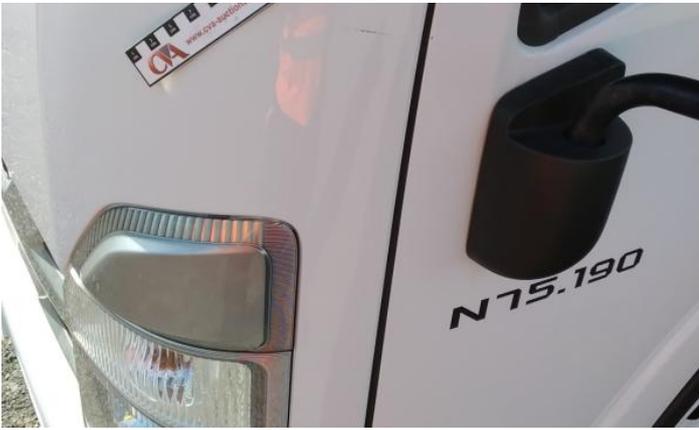
3: Moulding nsf Wing
Scratched (Painted)
Over 25mm Thru Paint

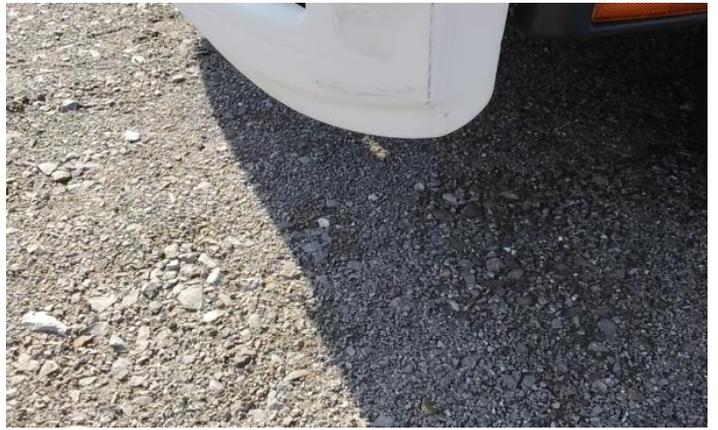
4: Bumper Front
Scratched
Over 100mm Thru Paint

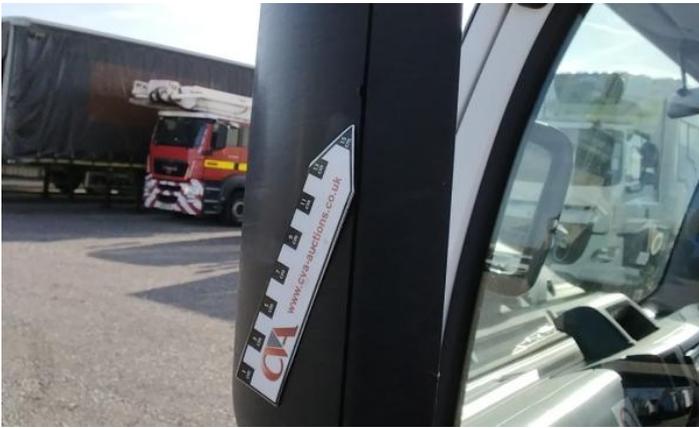
5: Door Mirror Assy nsf
Broken
Replace

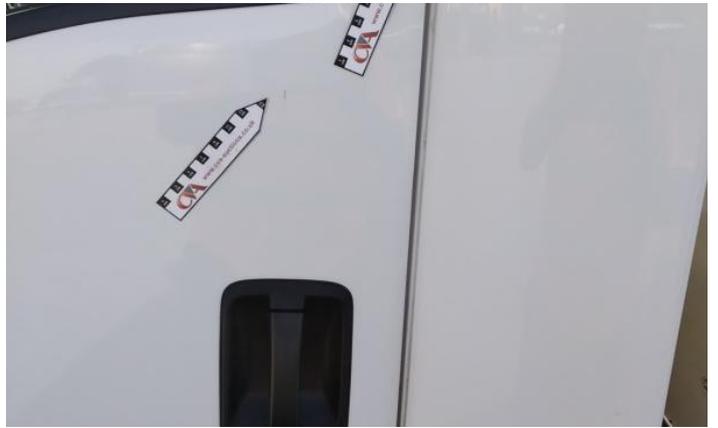
6: Door nsf
Scratched
Over 25mm Thru Paint

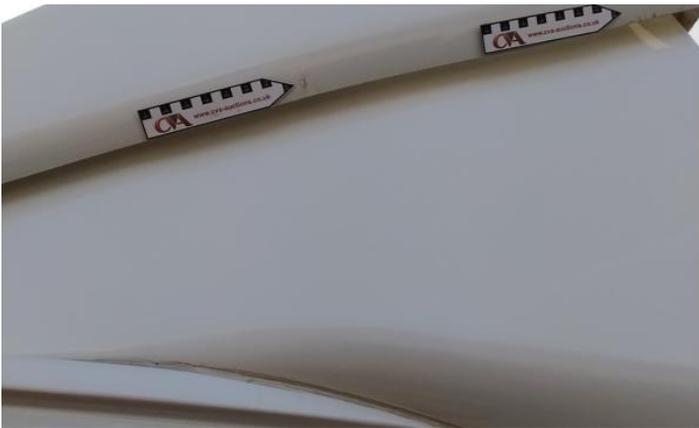
7: Roof
Cracked
Replace

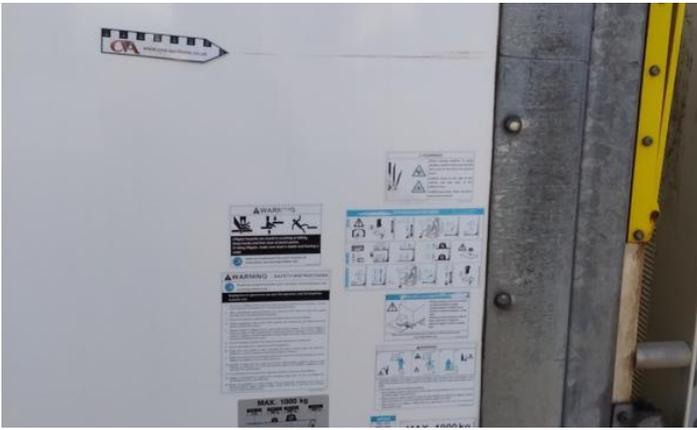
9: Qtr Panel nsr
Dented
With Paint Damage

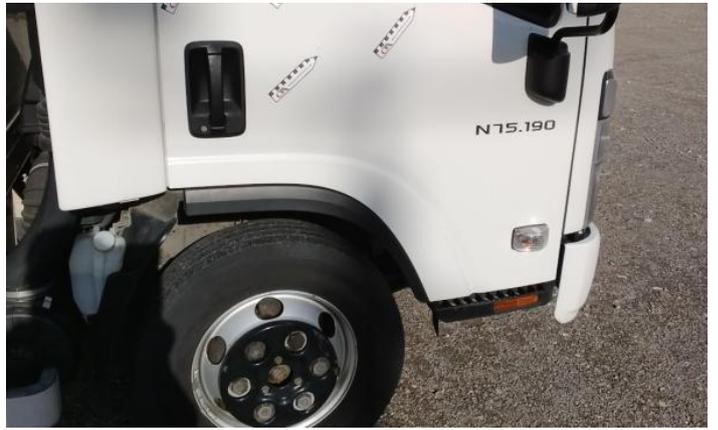
10: Door osf
Scratched
Over 25mm Thru Paint

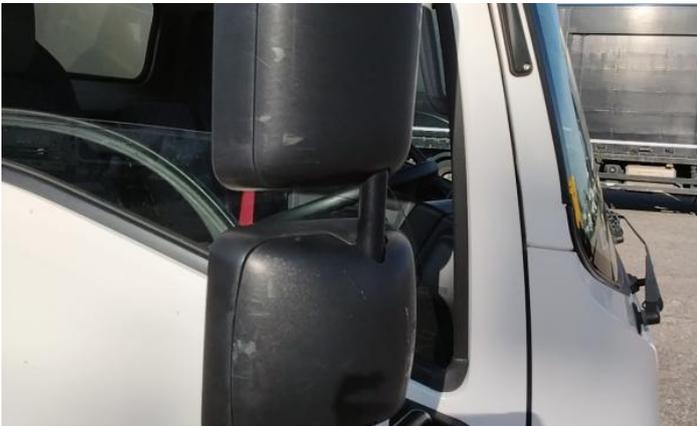
11: Door Mirror Assy osf
Scuffed (Unpainted)
Over 100mm

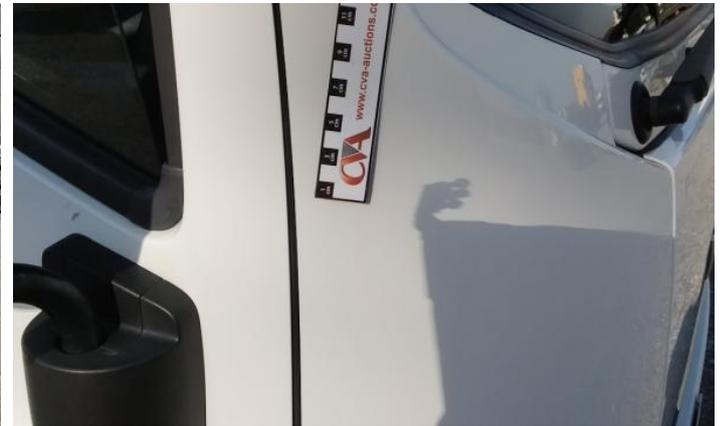
12: Moulding osf Wing
Scratched (Painted)
UpTo 25mm Thru Paint

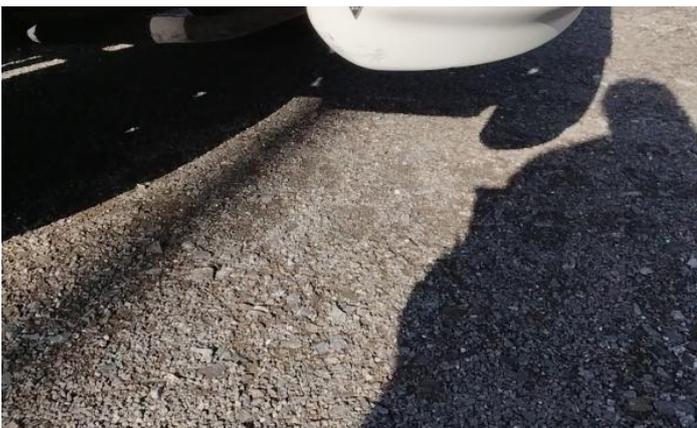
13: Bumper Front
Scratched
Over 100mm Thru Paint
