VEHICLE INSPECTION REPORT

Ford Transit Custom 300 2.0 ECOBLUE 130PS

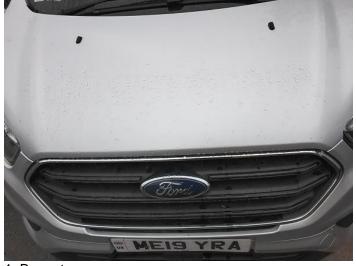
1: Bonnet Chipped Multiple Chips

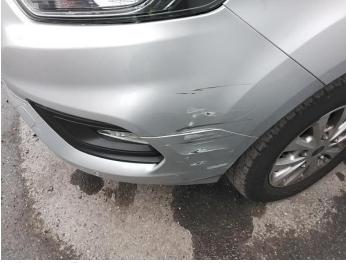
2: Bumper Front Scratched Over 100mm Thru Paint

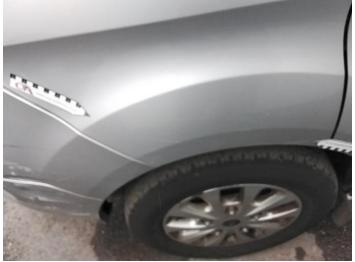
3: Wing nsf Scratched Over 25mm Thru Paint

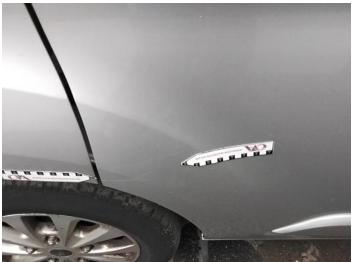
4: Door nsf Scratched Over 25mm Thru Paint

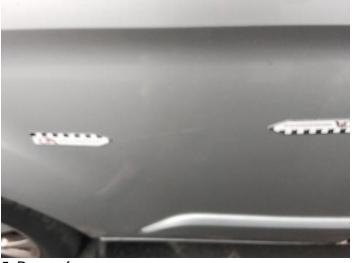
5: Door nsf Scratched Over 25mm Thru Paint

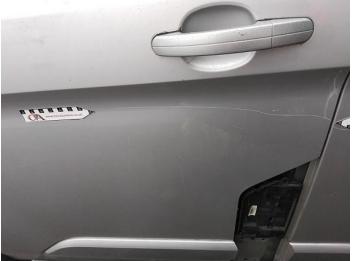
6: Door nsf Scratched Over 25mm Thru Paint

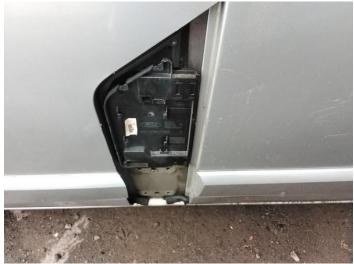
7: Door Moulding nsf Missing Replace

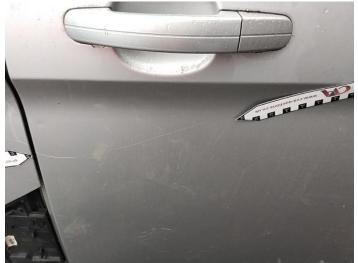
8: Qtr Panel nsr Scratched Over 25mm Thru Paint

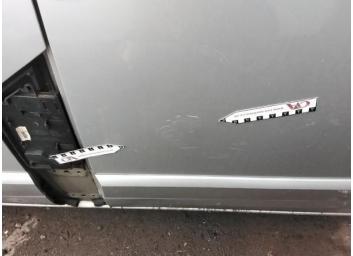
9: Qtr Panel nsr Scratched Over 25mm Thru Paint

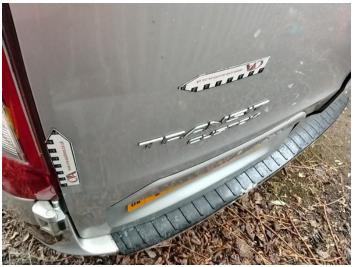
11: Door nsr Dented Over 30mm

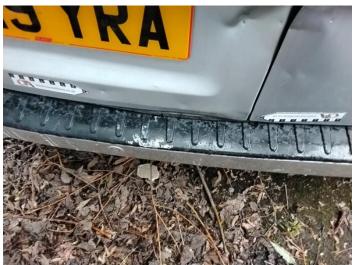
13: Door nsr Dented Over 30mm

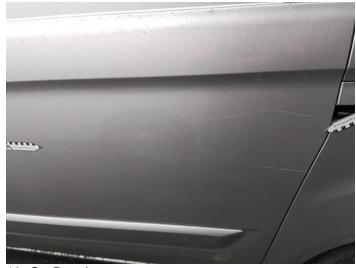
10: Qtr Panel nsr Scratched Over 25mm Thru Paint

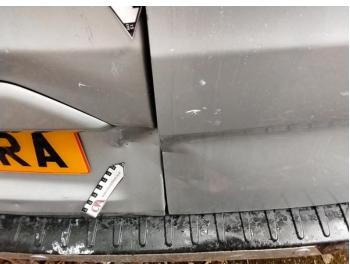
12: Door nsr Dented Over 30mm

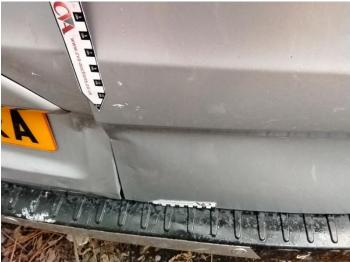
14: Door osr Dented Over 30mm

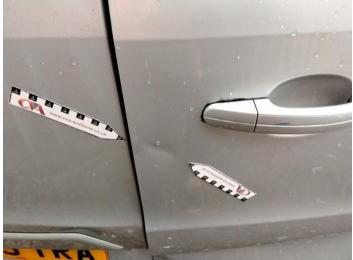
15: Door osr Dented Over 30mm

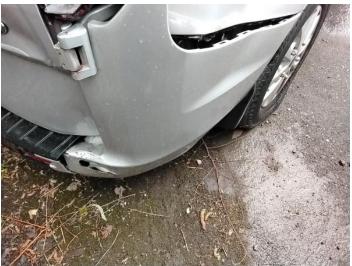
16: Bumper Rear Moulding Broken Replace

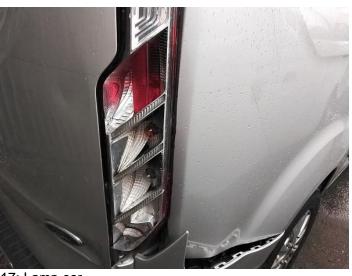
17: Lamp osr Broken Replace

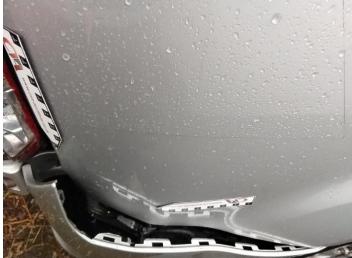
18: Qtr Panel osr Dented Over 30mm

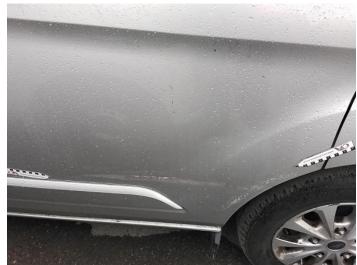
19: Door osf Scratched Over 25mm Thru Paint

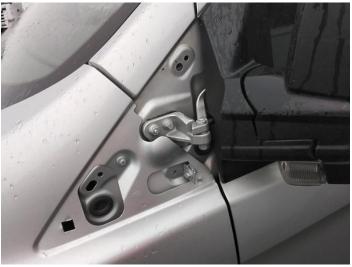
20: Door Moulding nsf Missing Replace

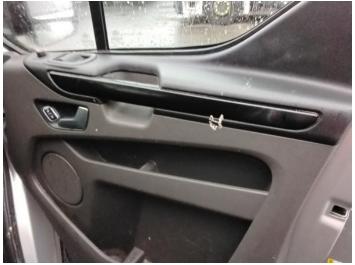
21: Door Pad osf Soiled Heavy

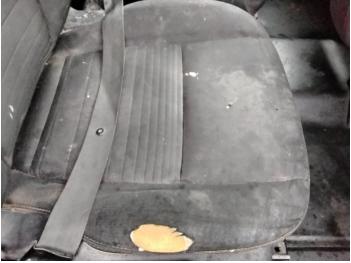
22: Seat Base Cover osf Torn Over 3mm

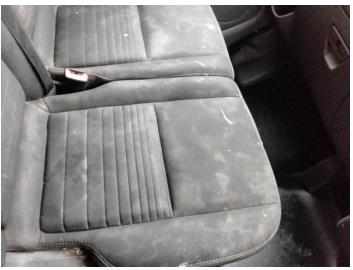
23: Seat Base Cover nsf Soiled Heavy
