VEHICLE INSPECTION REPORT

PF70DZW

Fiat Ducato 35 2.3 Multijet 140PS

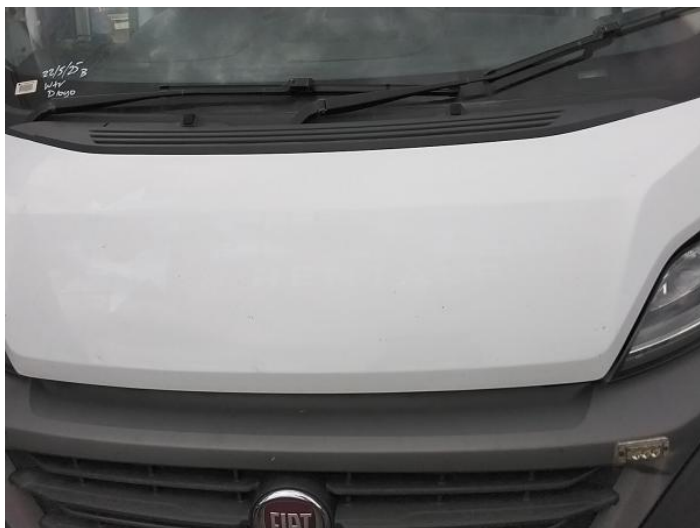
1: Bonnet
Chipped
Multiple Chips

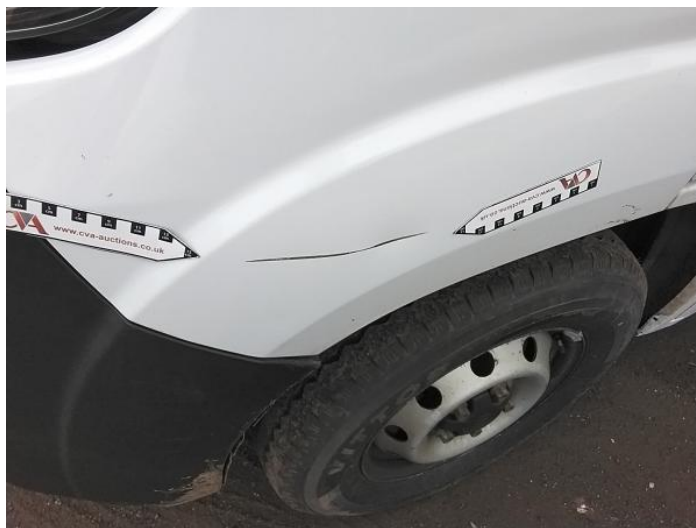
2: Wing nsf
Dented
Over 30mm

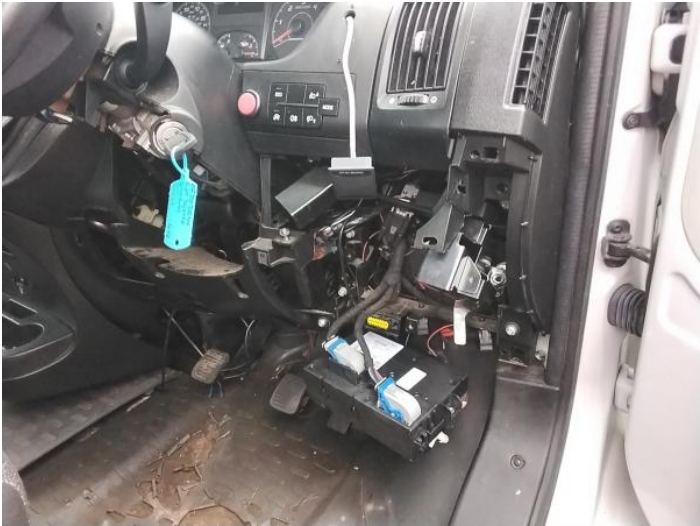
3: Fascia Panel
Missing
Replace
