# VEHICLE INSPECTION REPORT

**PE17JHX**

## VOLVO FM 370

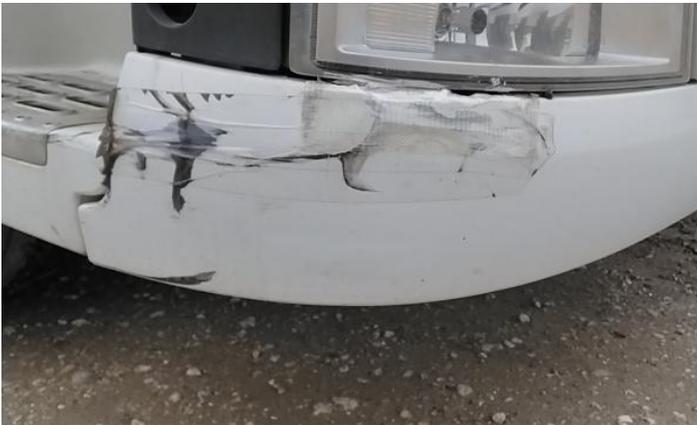
1: Bumper Front Moulding  
Broken  
Replace

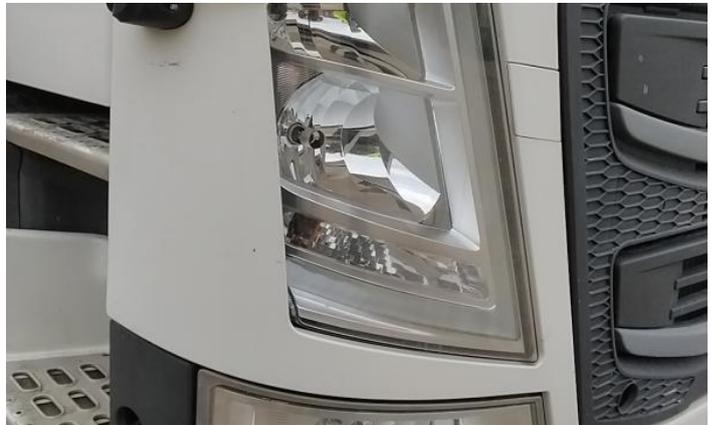
2: Fog Lamp Surround is  
Scratched (Painted)  
Over 25mm Not Thru Paint

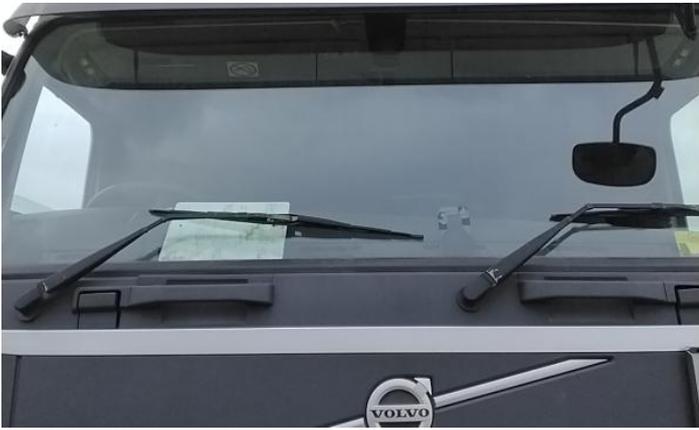
3: Screen Front  
Chipped  
Over 10mm

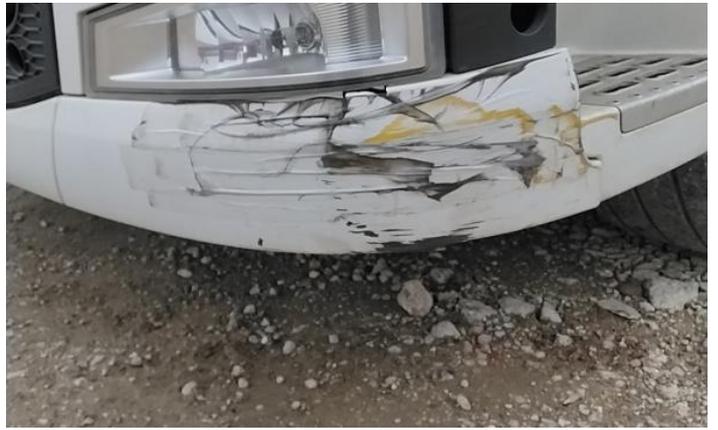
4: Bumper Front Moulding  
Broken  
Replace

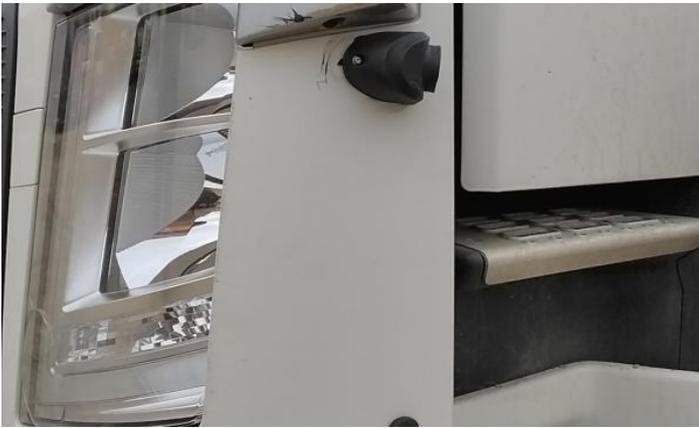
5: Fog Lamp Surrounds  
Scratched (Painted)  
Over 25mm Not Thru Paint

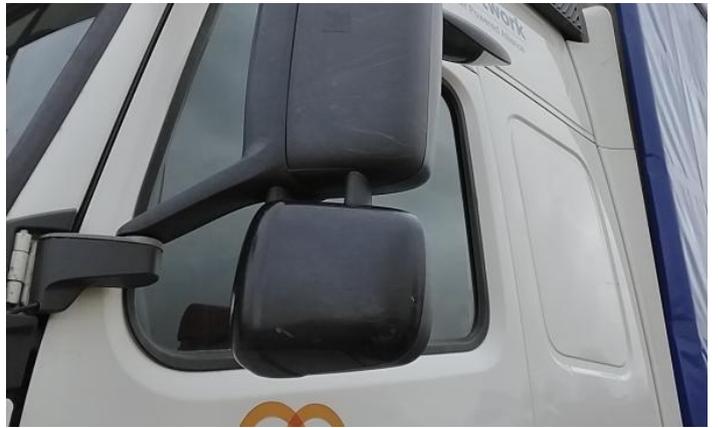
6: Door Mirror Assy nsf  
Scuffed (Unpainted)  
Over 100mm

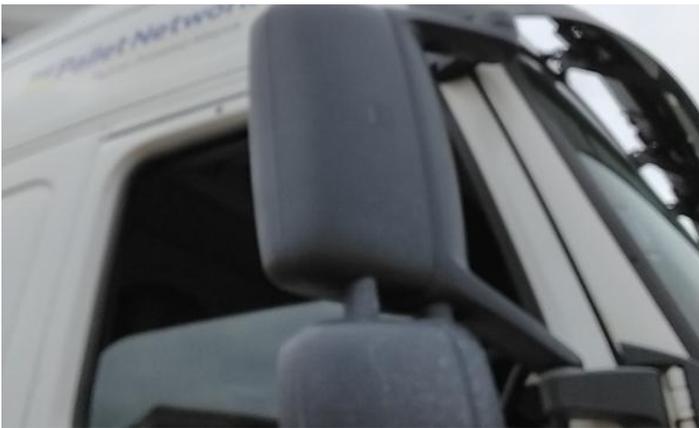
7: Door Mirror Assy osf  
Scuffed (Unpainted)  
Over 100mm

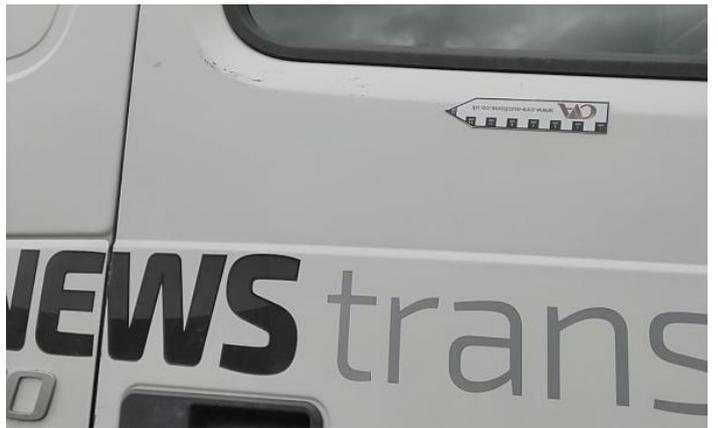
8: Door osf  
Scratched  
Over 25mm Not Thru Paint

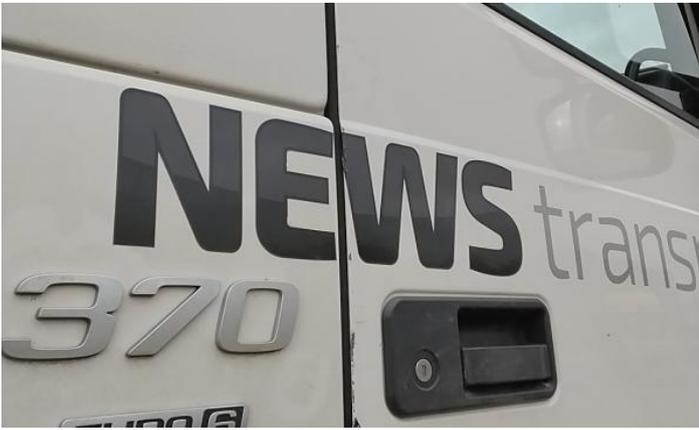
9: Door osf  
 Chipped  
 Edge Chip
