VEHICLE INSPECTION REPORT

DF13URP

Mercedes-Benz Actros 1842

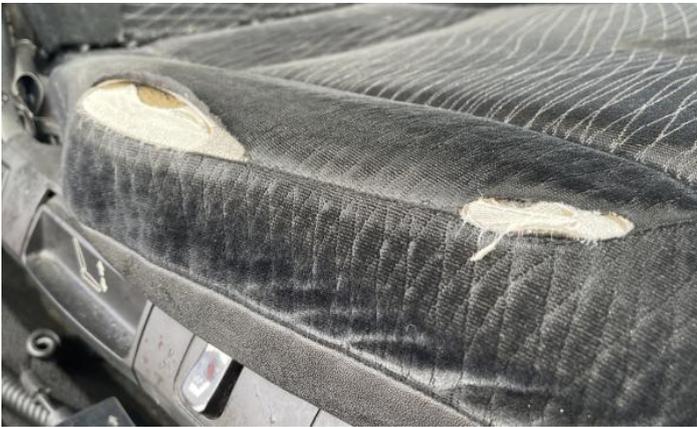
1: Seat Base Cover of
Torn
Over 3mm

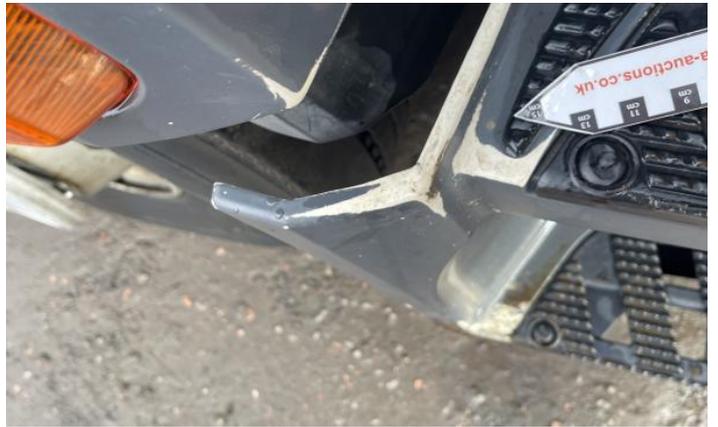
2: Door Moulding of
Scuffed (Unpainted)
Over 100mm

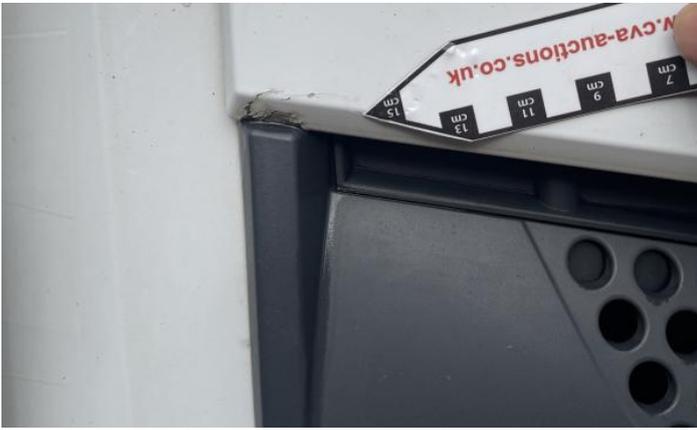
3: Bonnet
Cracked
Replace

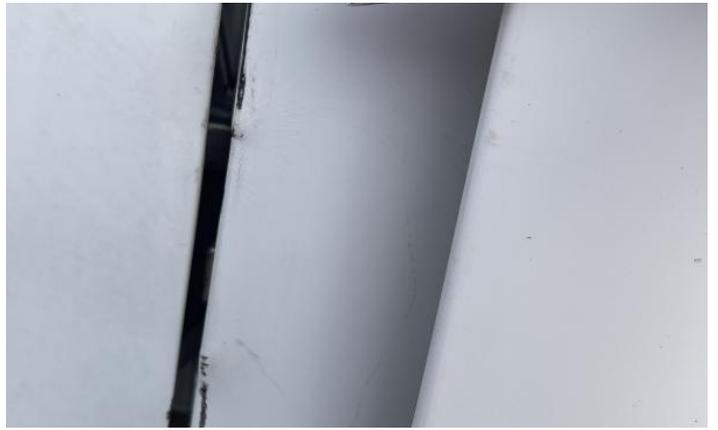
4: Wing nsf
Dented
With Paint Damage

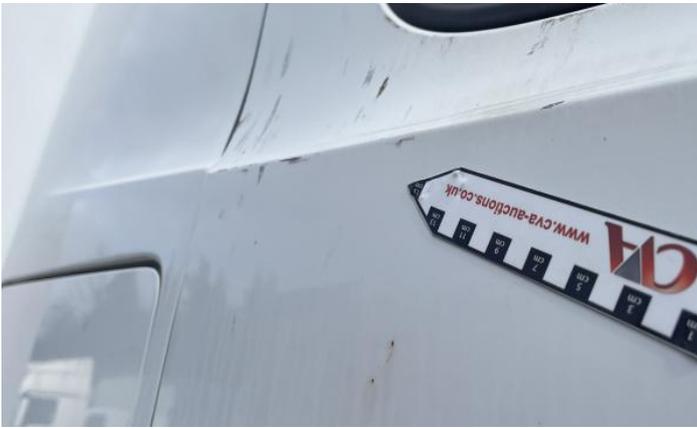
5: Door osf
Dented
With Paint Damage

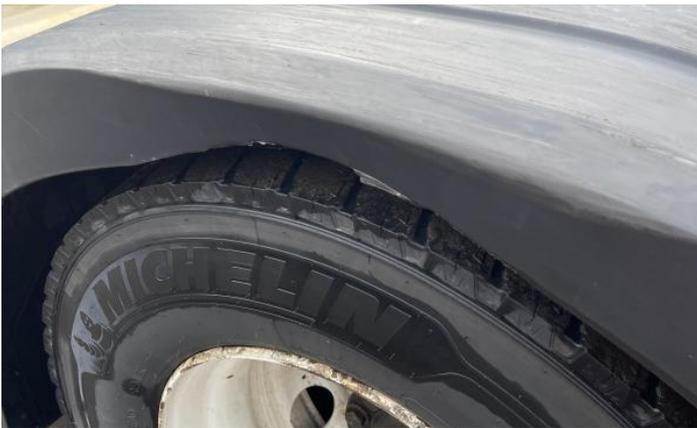
6: Qtr Panel Moulding os
Scuffed (Unpainted)
Over 100mm

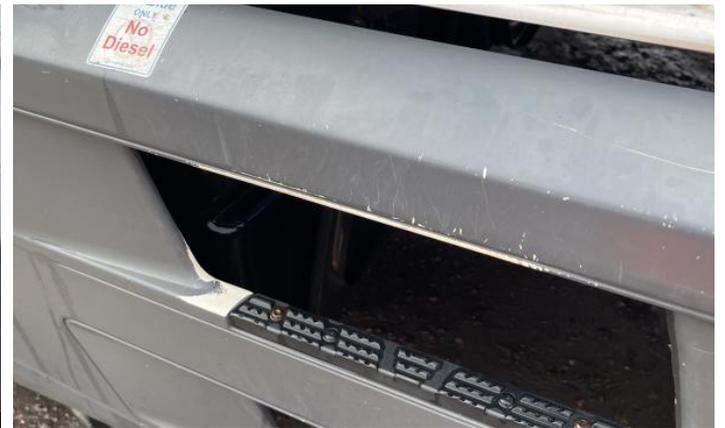
7: Qtr Panel Moulding ns
Broken
Replace

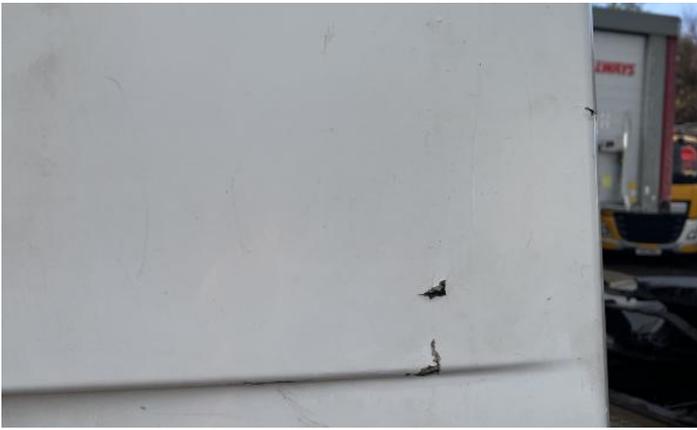
9: B Post ns
Cracked
Replace

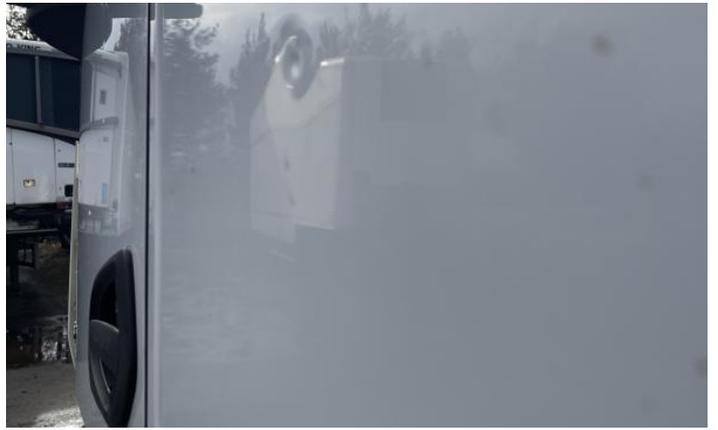
10: B Post ns
Dented
With Paint Damage

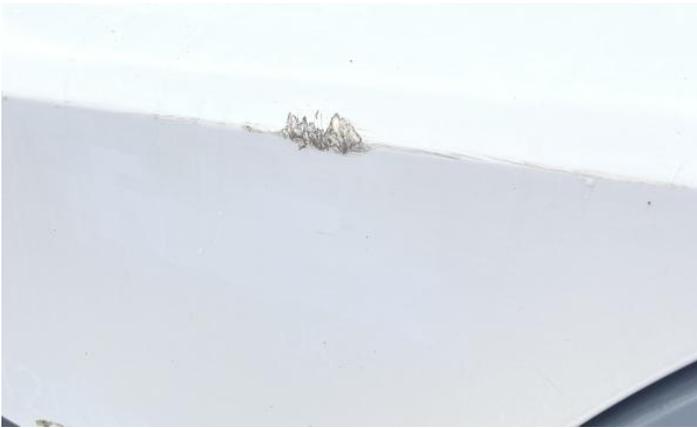
11: Door nsf
Dented
With Paint Damage

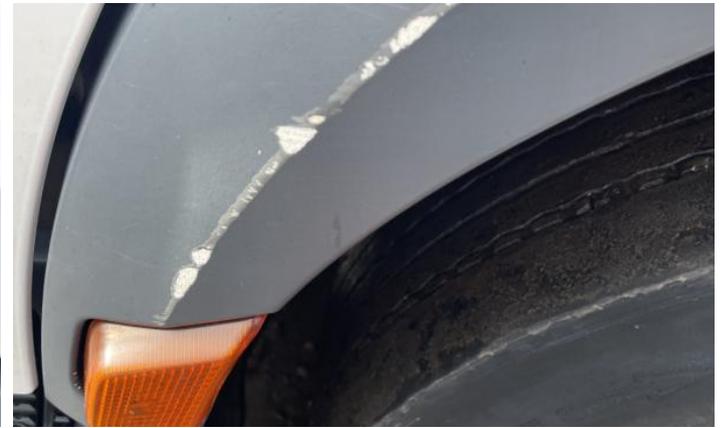
12: Door Moulding nsf
Scuffed (Unpainted)
Over 100mm
