VEHICLE INSPECTION REPORT

DG16JXL

Mercedes-Benz Sprinter 516 CDI

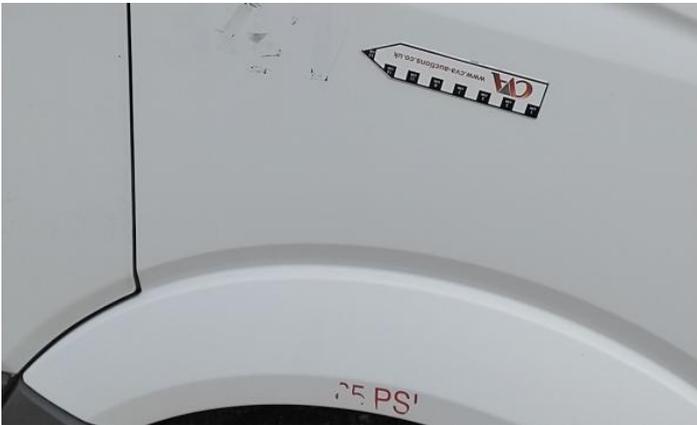
1: Wing of
Scratched
Over 25mm Thru Paint

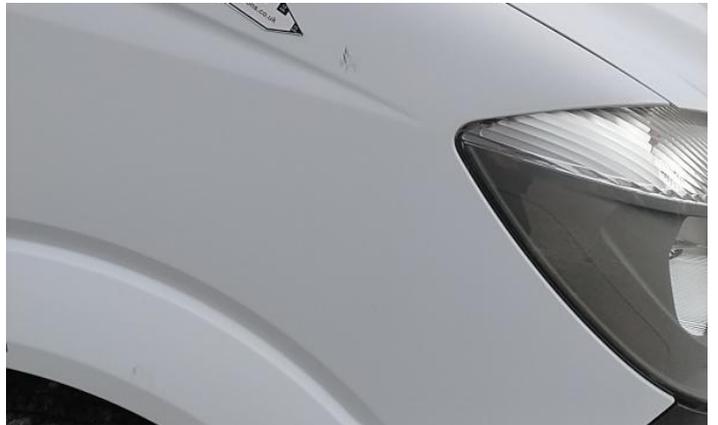
2: Wing of
Scratched
Up To 25mm Thru Paint

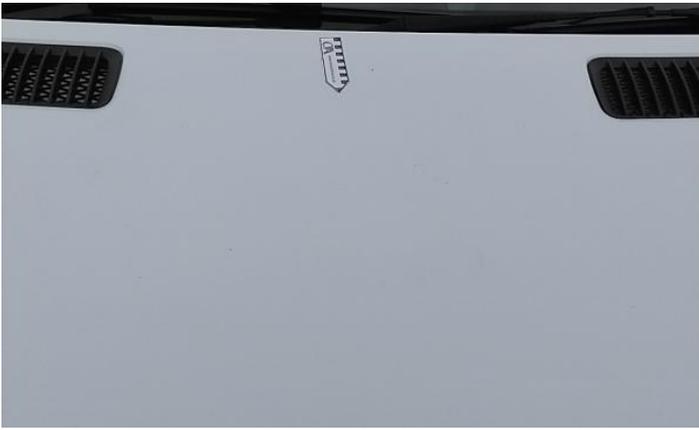
3: Bonnet
Chipped
Multiple Chips

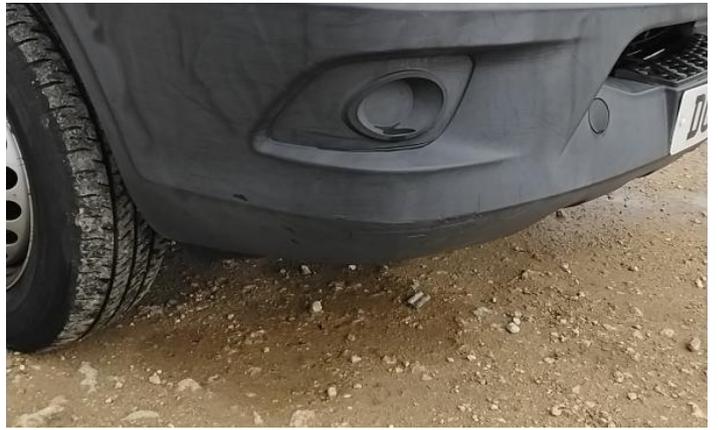
4: Bumper Front Moulding
Scuffed (Unpainted)
Over 100mm

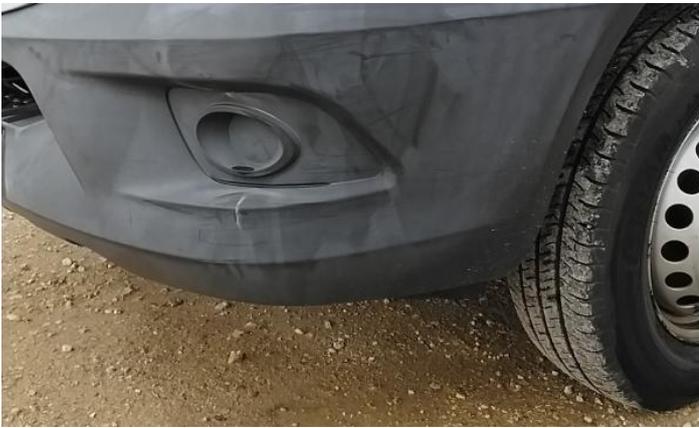
5: Bumper Front Moulding
Scuffed (Unpainted)
Over 100mm

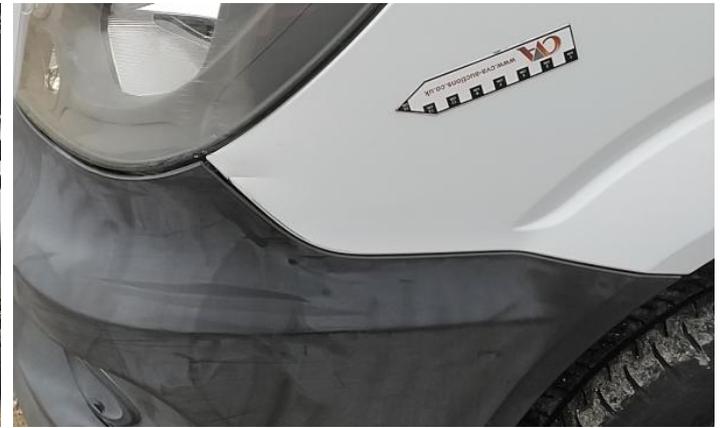
6: Wing nsf
Dented
With Paint Damage

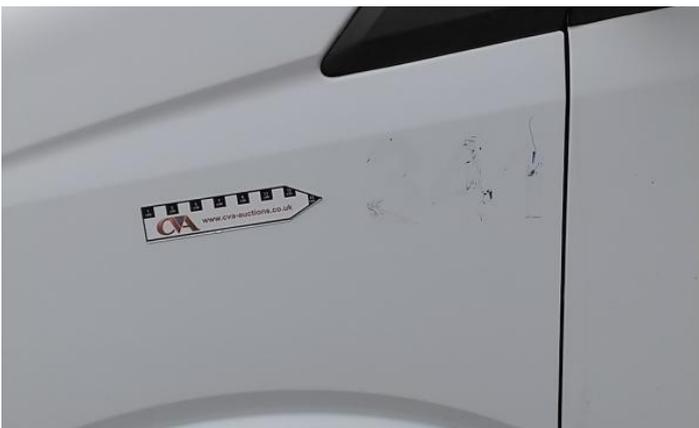
7: Wing nsf
Scratched
Over 25mm Thru Paint

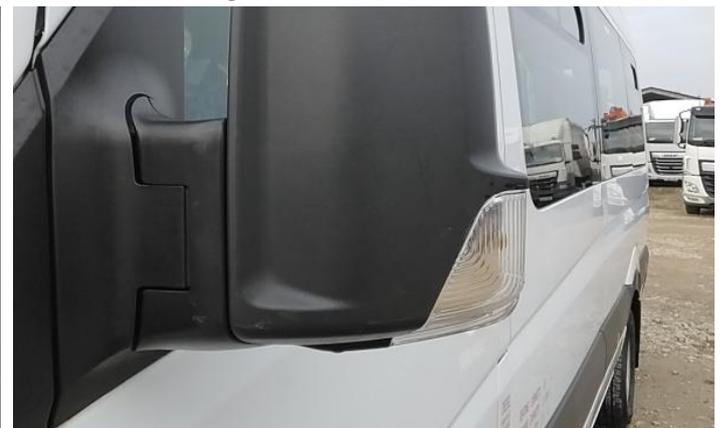
8: Door Mirror Assy nsf
Scuffed (Unpainted)
Over 100mm

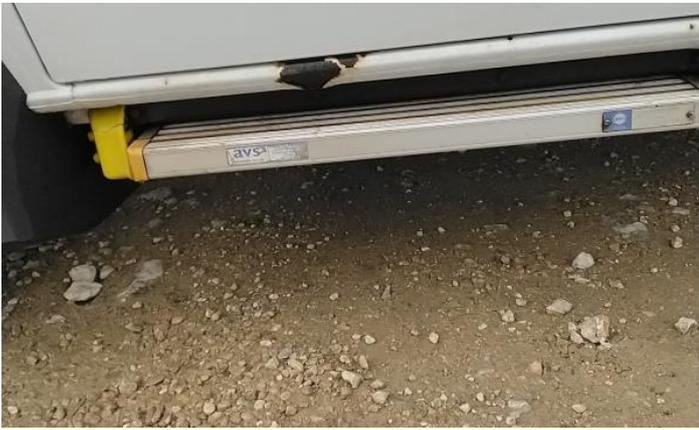
9: Sill ns
Rusted
Over 5mm

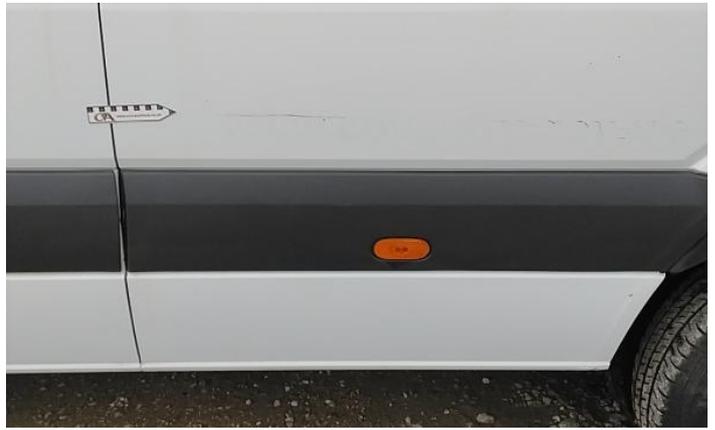
10: Qtr Panel nsr
Scratched
Over 25mm Not Thru Paint

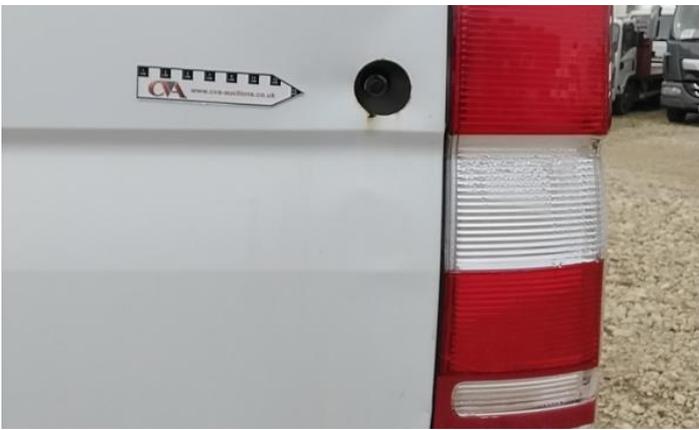
11: Qtr Panel nsr
Rusted
Over 5mm

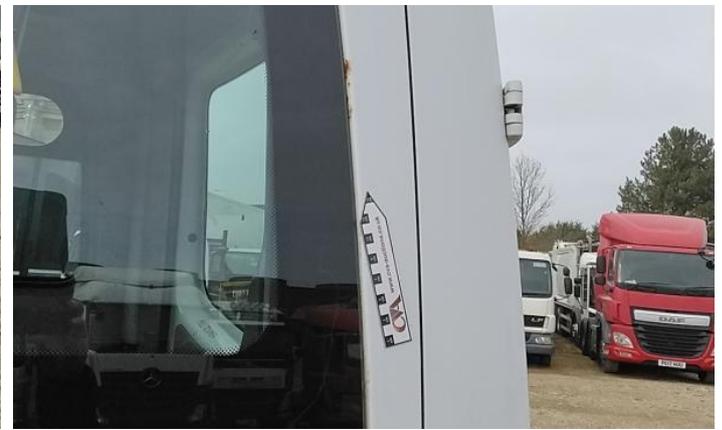
12: Qtr Panel nsr
Rusted
Over 5mm

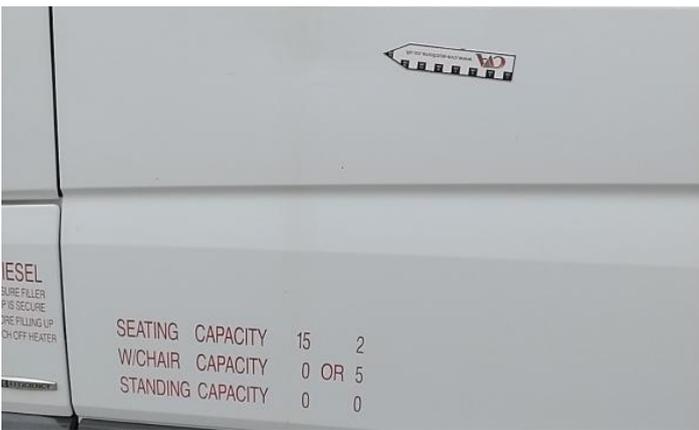
13: Qtr Panel nsr
Dented
Over 30mm

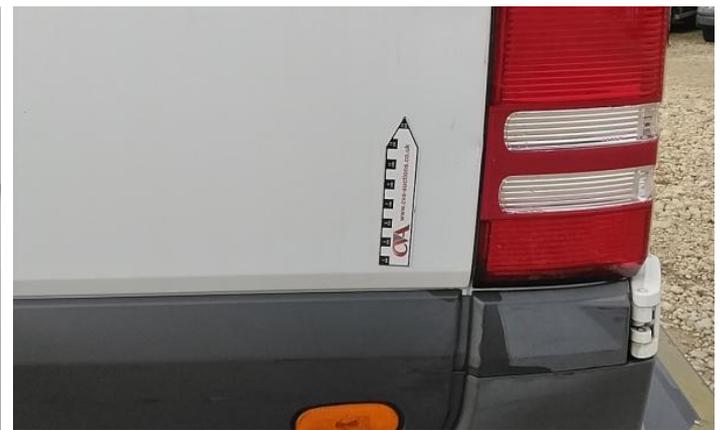
14: Qtr Panel nsr
Dented
Over 30mm

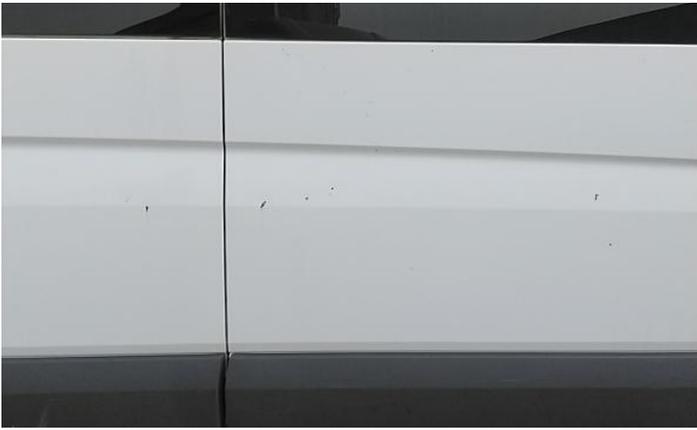
15: Qtr Panel osr
Rusted
Over 5mm

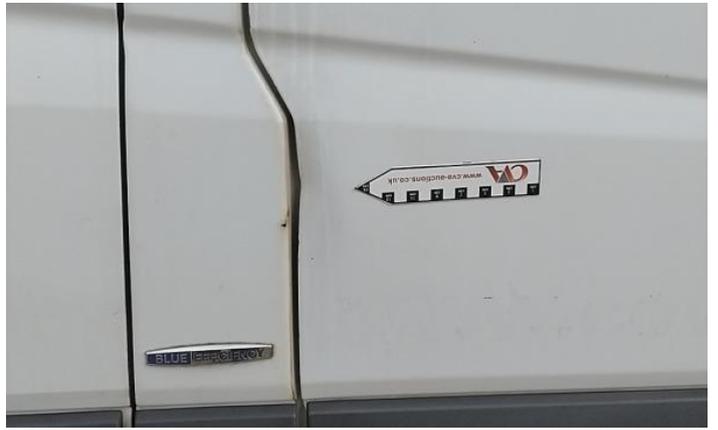
16: Door osf
Dented
Between 10mm + 30mm

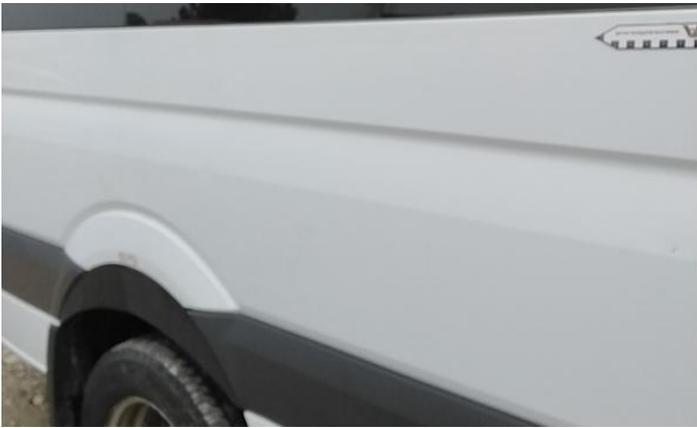
17: Qtr Panel osr
Scratched
Over 25mm Not Thru Paint
