VEHICLE INSPECTION REPORT

DG16JXM

Mercedes-Benz Sprinter 516 CDI

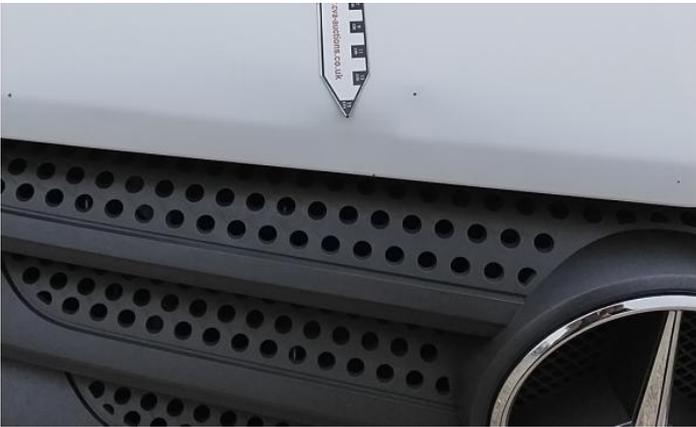
1: Bonnet
Dented
Between 10mm + 30mm

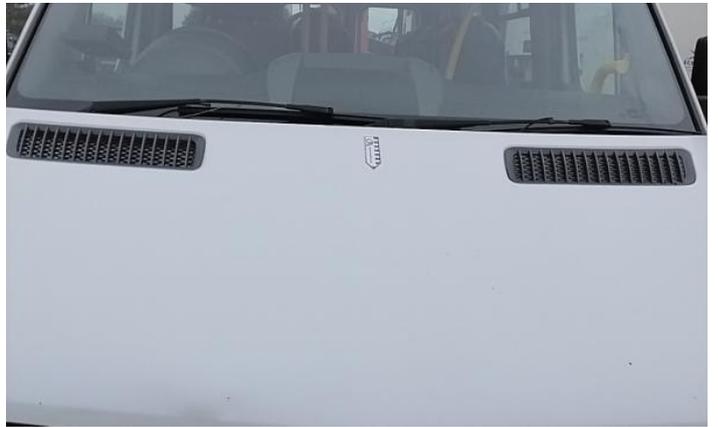
2: Bonnet
Chipped
Multiple Chips

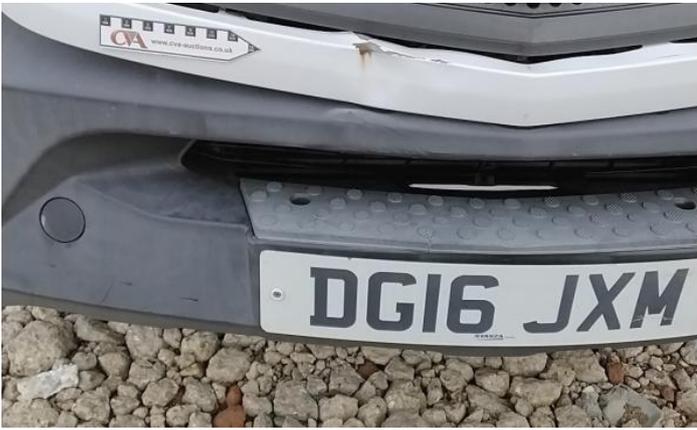
3: Grille Front
Broken
Replace

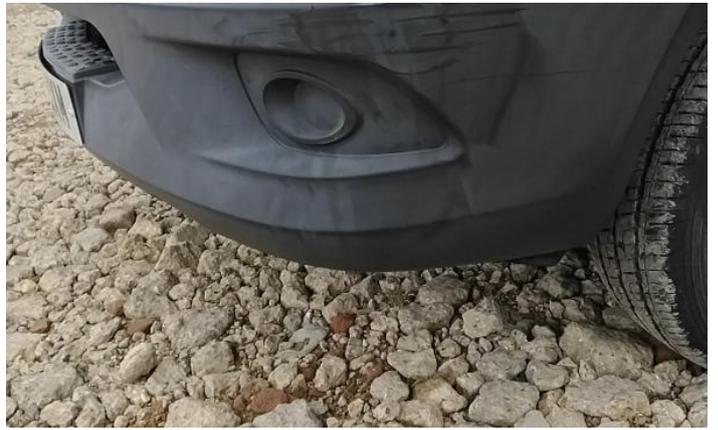
4: Bumper Front Moulding
Scuffed (Unpainted)
Over 100mm

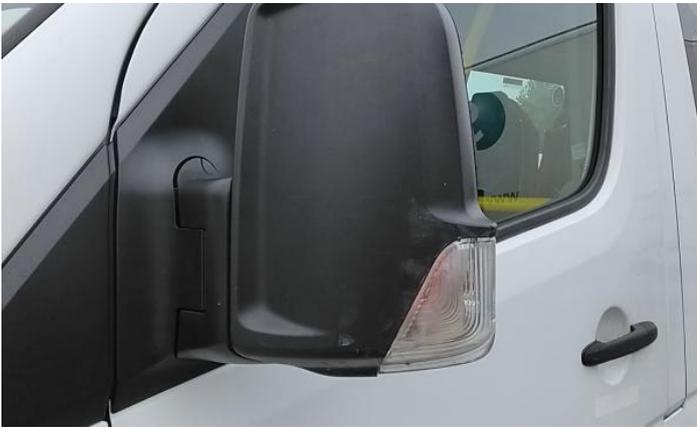
5: Door Mirror Assy nsf
Scuffed (Unpainted)
Over 100mm

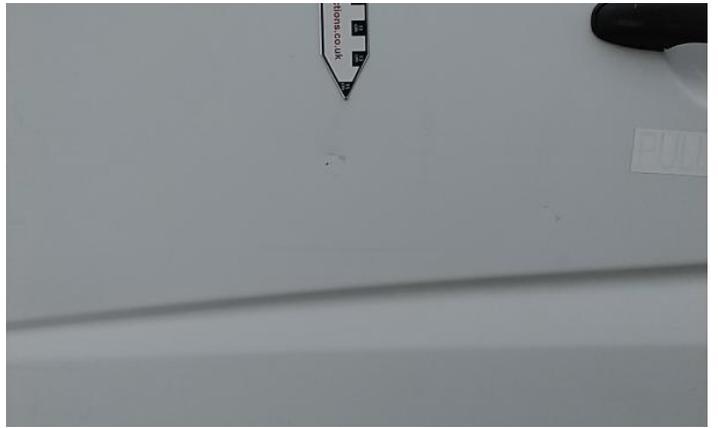
6: Door nsf
Dented
With Paint Damage

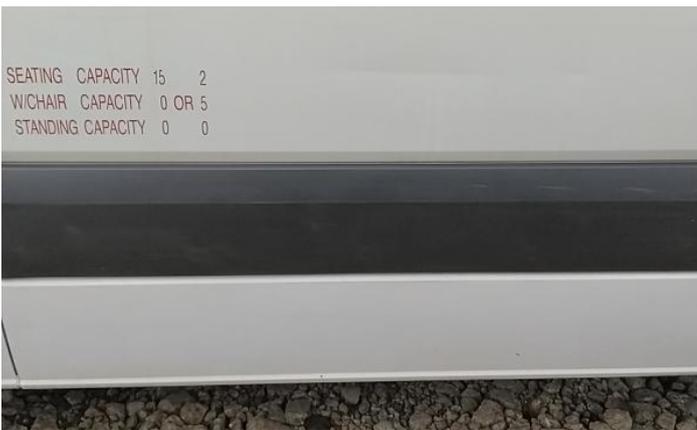
7: Qtr Panel Moulding ns
Scuffed (Unpainted)
Over 100mm

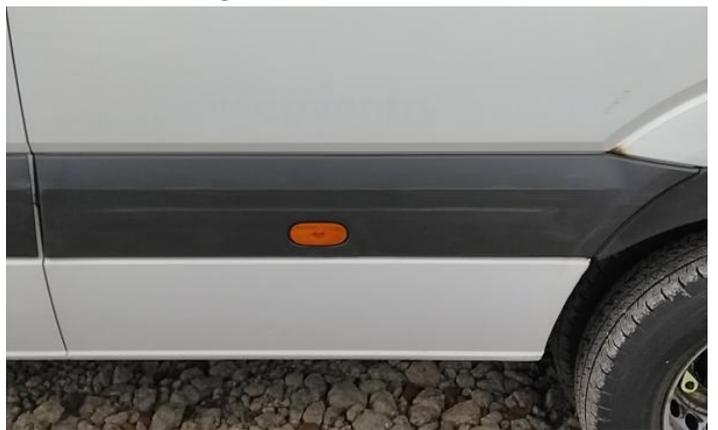
8: Qtr Panel Moulding ns
Scuffed (Unpainted)
Over 100mm

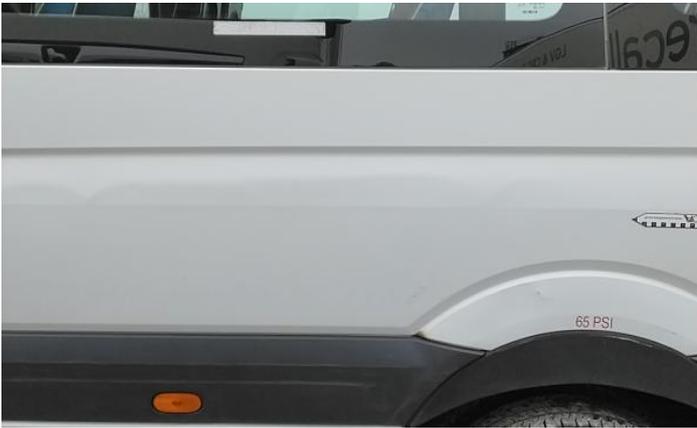
9: Qtr Panel nsr
Dented
Over 30% Of Panel

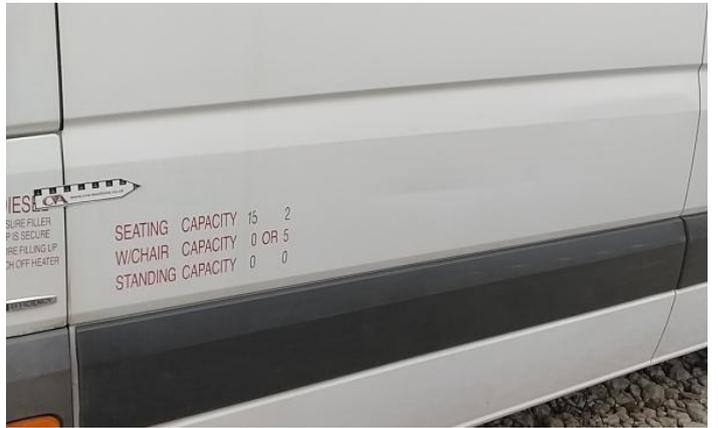
10: Qtr Panel nsr
Dented
Over 30% Of Panel

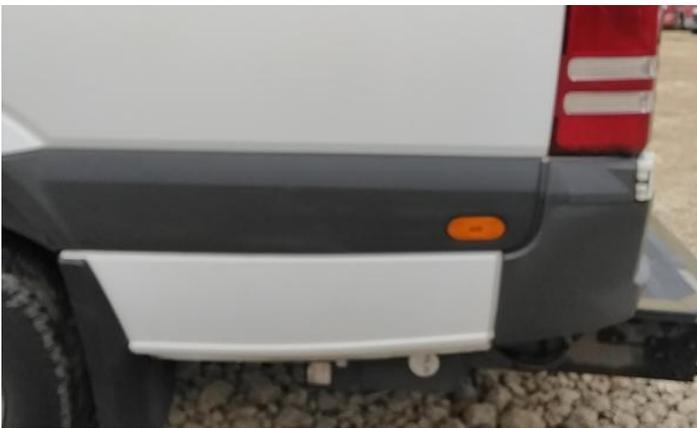
11: Qtr Panel Moulding ns
Scuffed (Unpainted)
Over 100mm

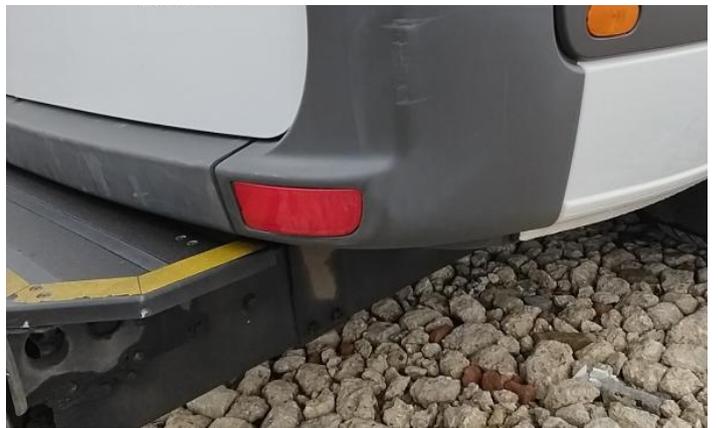
12: Bumper Rear Moulding
Scuffed (Unpainted)
Over 100mm

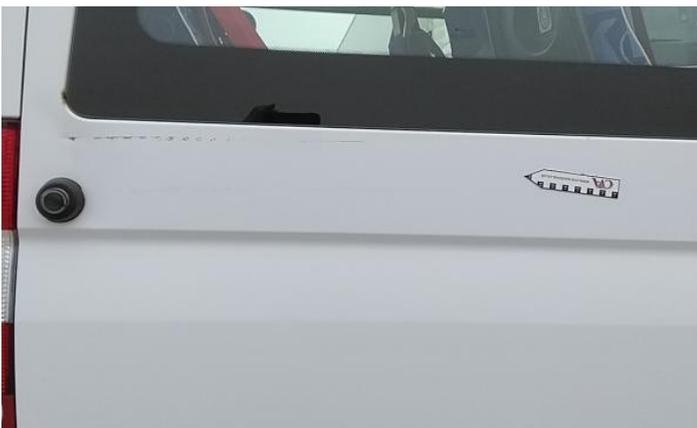
13: Qtr Panel osr
Dented
With Paint Damage

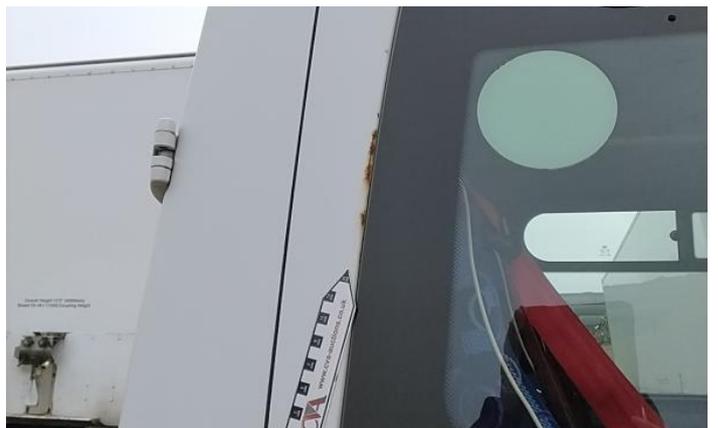
14: Qtr Panel osr
Rusted
Over 5mm

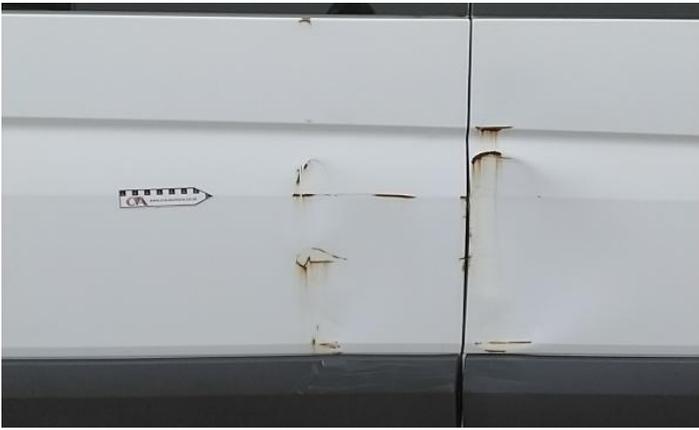
15: Qtr Panel osr
Dented
With Paint Damage

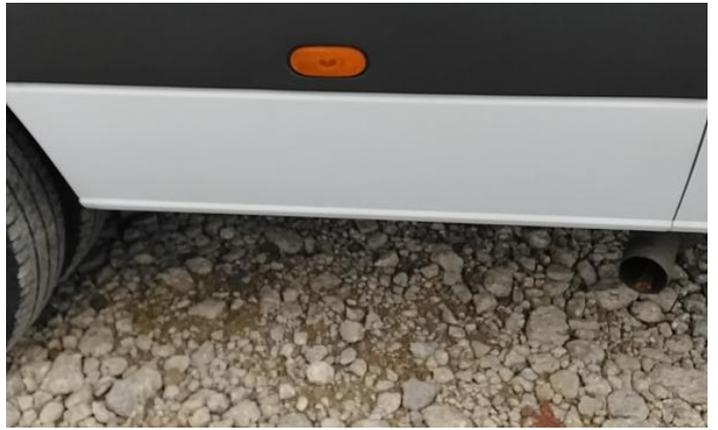
16: Qtr Panel Moulding os
Scuffed (Unpainted)
Over 100mm

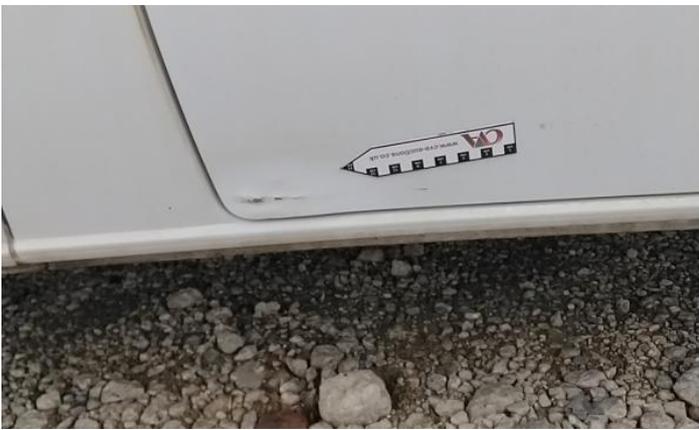
17: Door osf
Dented
With Paint Damage
