# VEHICLE INSPECTION REPORT

**EY19LSU**

## Mercedes-Benz Sprinter 514 CDI

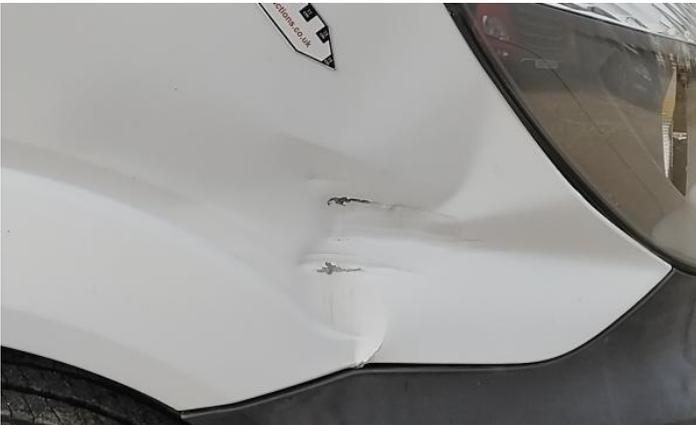
1: Wing of  
Dented  
With Paint Damage

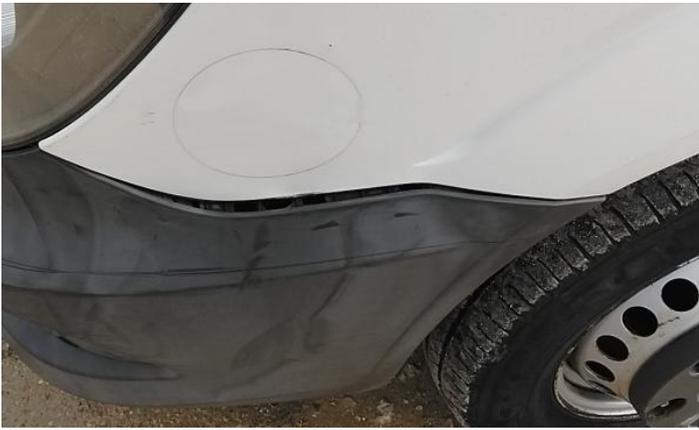
3: Bumper Front Moulding  
Broken  
Replace

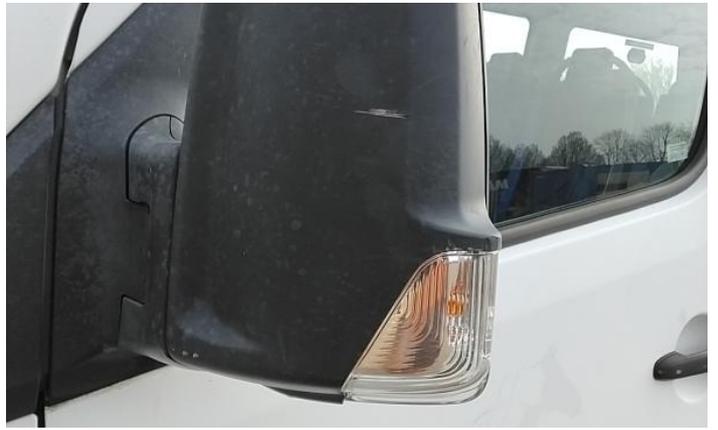
4: Door Mirror Assy nsf  
Scuffed (Unpainted)  
UpTo 100mm

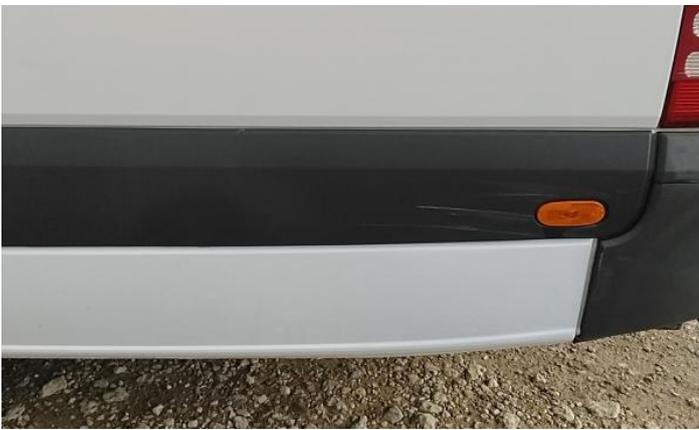
5: Qtr Panel Moulding ns  
Scuffed (Unpainted)  
Over 100mm

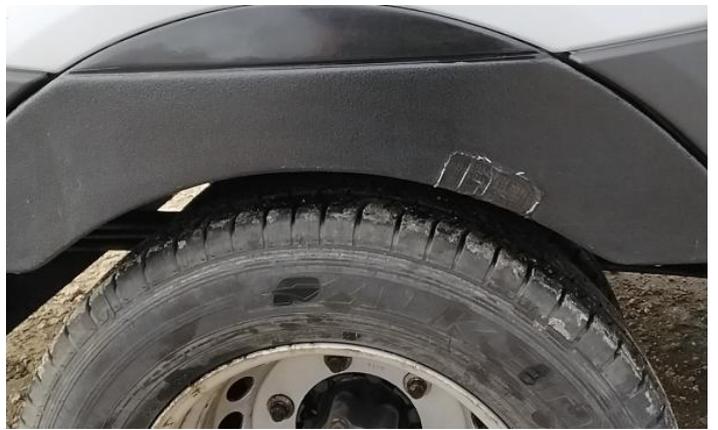
6: Qtr Panel Arch Extension os  
Broken  
Replace

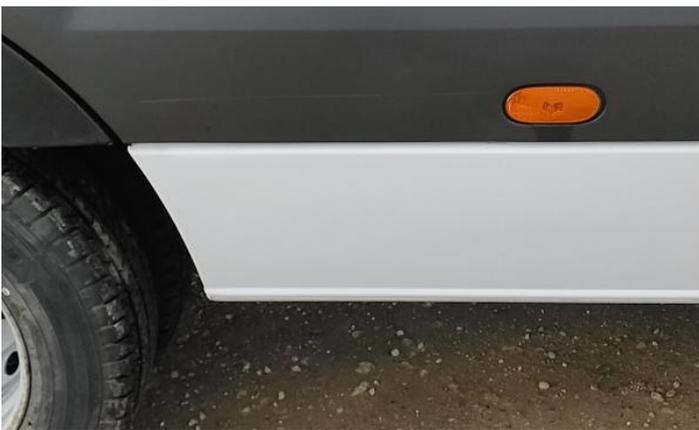
7: Qtr Panel Moulding os  
Scuffed (Unpainted)  
Over 100mm

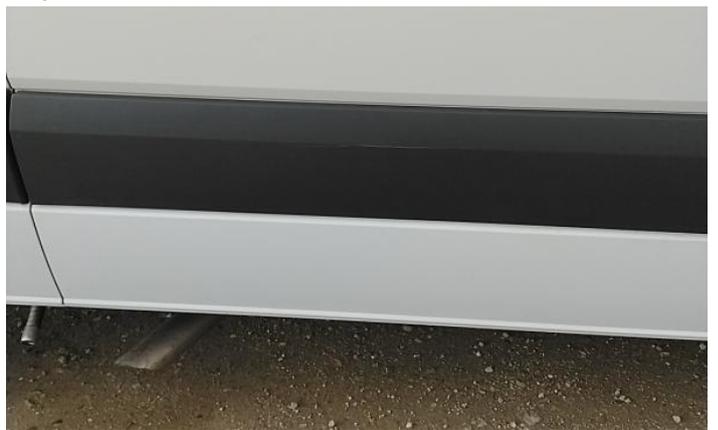
8: Qtr Panel Moulding os  
Scuffed (Unpainted)  
Over 100mm

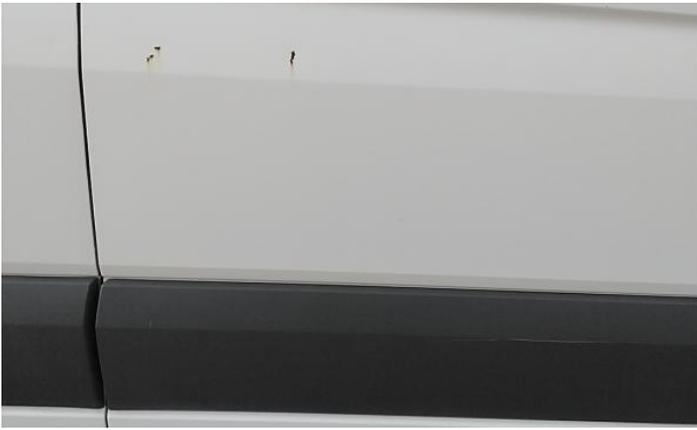
9: Qtr Panel osr  
Rusted  
Over 5mm

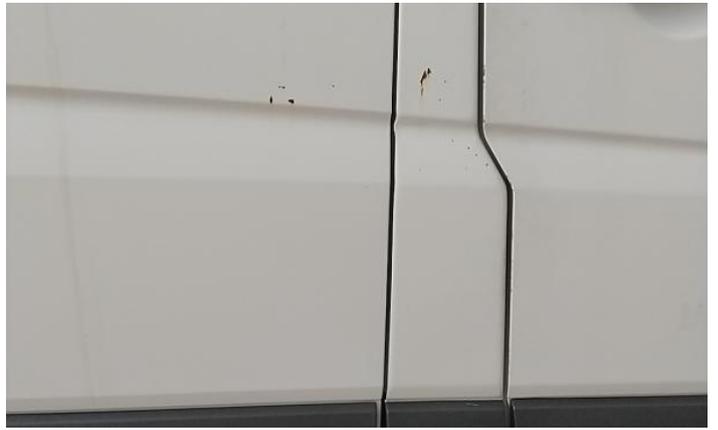
10: B Post os  
Rusted  
Over 5mm

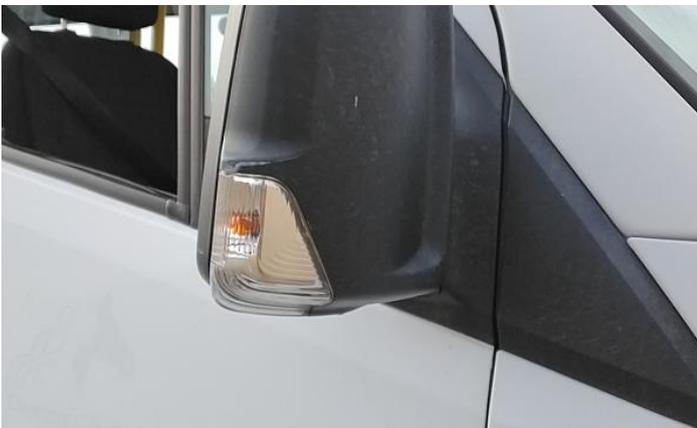
11: Door Mirror Assy osf  
Scuffed (Unpainted)  
UpTo 100mm

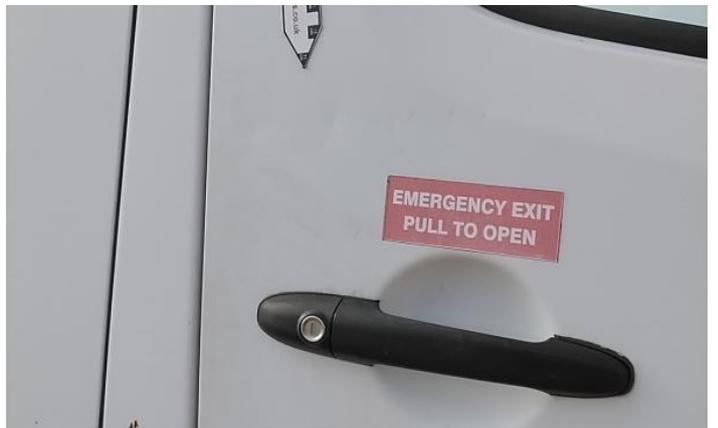
12: Door osf  
Dented  
Over 2 UpTo 10mm
