VEHICLE INSPECTION REPORT

DK15CFO

Mercedes-Benz Sprinter 516 CDI

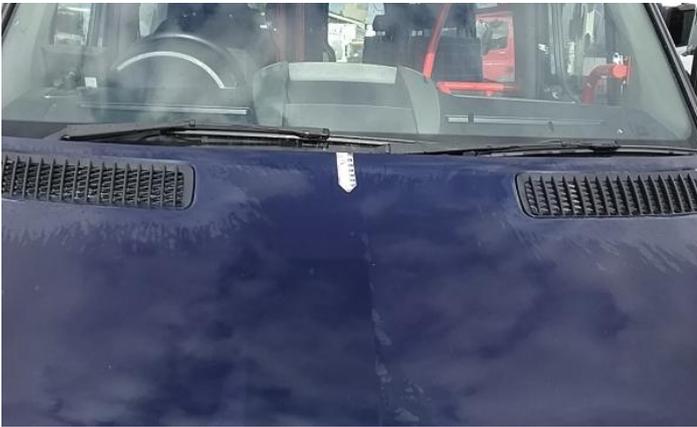
1: Bonnet
Chipped
Multiple Chips

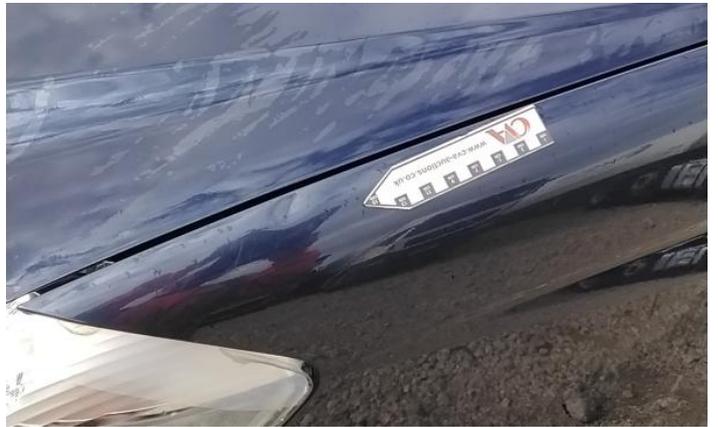
2: Wing nsf
Dented
Between 10mm + 30mm

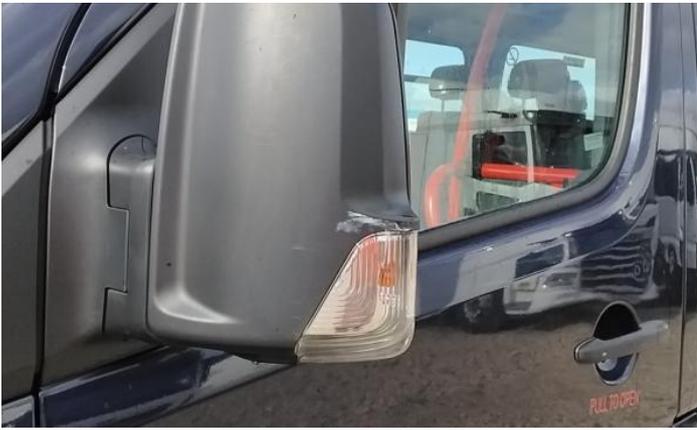
3: Door Mirror Assy nsf
Scuffed (Unpainted)
Over 100mm

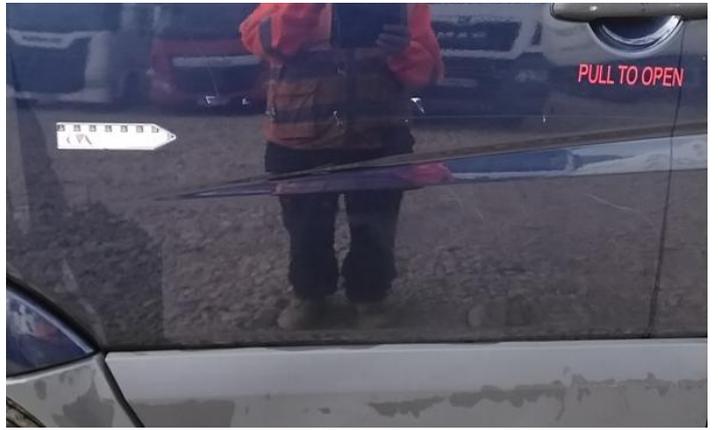
4: Door nsf
Scratched
Over 25mm Thru Paint

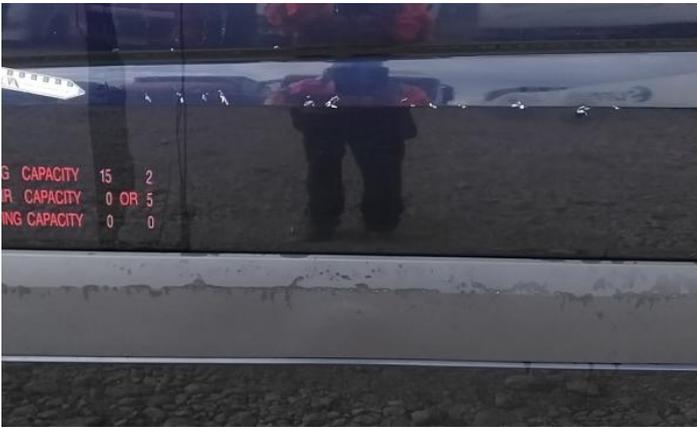
5: Qtr Panel nsr
Scratched
Over 25mm Thru Paint

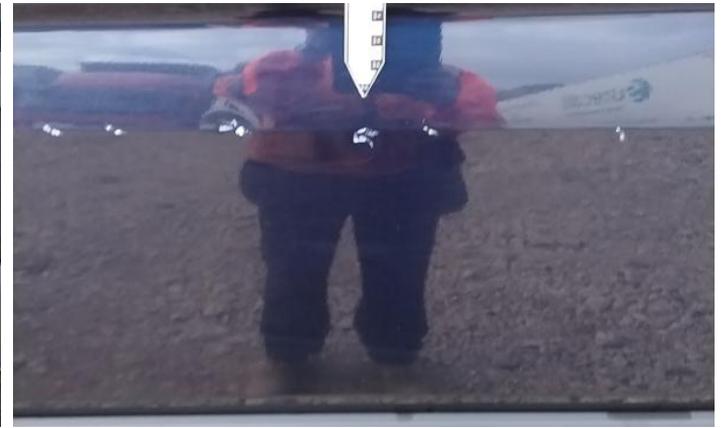
6: Qtr Panel nsr
Dented
With Paint Damage

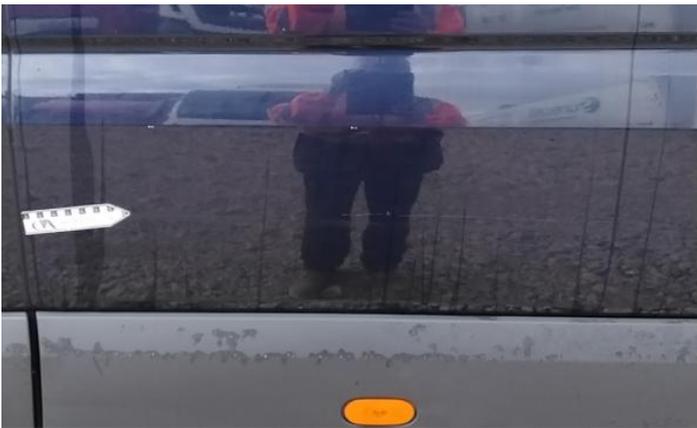
7: Qtr Panel nsr
Scratched
Over 25mm Thru Paint

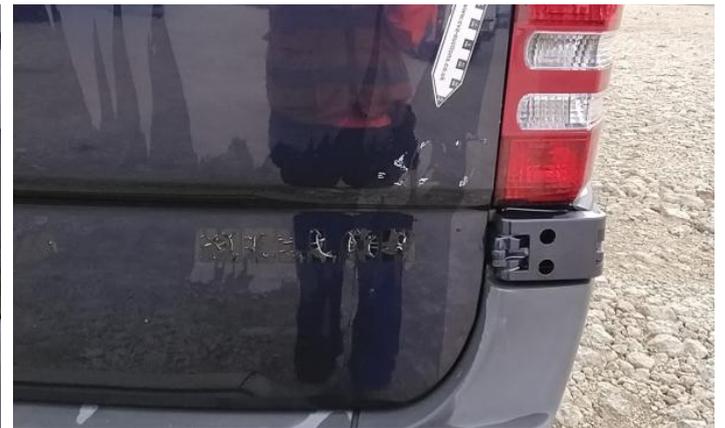
8: Door osr
Scratched
Over 25mm Thru Paint

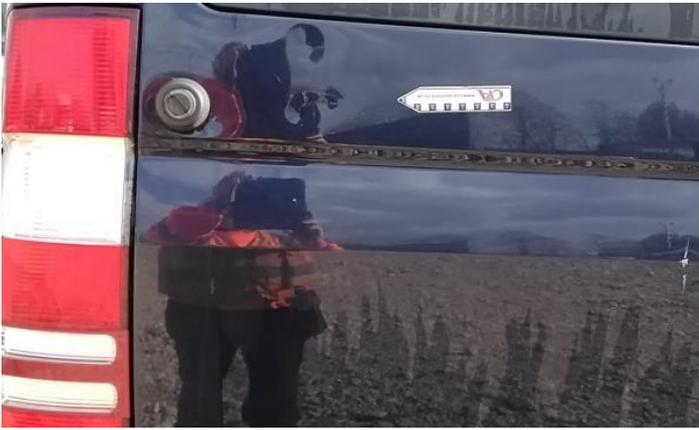
9: Qtr Panel osr
Dented
Between 10mm + 30mm

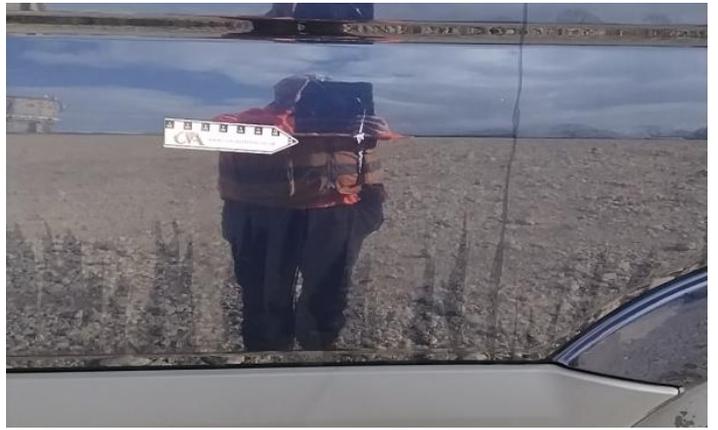
10: Qtr Panel osr
Scratched
Over 25mm Not Thru Paint

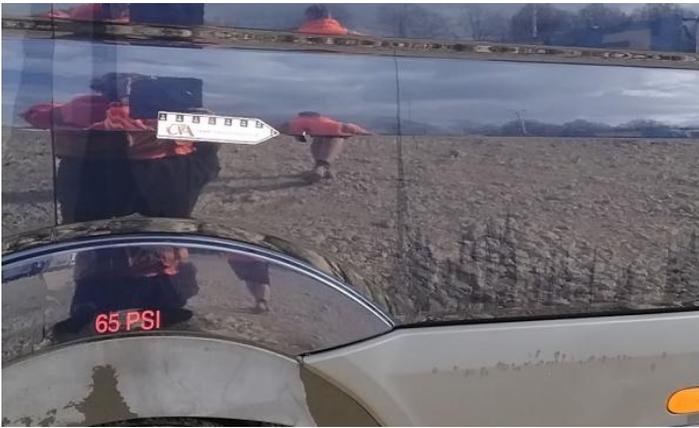
11: Qtr Panel osr
Dented
With Paint Damage

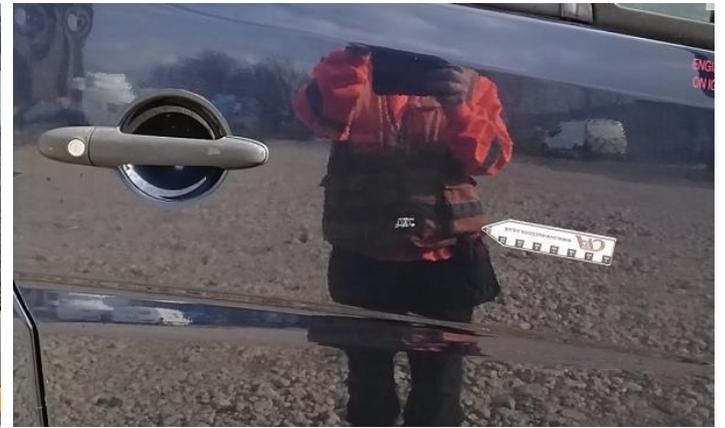
12: Door osf
Scratched
Over 25mm Thru Paint

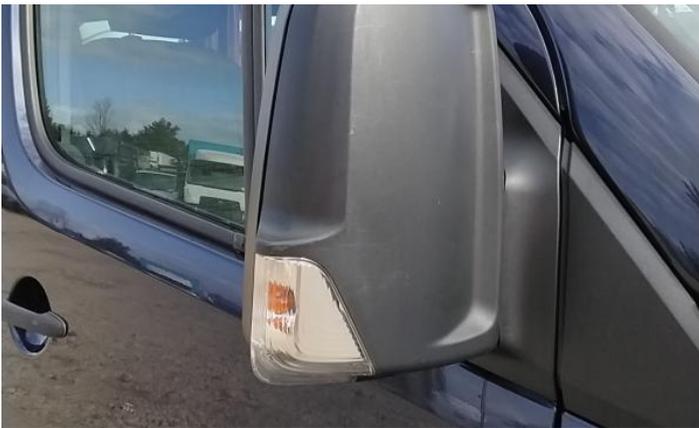
13: Door Mirror Assy osf
Scuffed (Unpainted)
Over 100mm

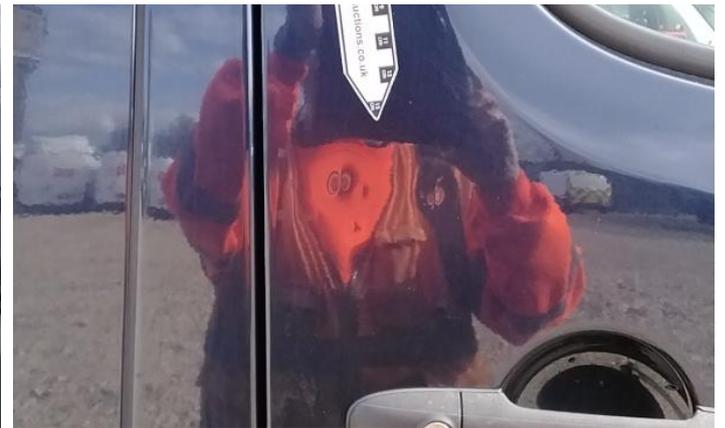
14: Door osf
Dented
Over 2 UpTo 10mm

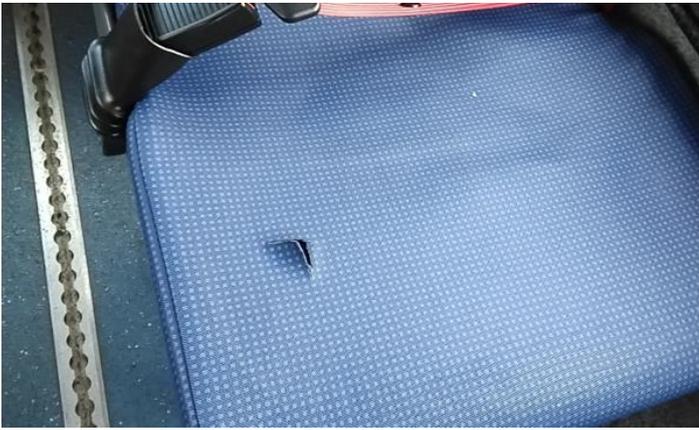
15: Seat Base Cover nsr
 Holed
 Over 3mm
