# VEHICLE INSPECTION REPORT

**CN61DFU**

## Mercedes-Benz Sprinter 513 CDI

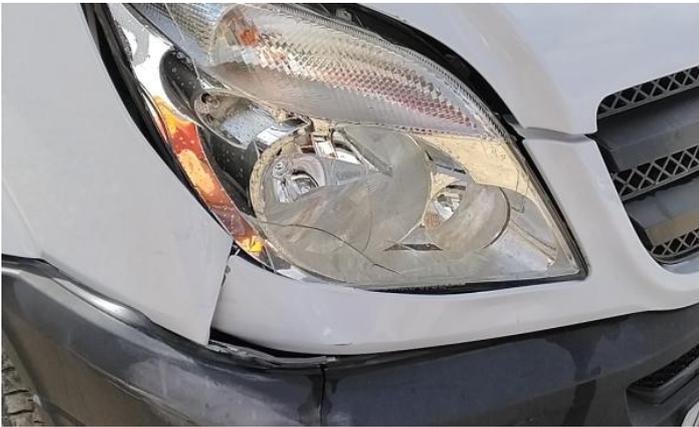
1: Headlamp os  
Broken  
Replace

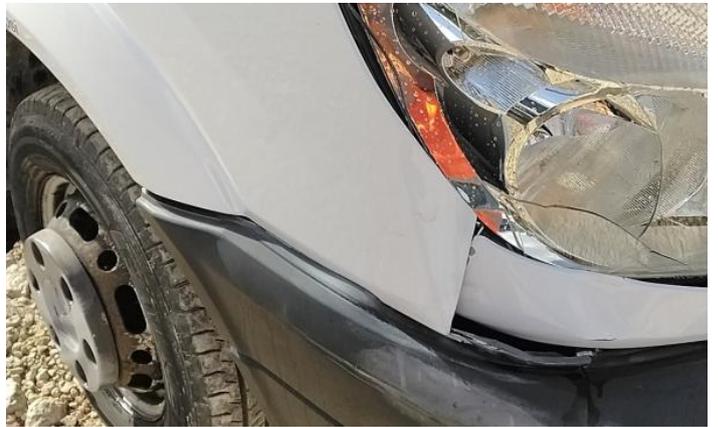
2: Wing osf  
Dented  
Over 30mm

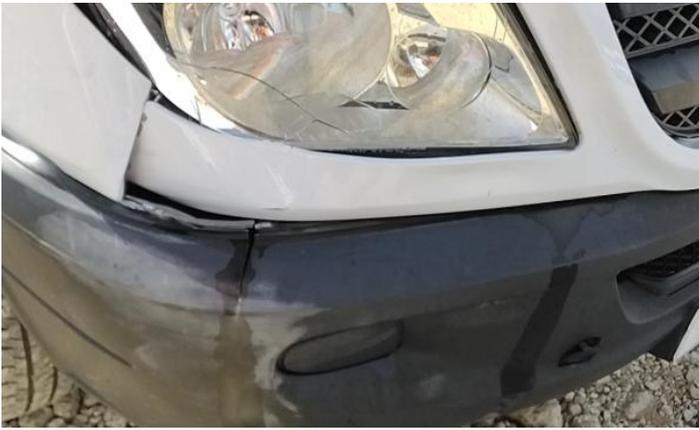
3: Panel Front  
Dented  
With Paint Damage

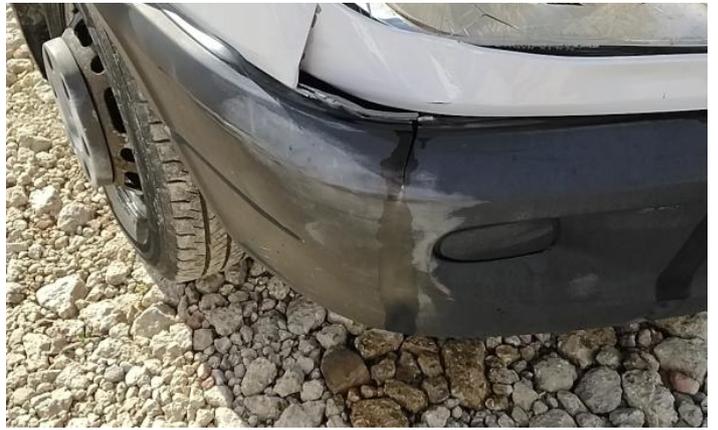
4: Bumper Front  
Cracked  
Over 25mm

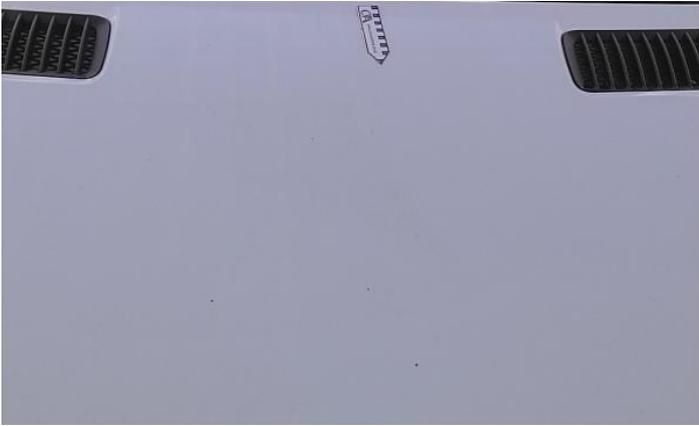
5: Bonnet  
Chipped  
Multiple Chips

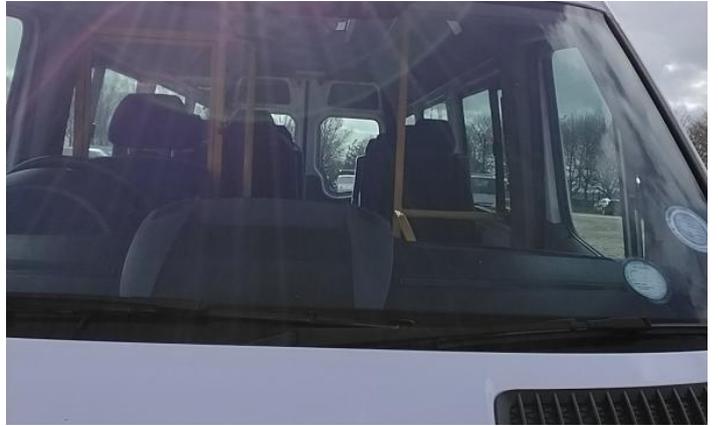
6: Screen Front  
Chipped  
Over 10mm

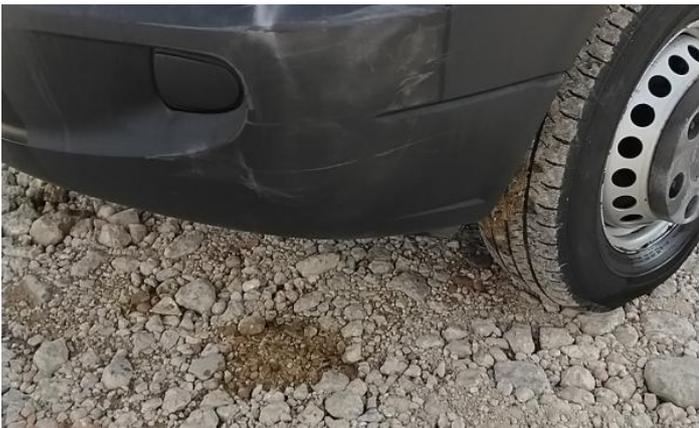
7: Bumper Front Moulding  
Scuffed (Unpainted)  
Over 100mm

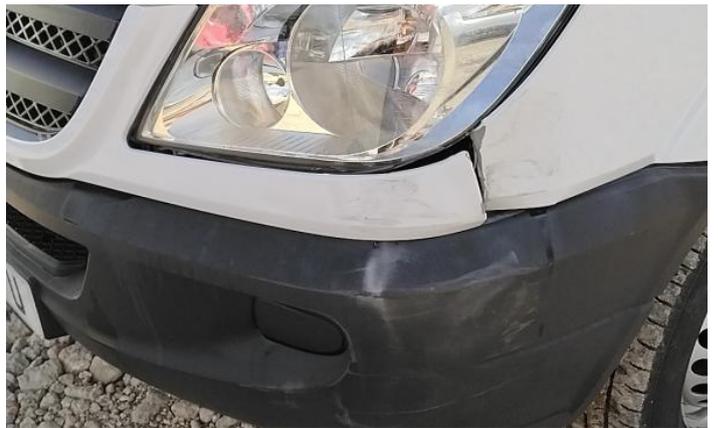
8: Panel Front  
Dented  
With Paint Damage

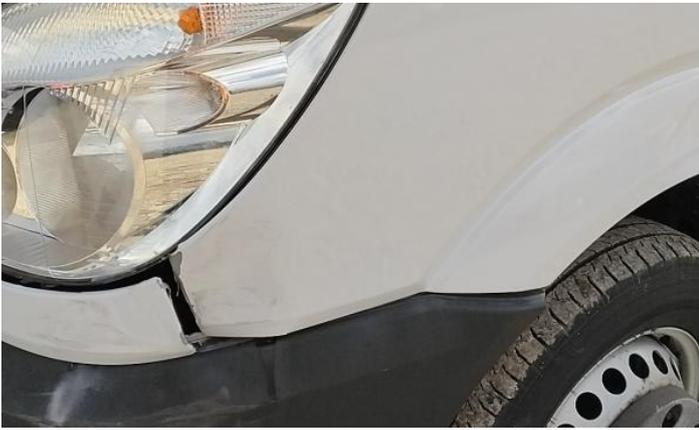
9: Wing nsf  
Dented  
With Paint Damage

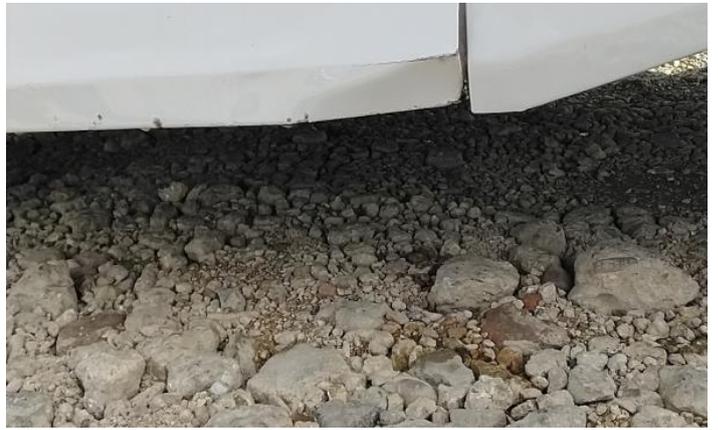
10: Door nsf  
Dented  
With Paint Damage

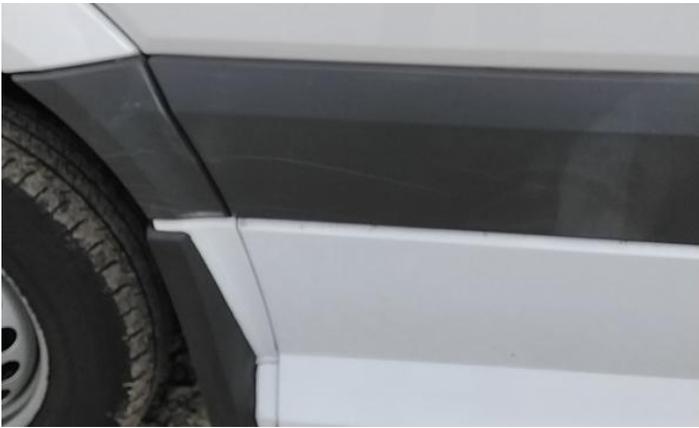
11: Door Moulding nsf  
Scuffed (Unpainted)  
Over 100mm

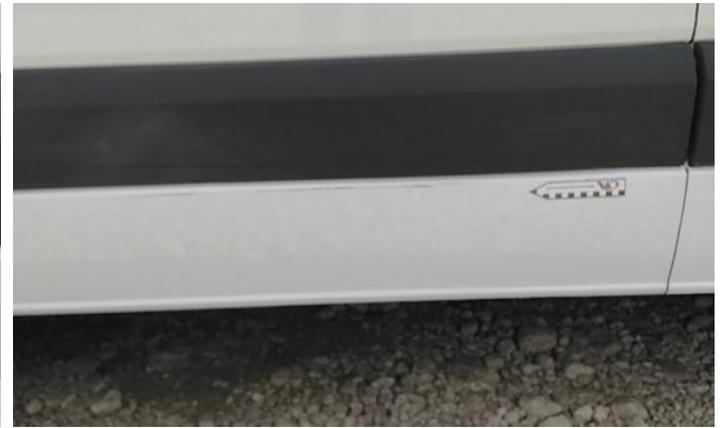
12: Qtr Panel nsr  
Scratched  
Over 25mm Not Thru Paint

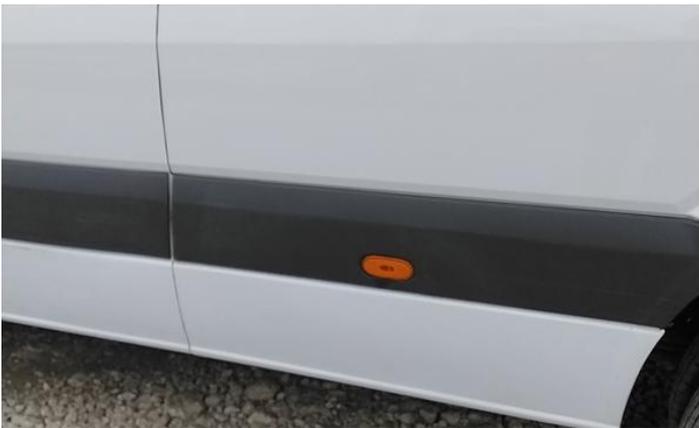
13: Qtr Panel Moulding ns  
Scuffed (Unpainted)  
Over 100mm

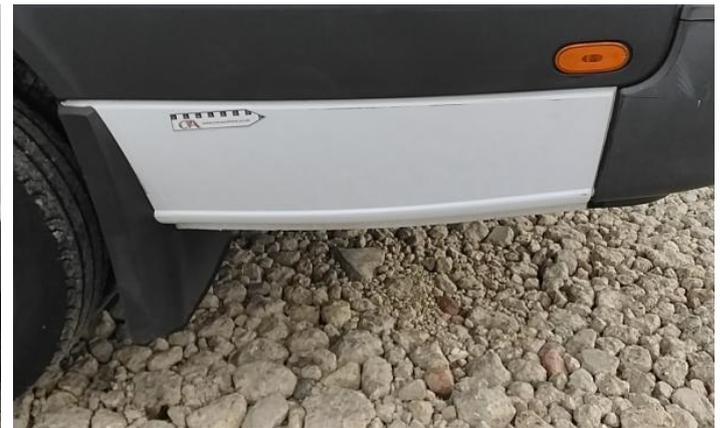
14: Qtr Panel nsr  
Scratched  
Over 25mm Not Thru Paint

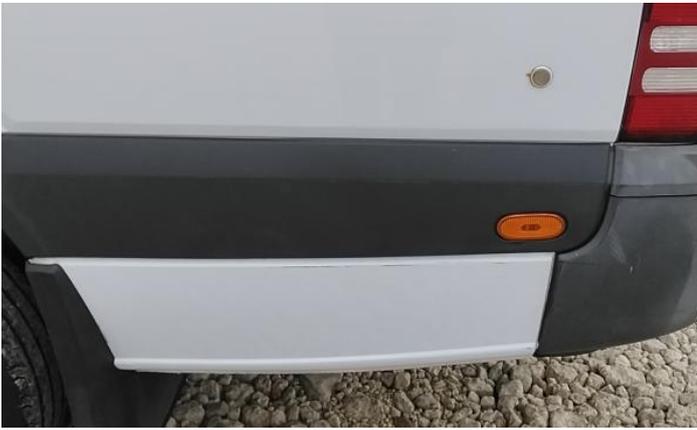
15: Qtr Panel Moulding ns  
Scuffed (Unpainted)  
Over 100mm

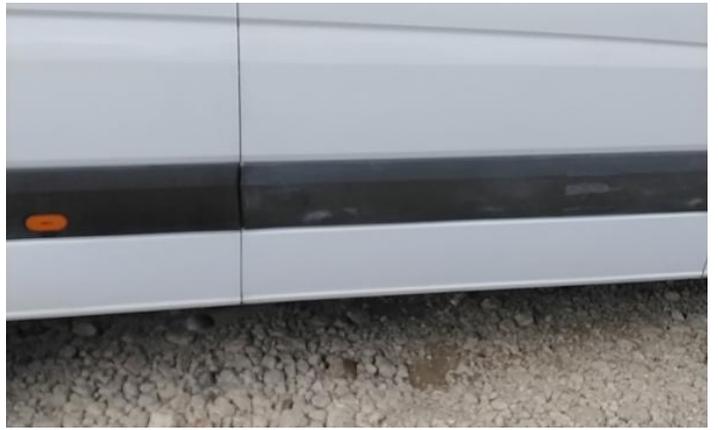
16: Qtr Panel Moulding os  
Scuffed (Unpainted)  
Over 100mm

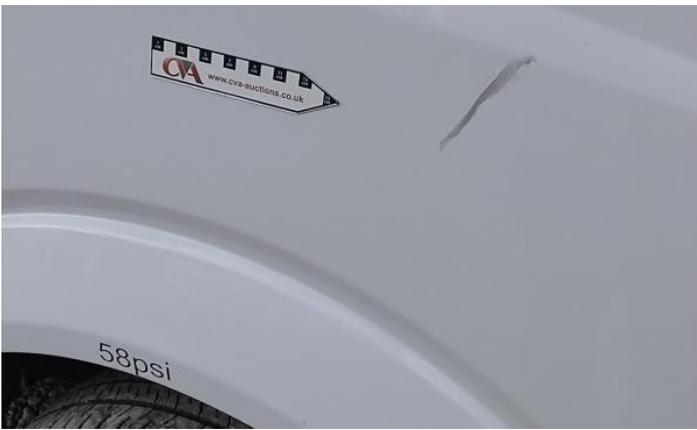
17: Wing osf  
Scratched  
Over 25mm Not Thru Paint
