# VEHICLE INSPECTION REPORT

**CU65CKD**

## FORD TRANSIT 350 2.2 TDCI 155PS ECONETIC

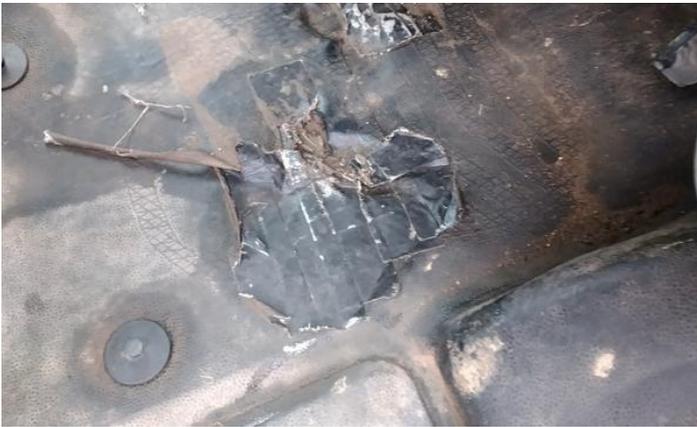
1: Carpets Front  
Holed  
Over 3mm

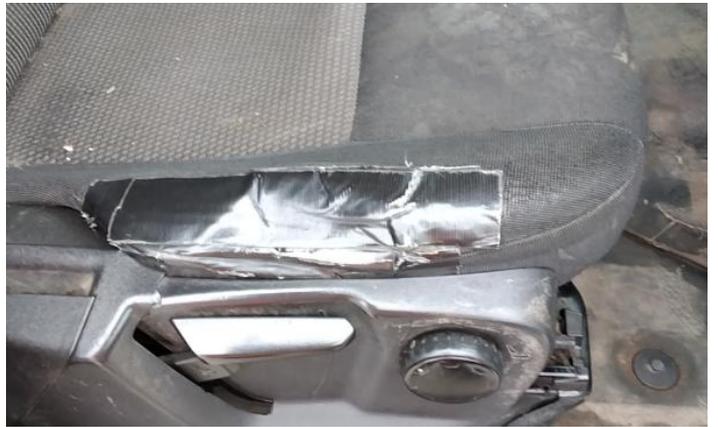
2: Seat Base Cover of  
Holed  
Over 3mm

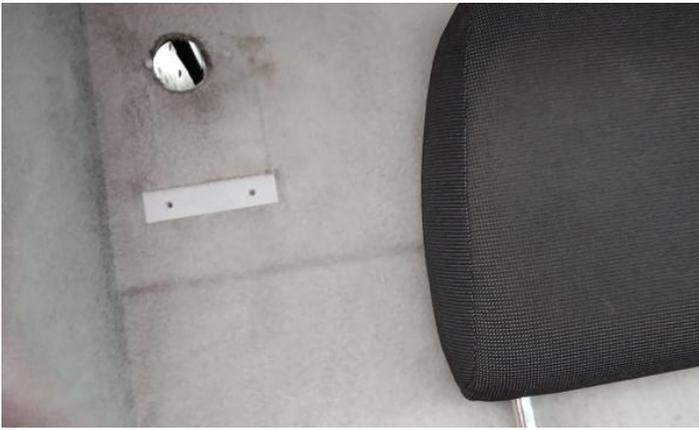
3: Rear Panel Trim Int  
Holed  
Over 3mm

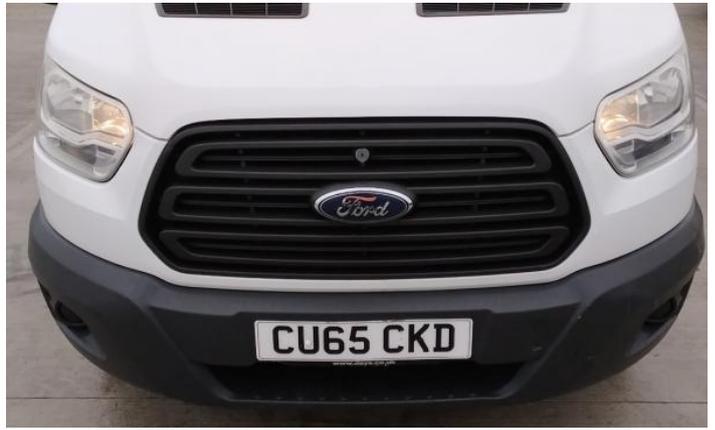
4: Bonnet  
Chipped  
Multiple Chips

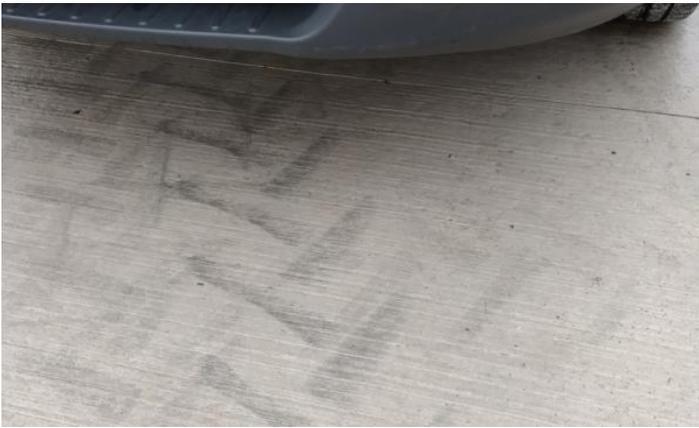
5: Bumper Front  
Hole  
Over 25mm

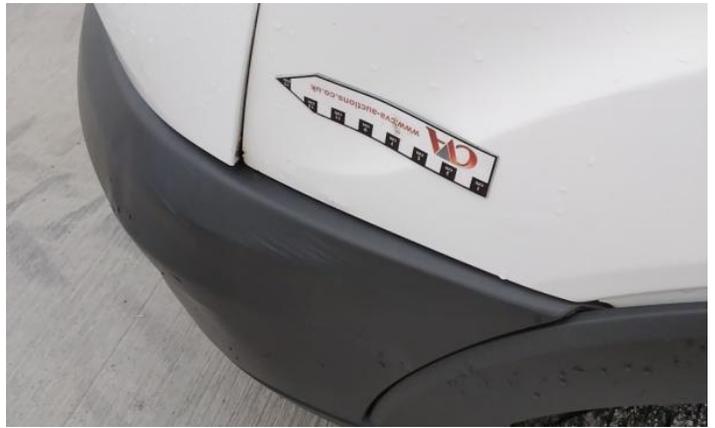
6: Wing nsf  
Dented  
With Paint Damage

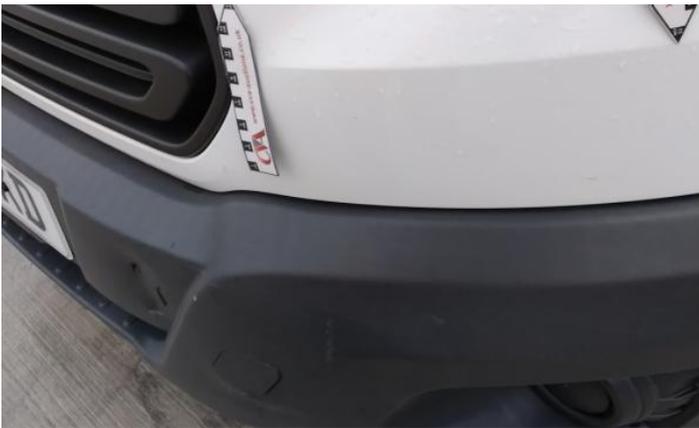
7: Bumper Front Moulding  
Scratched (Painted)  
Over 25mm Thru Paint

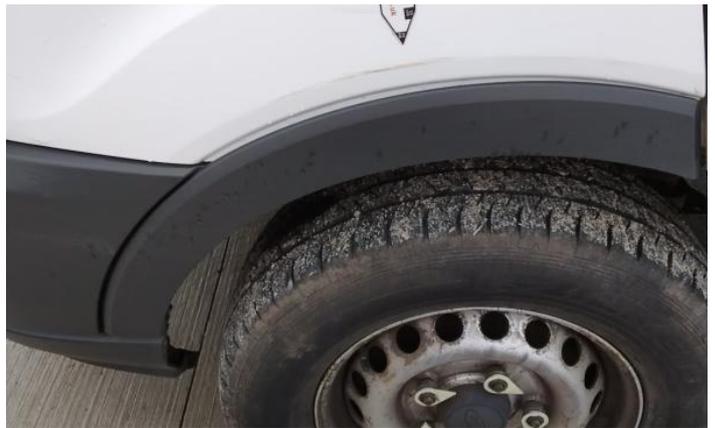
8: Wing nsf  
Scratched  
Over 25mm Thru Paint

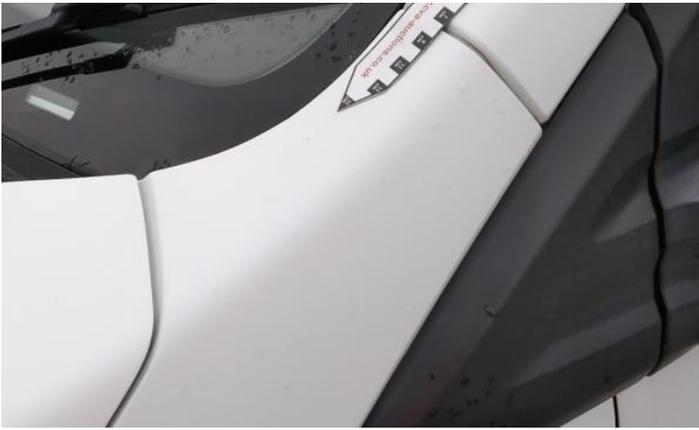
9: A Post ns  
Chipped  
Multiple Chips

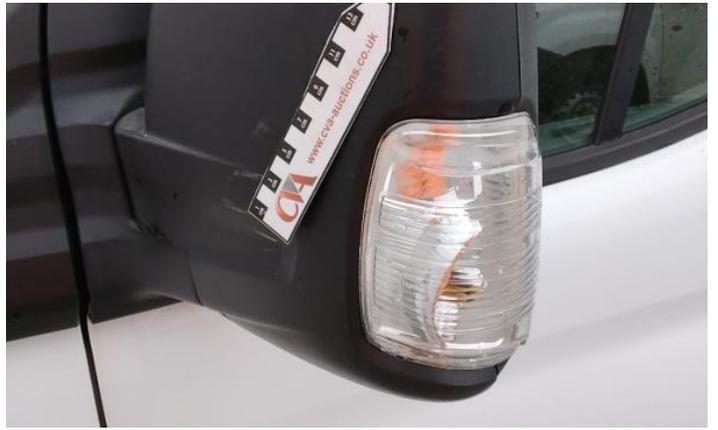
10: Door Mirror Assy nsf  
Broken  
Replace

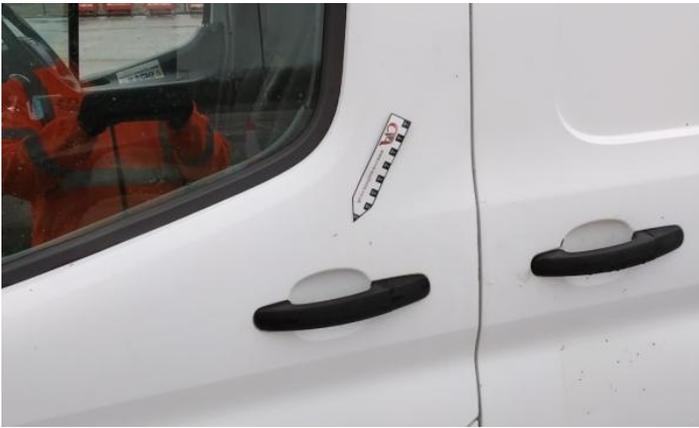
11: Door nsf  
Scratched  
Over 25mm Thru Paint

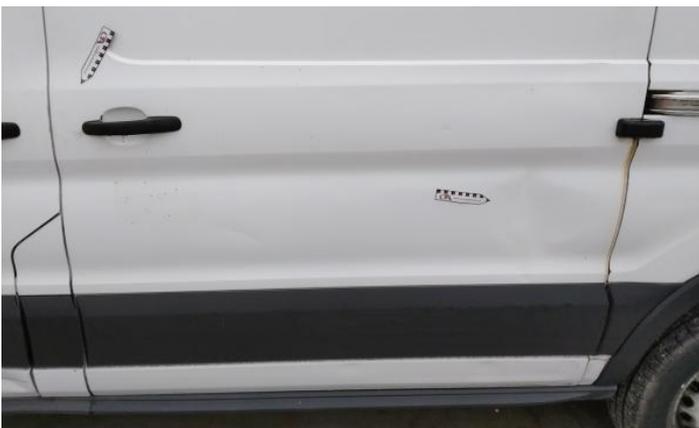
13: Qtr Panel nsr  
Dented  
With Paint Damage

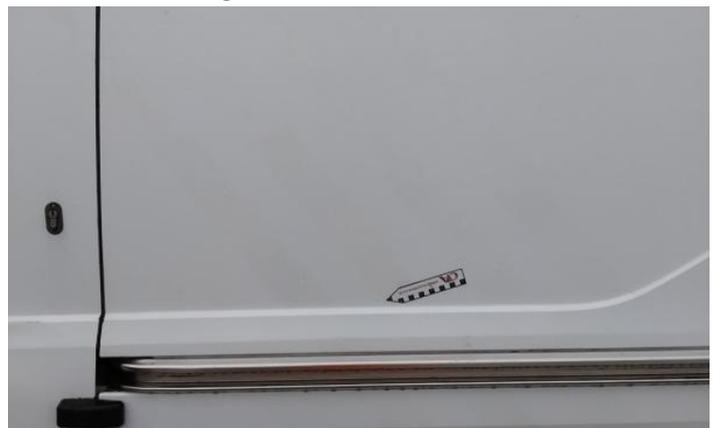
14: Qtr Panel nsr  
Scratched  
Over 25mm Thru Paint

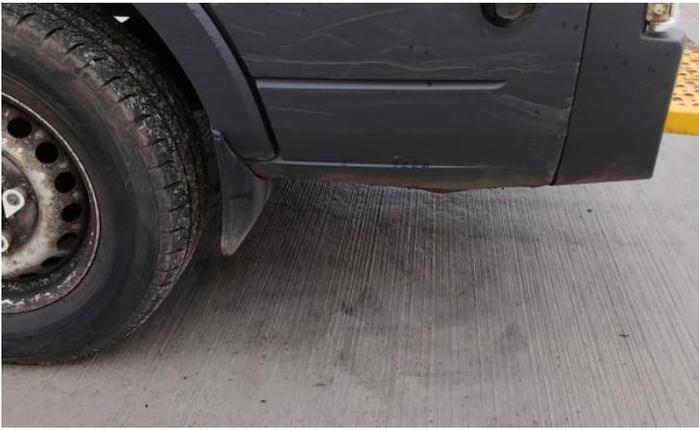
15: Bumper Rear  
Scratched  
Over 100mm Thru Paint

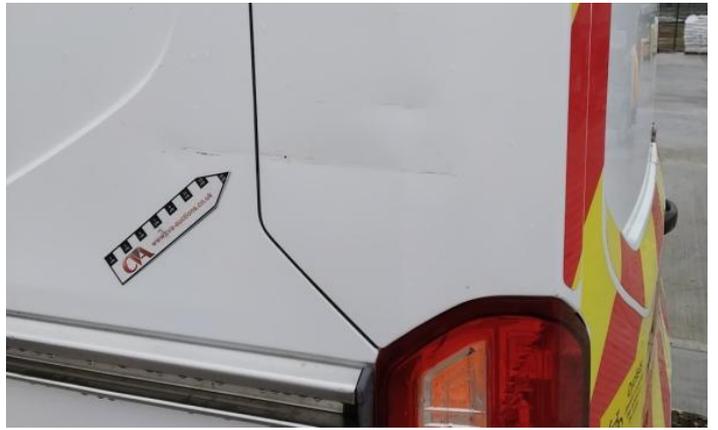
16: Qtr Panel nsr  
Scratched  
Over 25mm Thru Paint

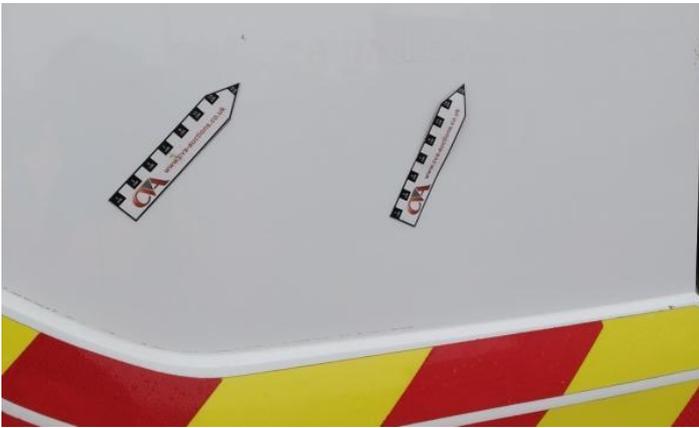
17: Door nsr  
Scratched  
Over 25mm Thru Paint

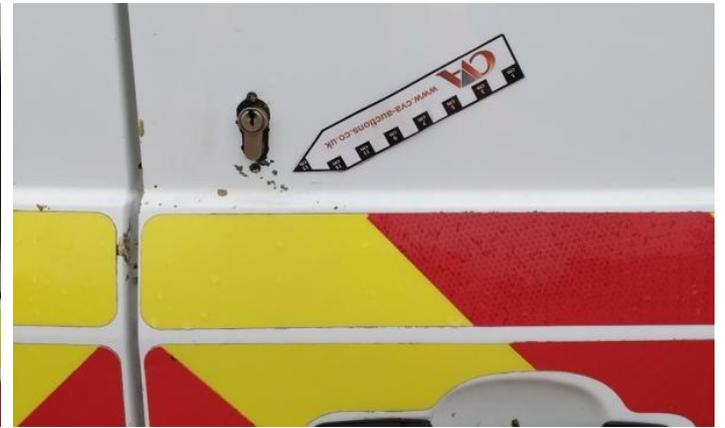
18: Door osr  
Chipped  
Multiple Chips

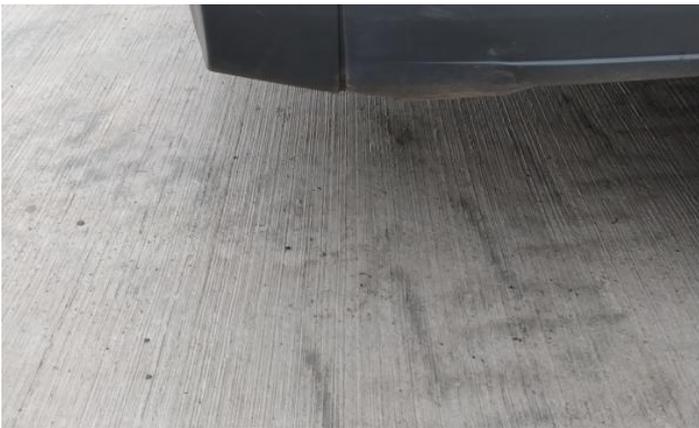
19: Bumper Rear  
Scratched  
Over 100mm Thru Paint

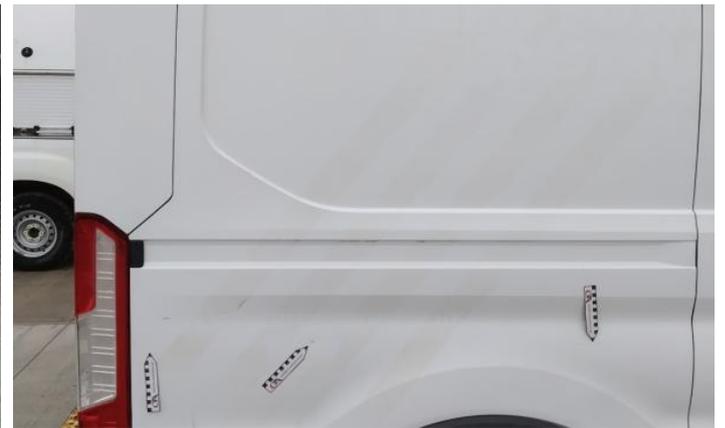
20: Qtr Panel osr  
Dented  
With Paint Damage

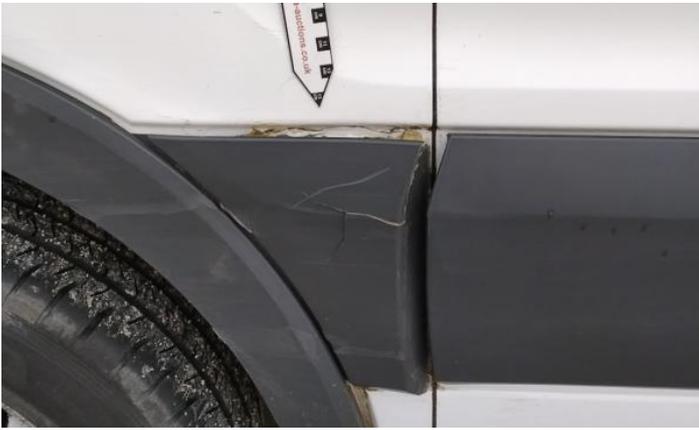
21: Qtr Panel Moulding os  
Broken  
Replace

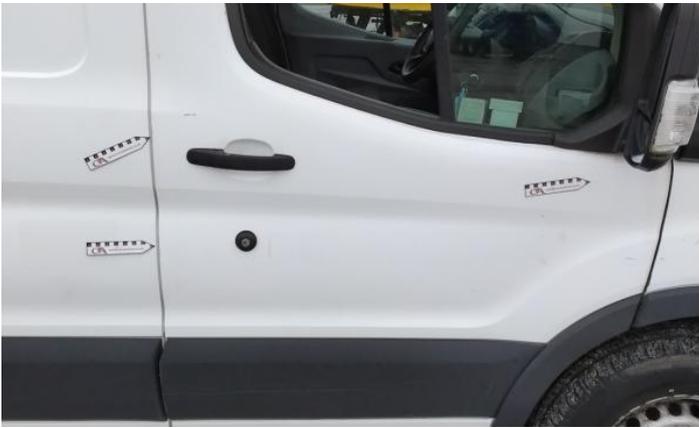
23: Door osf  
Scratched  
Over 25mm Thru Paint

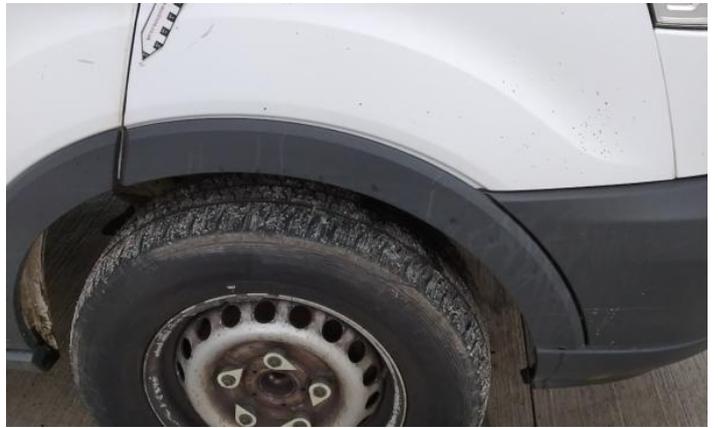
24: Wing osf  
Chipped  
Multiple Chips

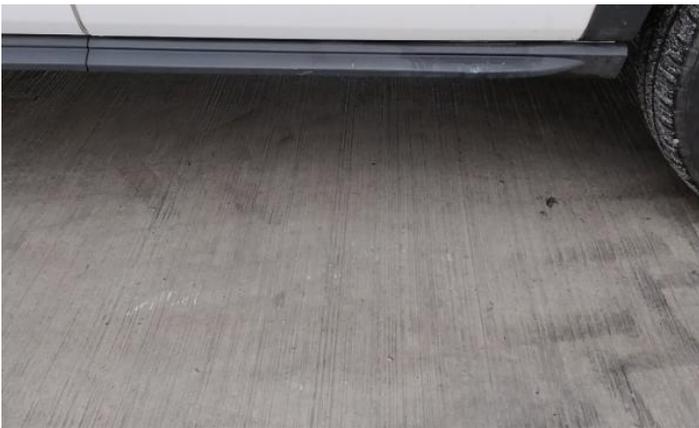
25: Door Moulding osf  
Scratched (Painted)  
Over 25mm Thru Paint

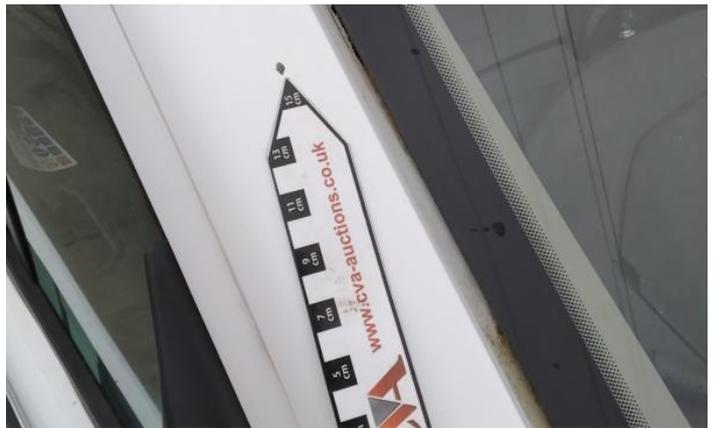
26: A Post os  
Chipped  
Over 5mm

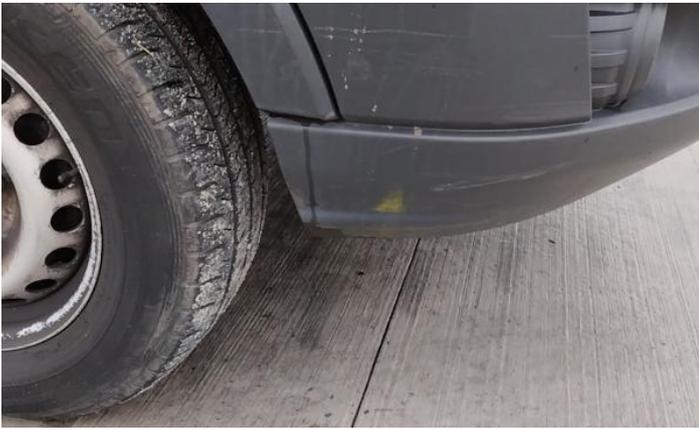
27: Bumper Front  
 Scratched  
 Over 100mm Thru Paint

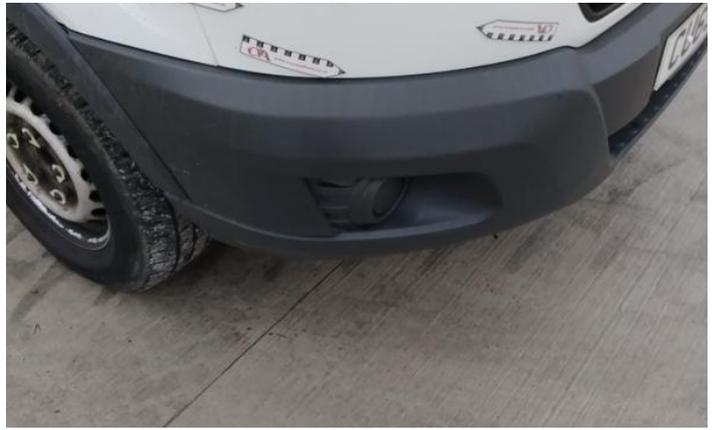
28: Bumper Front Moulding  
 Scratched (Painted)  
 Over 25mm Thru Paint
