VEHICLE INSPECTION REPORT

2625589

Iveco Eurocargo 120E21

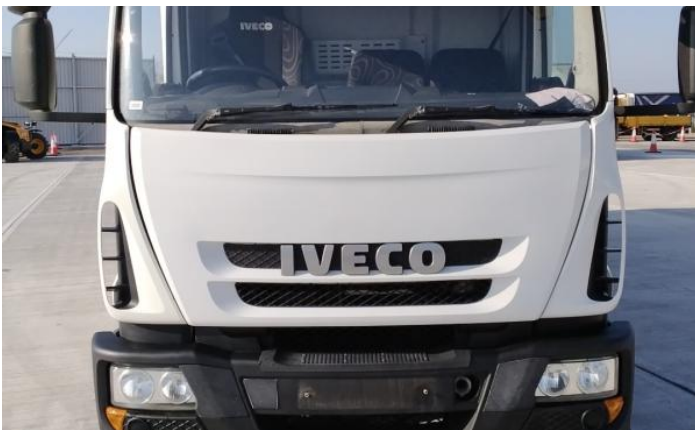
1: Bonnet
Chipped
Multiple Chips

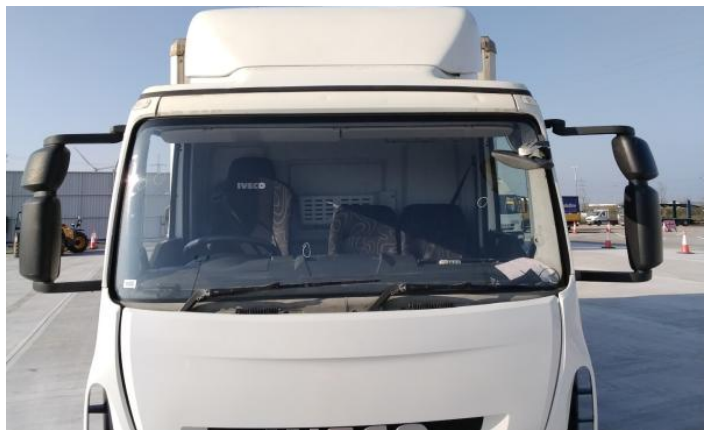
2: Screen Front
Chipped
Over 10mm

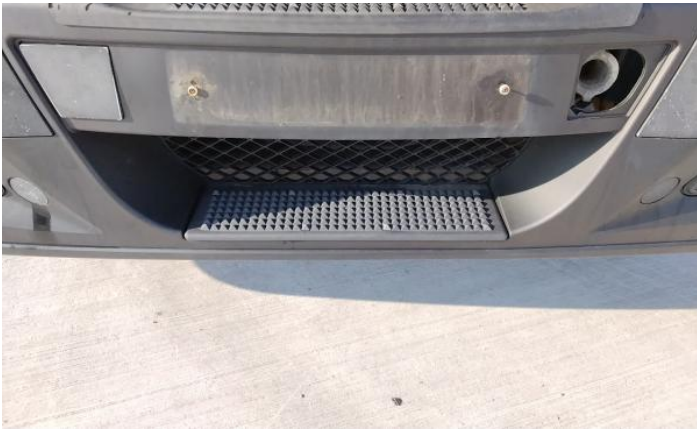
3: Number Plate Front
Missing
Replace

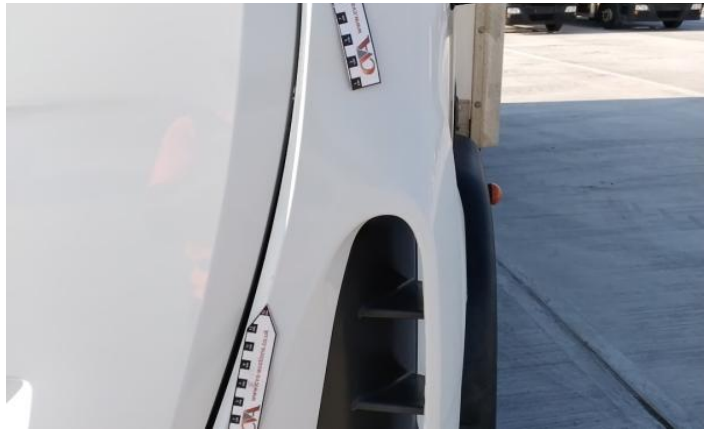
4: Moulding nsf Wing
Scratched (Painted)
Over 25mm Thru Paint

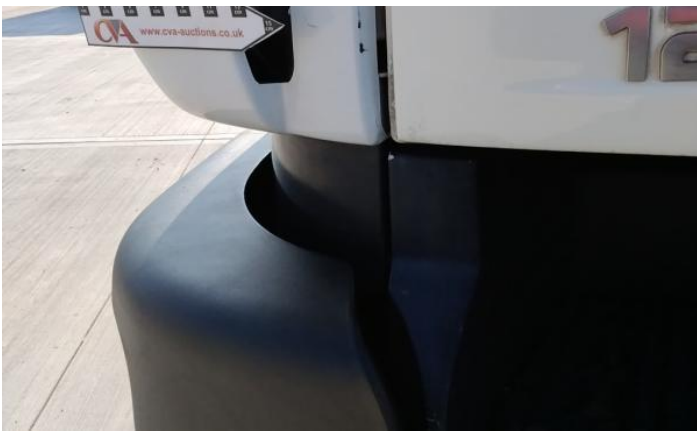
5: Wing nsf
Scratched
Over 25mm Thru Paint

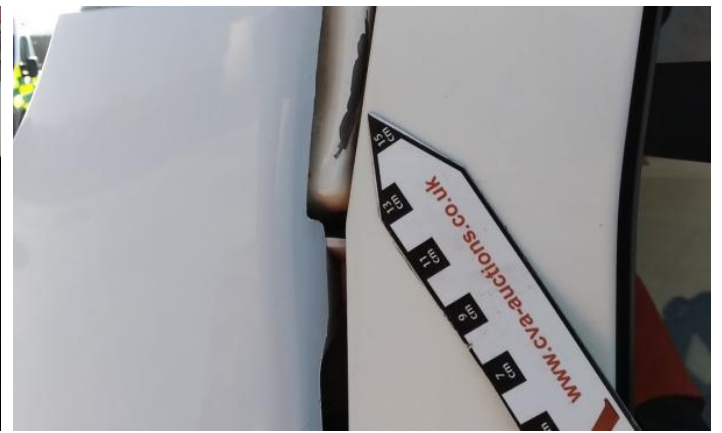
6: A Post ns
Scratched
Over 25mm Thru Paint

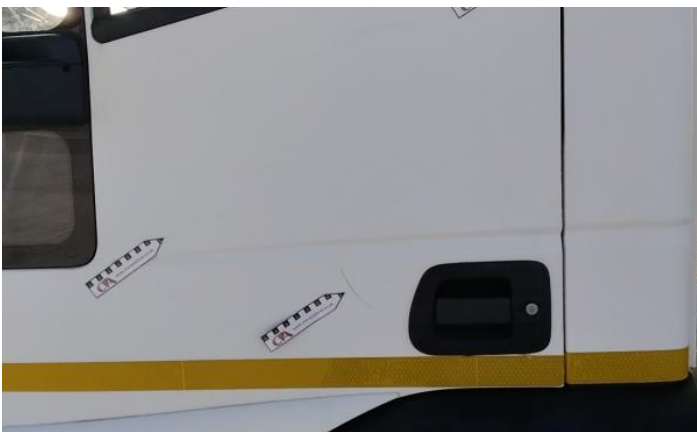
7: Door nsf
Scratched
Over 25mm Thru Paint

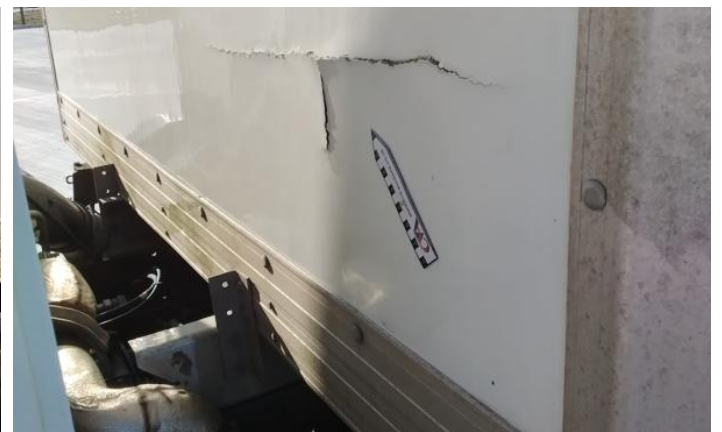
8: Panel Front
Cracked
Replace

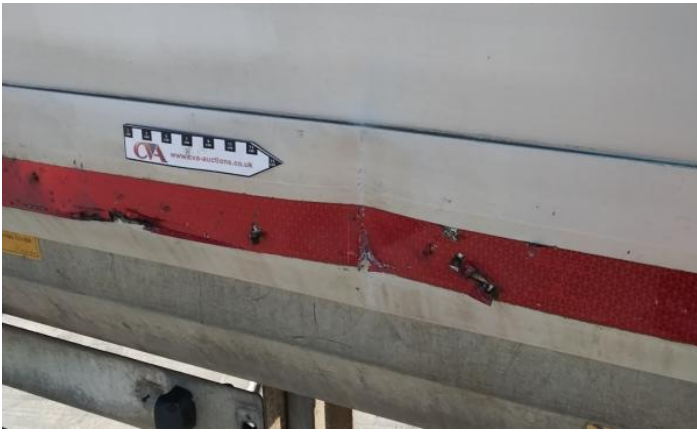
9: Door nsr
Dented
With Paint Damage

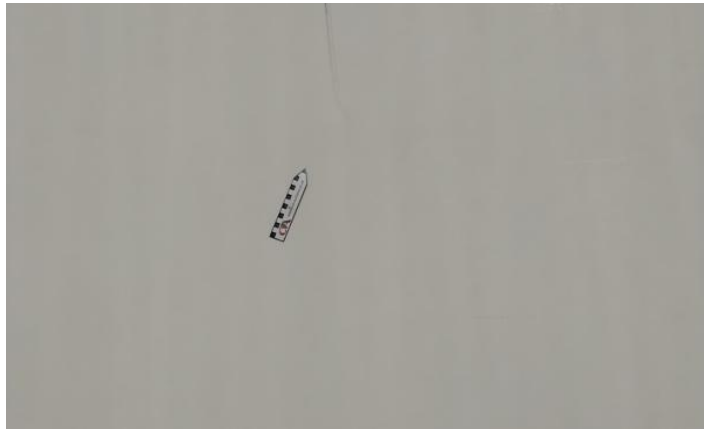
10: Qtr Panel osr
Scratched
Over 25mm Thru Paint

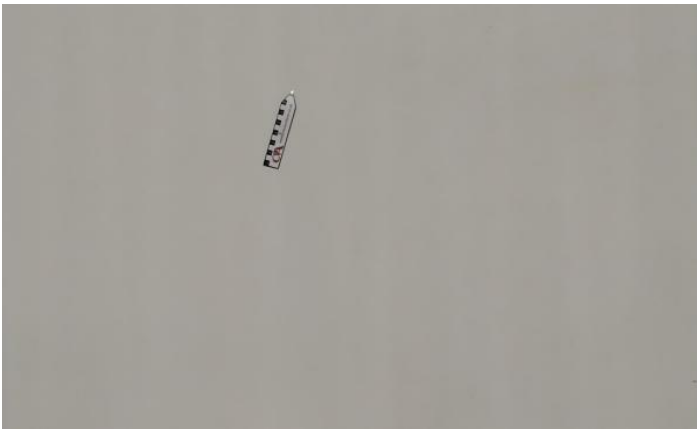
11: Qtr Panel osr
Scratched
Over 25mm Thru Paint

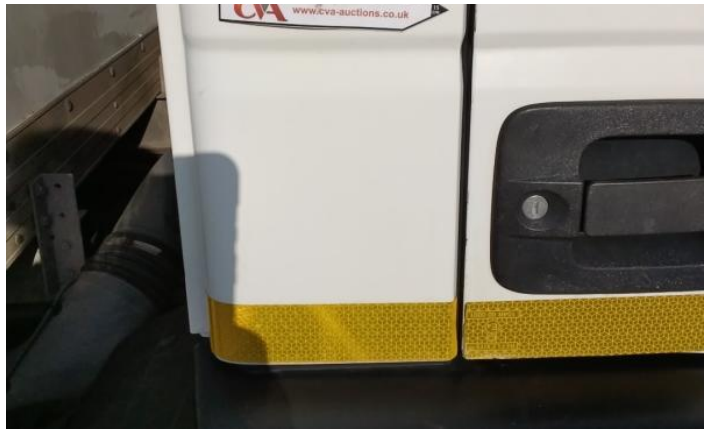
12: Door osf
Chipped
Multiple Chips

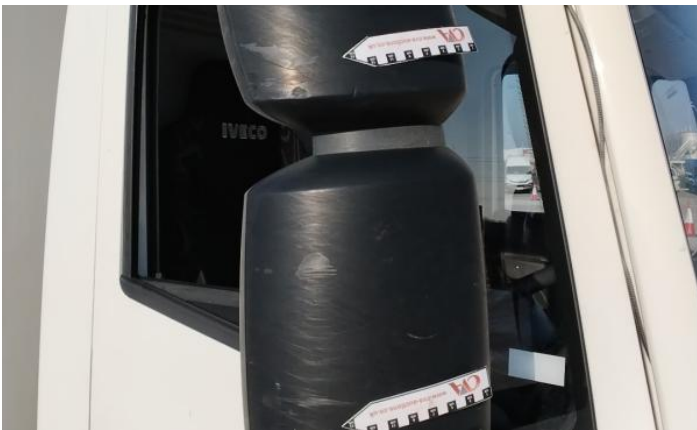
13: Door Mirror Assy osf
Scuffed (Unpainted)
Over 100mm

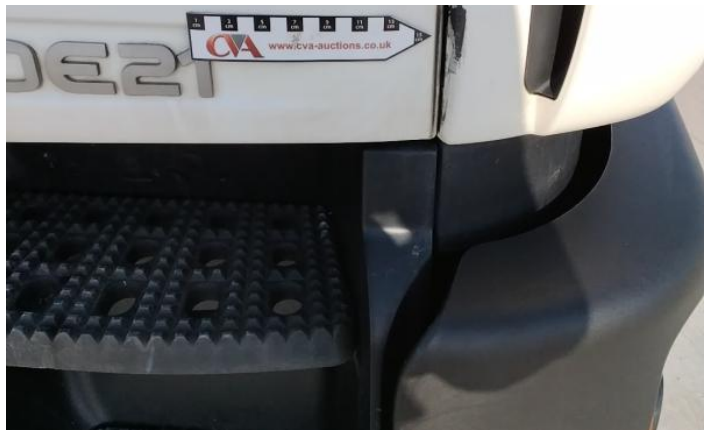
14: Moulding osf Wing
Scratched (Painted)
Over 25mm Thru Paint

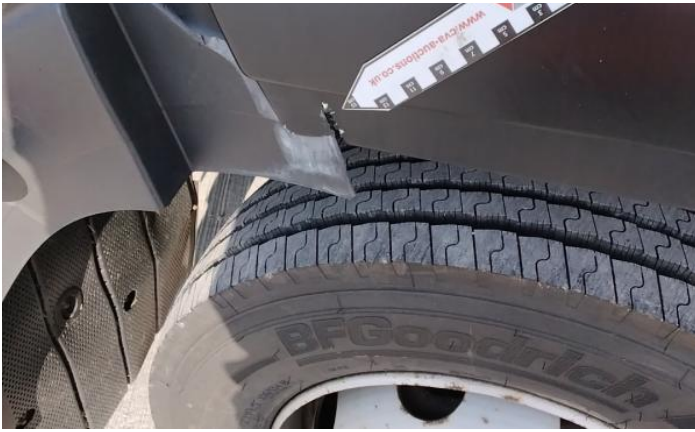
15: Qtr Panel Arch Extension os
Broken
Replace

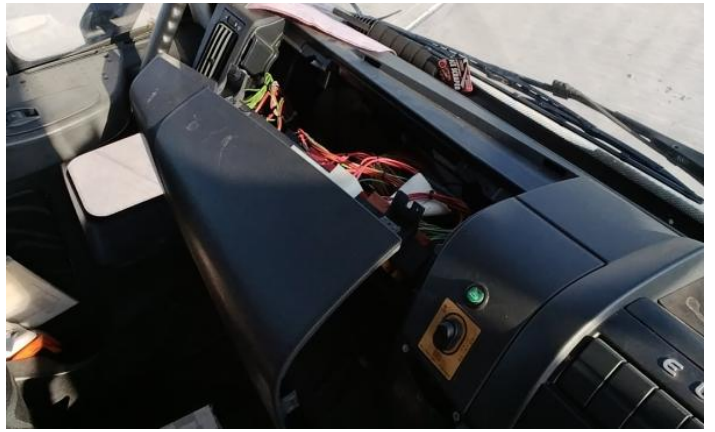
16: Centre Console Front
Broken
Replace

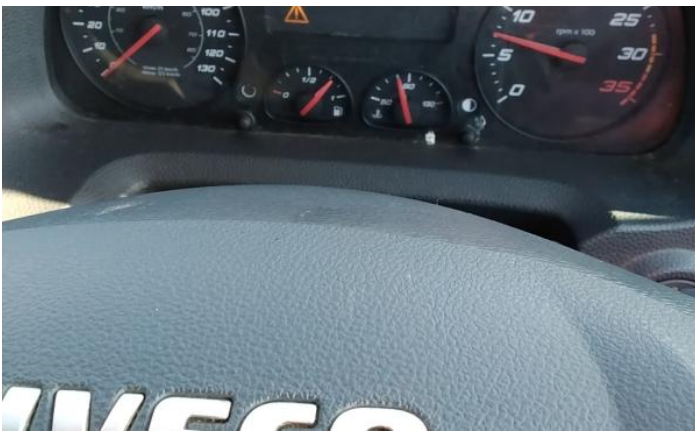
17: Dash Warning Lights
Displayed
No Action
