VEHICLE INSPECTION REPORT

SN13BVL

Daf LF 55.250

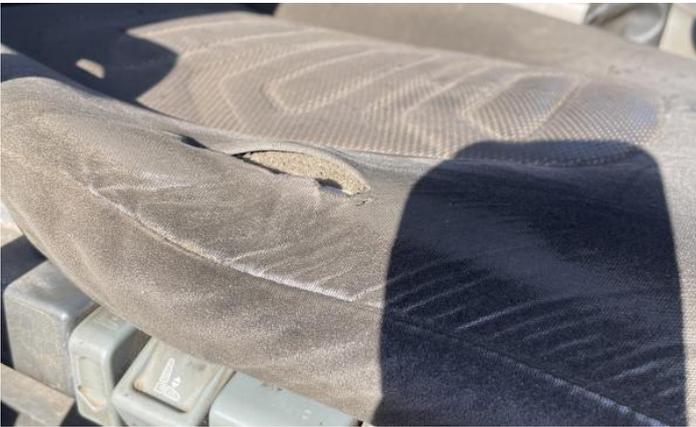
1: Seat Base Cover of
Torn
Over 3mm

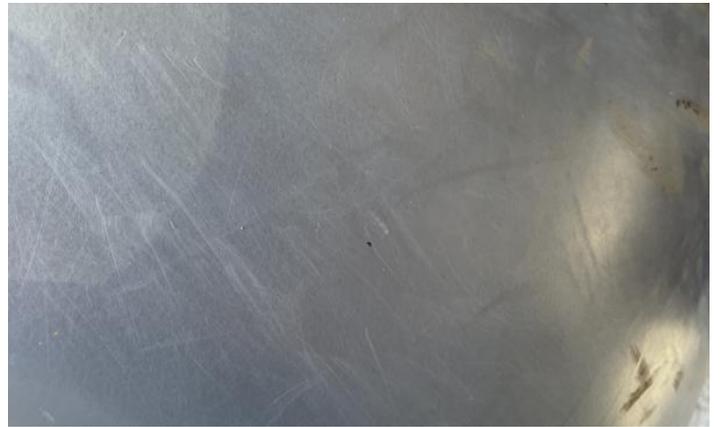
2: Door Moulding of
Scuffed (Unpainted)
Over 100mm

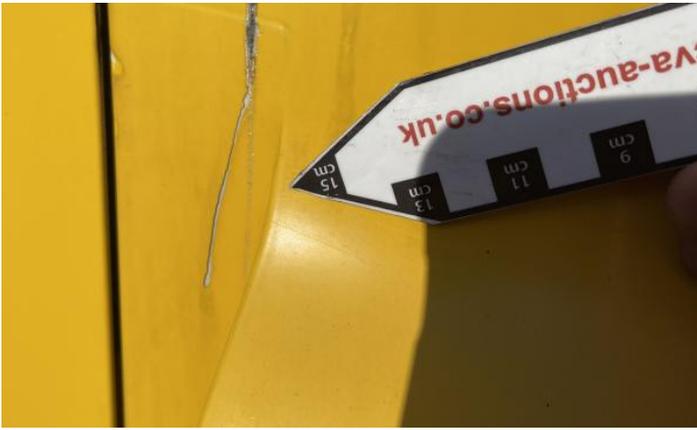
3: Wing of
Scratched
Over 25mm Thru Paint

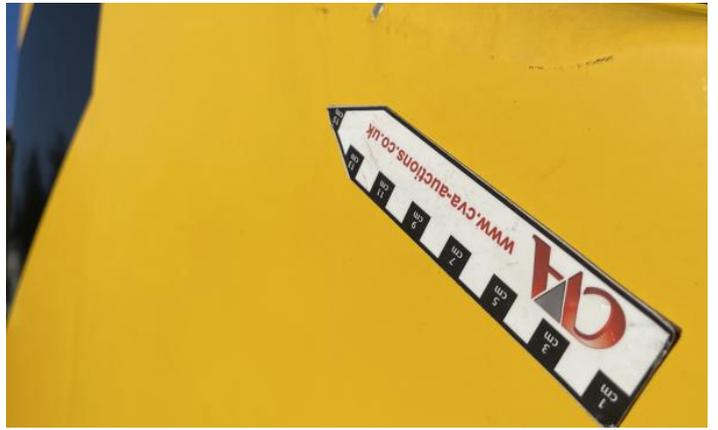
4: Door of
Dented
Over 30mm

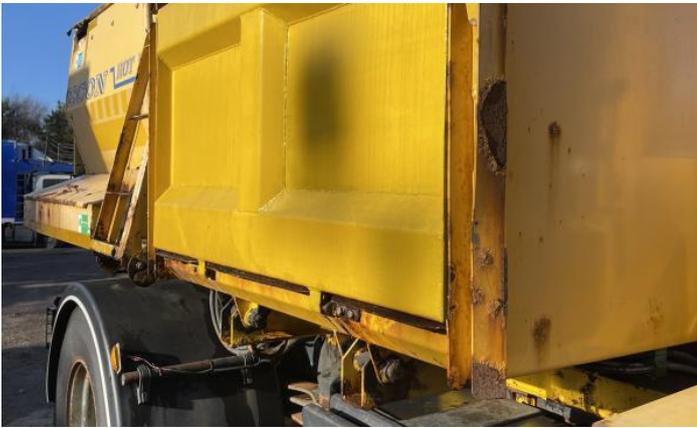
5: Qtr Panel of
Rusted
Over 5mm

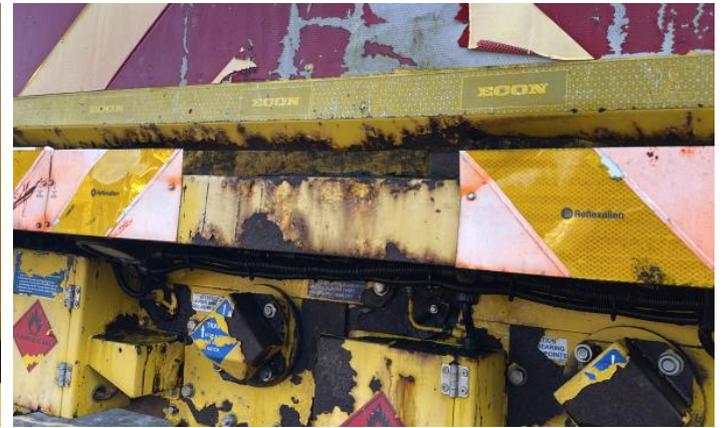
6: Tailgate
Rusted
Over 5mm

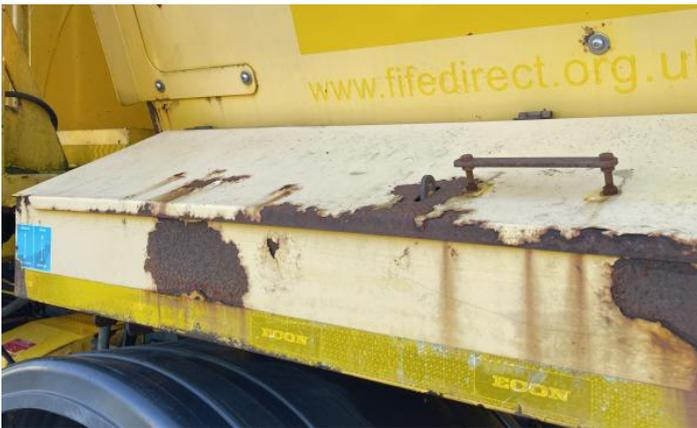
7: Qtr Panel of
Rusted
Over 5mm

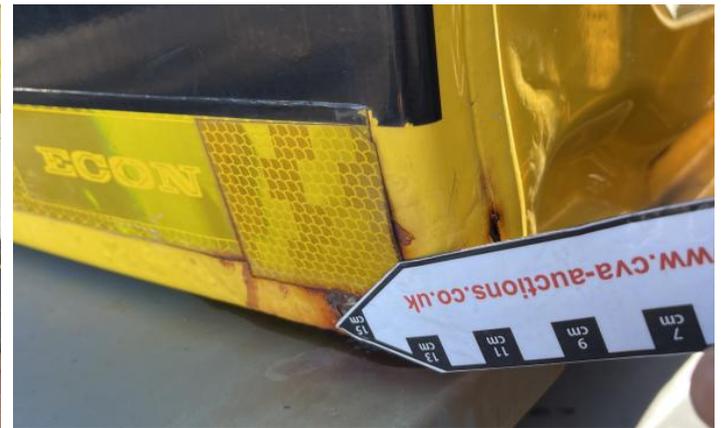
8: B Post of
Rusted
Over 5mm
