VEHICLE INSPECTION REPORT

DA13RYU

Mercedes-Benz Actros 1842

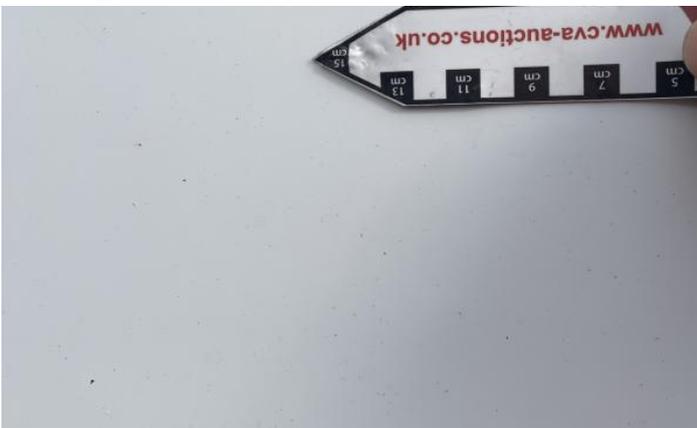
1: Bonnet
Chipped
Multiple Chips

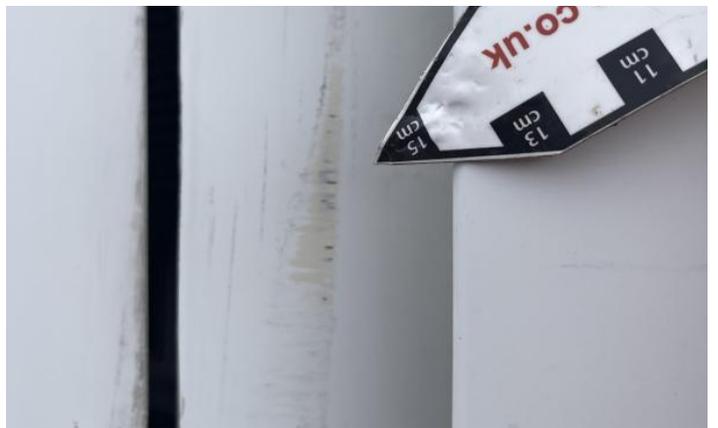
2: Wing of
Scratched
Over 25mm Thru Paint

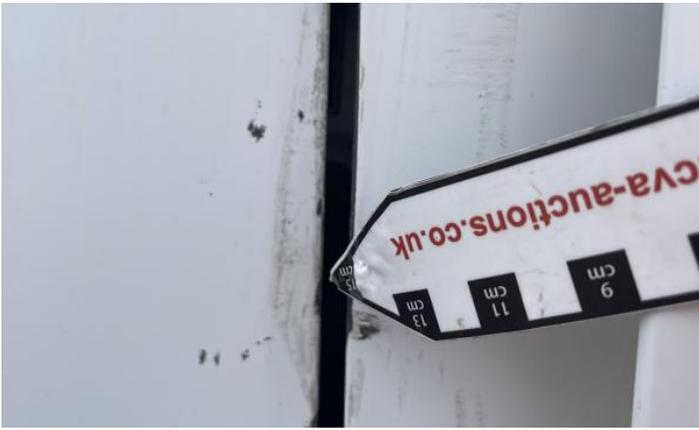
3: Door osf
Dented
Over 30mm

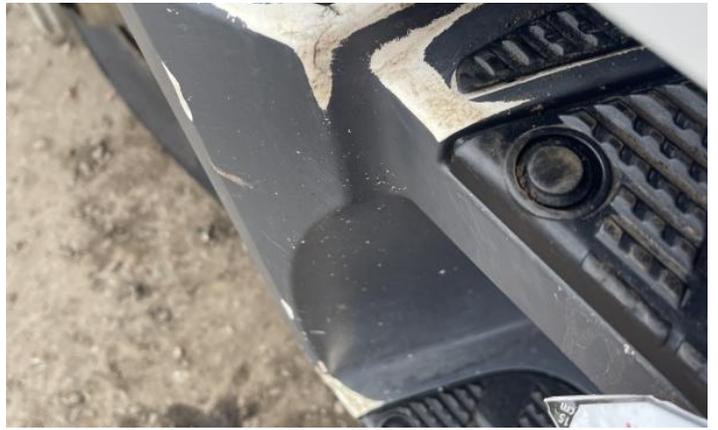
4: Door Moulding osf
Scuffed (Unpainted)
Over 100mm

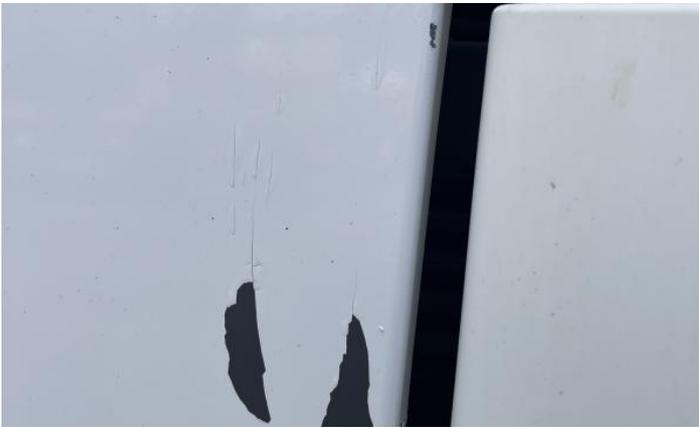
5: Qtr Panel osr
Poor Previous Repair
Paint Flake

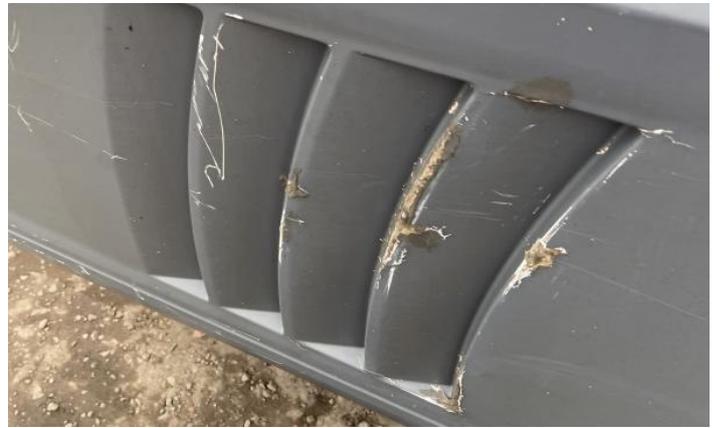
6: Qtr Panel Arch Extension os
Scuffed (Unpainted)
Over 100mm

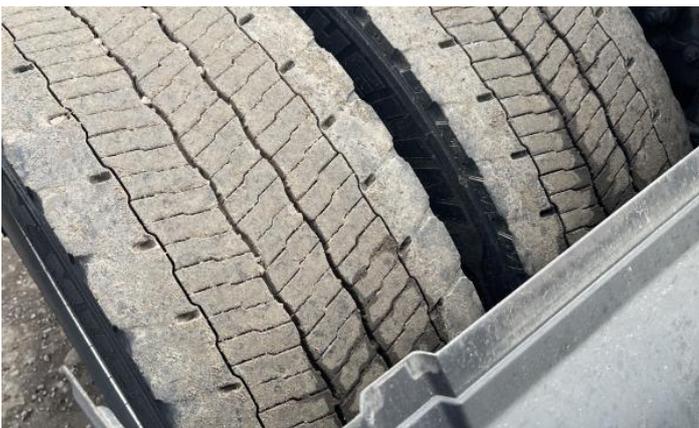
7: Qtr Panel Trim os
Missing
Replace

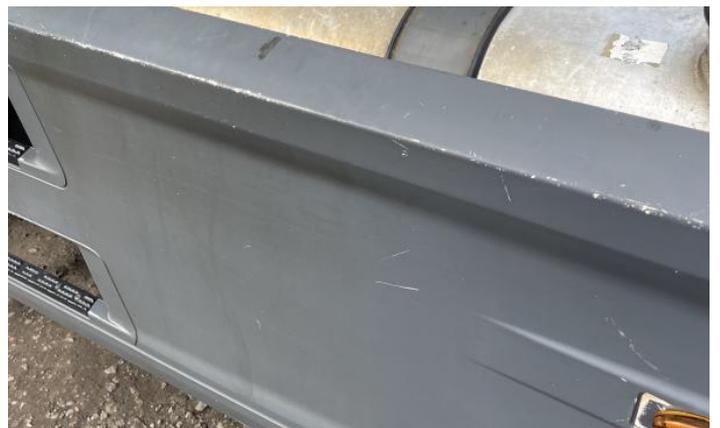
8: Qtr Panel Moulding ns
Scuffed (Unpainted)
Over 100mm

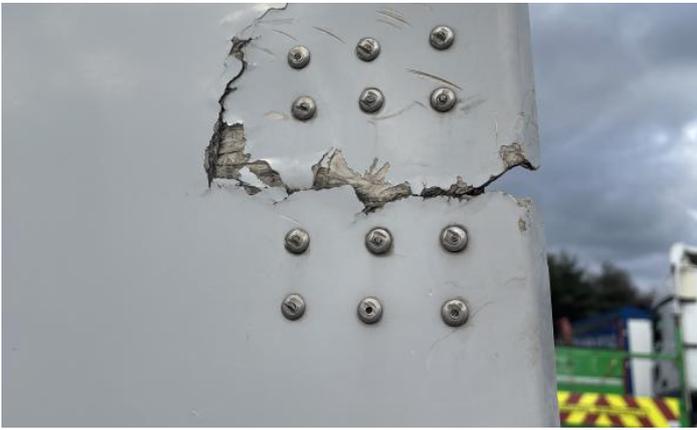
9: Qtr Panel Moulding nsf
Broken
Replace

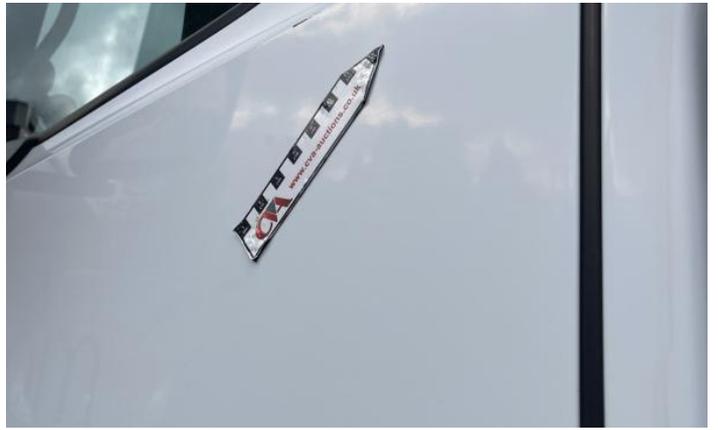
10: Door nsf
Dented
With Paint Damage

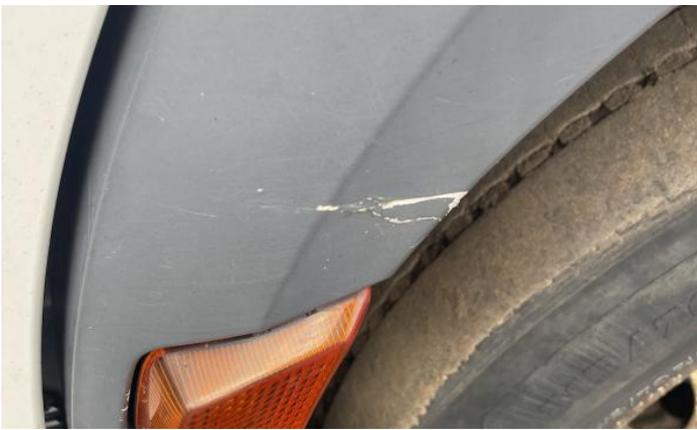
11: Door Moulding nsf
Scuffed (Unpainted)
Over 100mm
