VEHICLE INSPECTION REPORT

HK65KJF

TOYOTA HILUX INVINCIBLE 3.0 D-4D 171PS

Non Runner

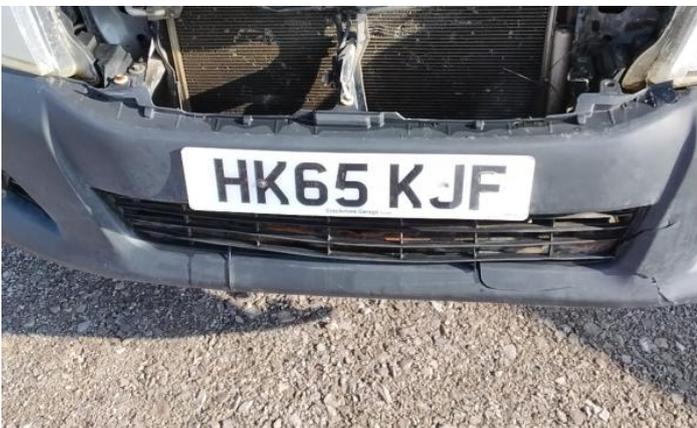
1: Bumper Front Grill
Missing
Replace

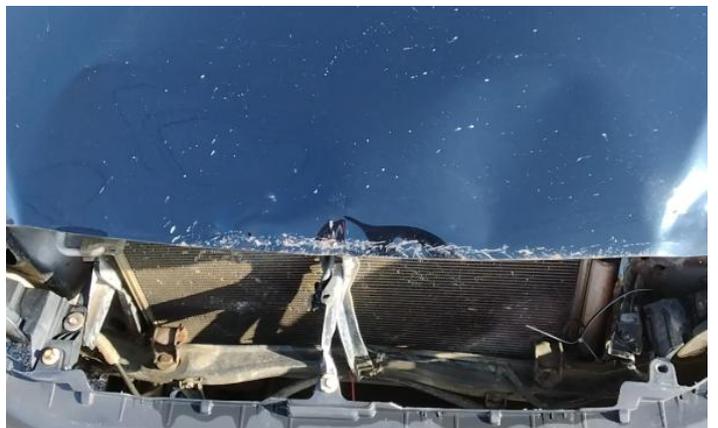
2: Bonnet
Dented
With Paint Damage

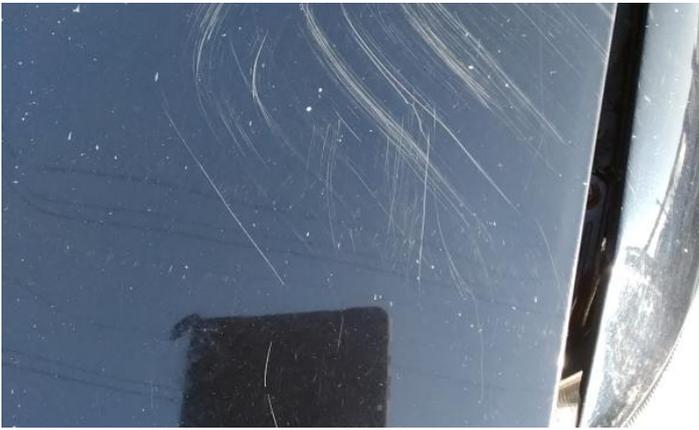
3: Bonnet
Scratched
Over 25mm Thru Paint

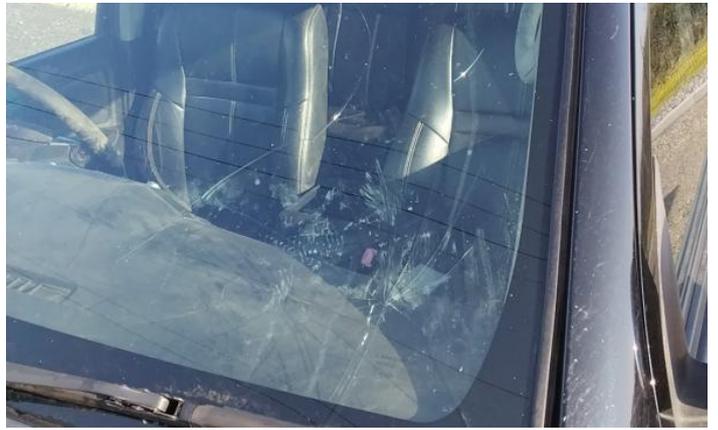
4: Screen Front
Cracked
Replace

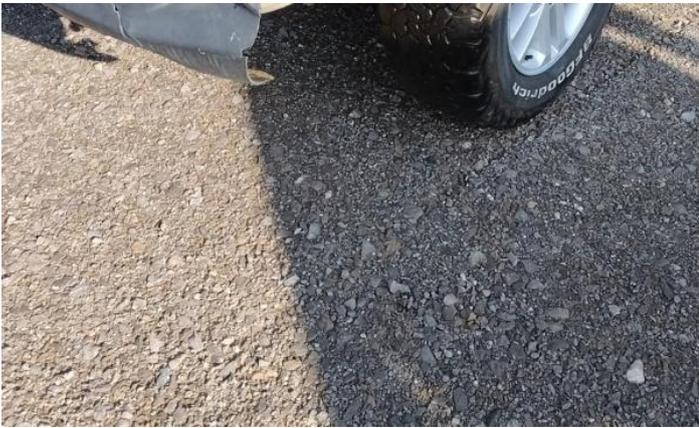
5: Bumper Front
Missing
Replace

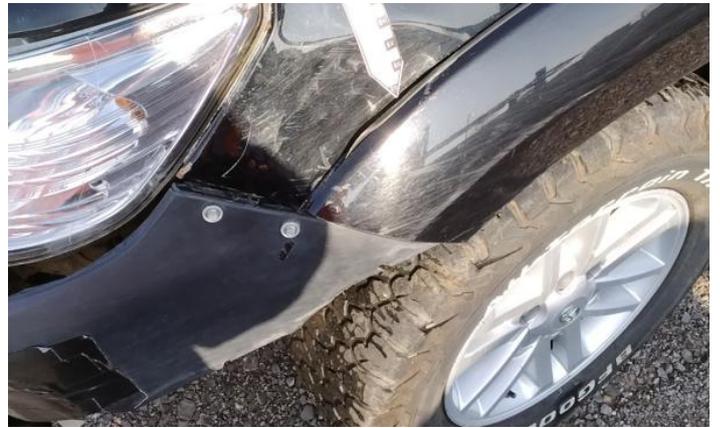
6: Wing Front Arch Extension ns
Broken
Replace

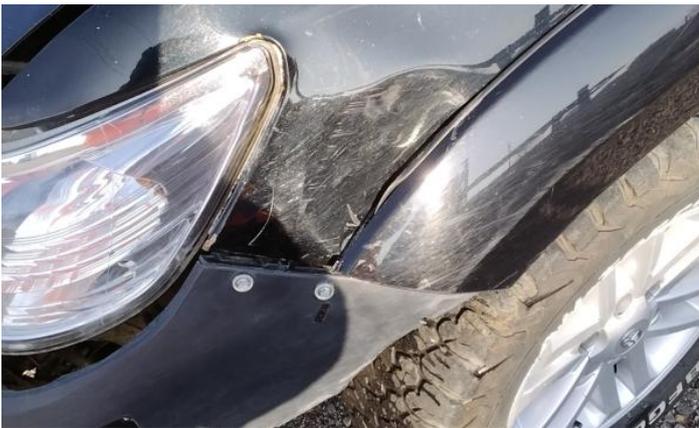
7: Wing nsf
Dented
With Paint Damage

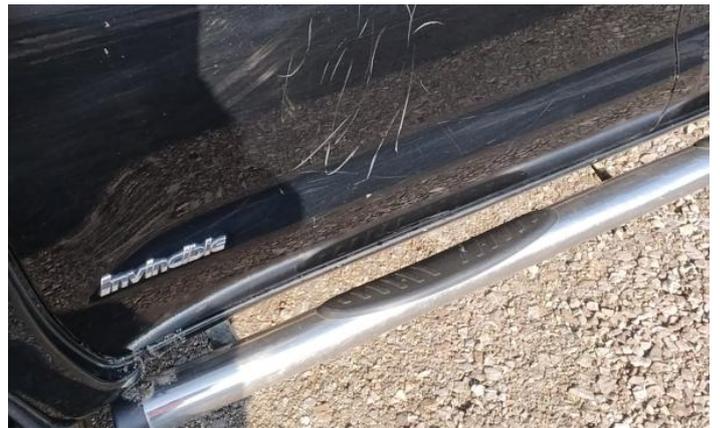
8: Door nsf
Scratched
Over 25mm Thru Paint

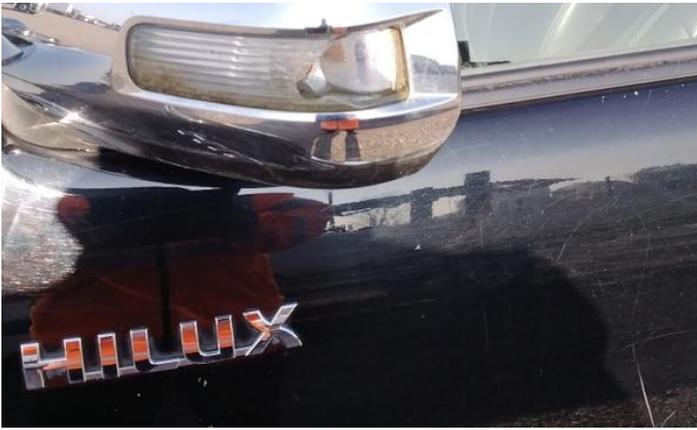
9: Door Mirror Assy nsf
Broken
Replace

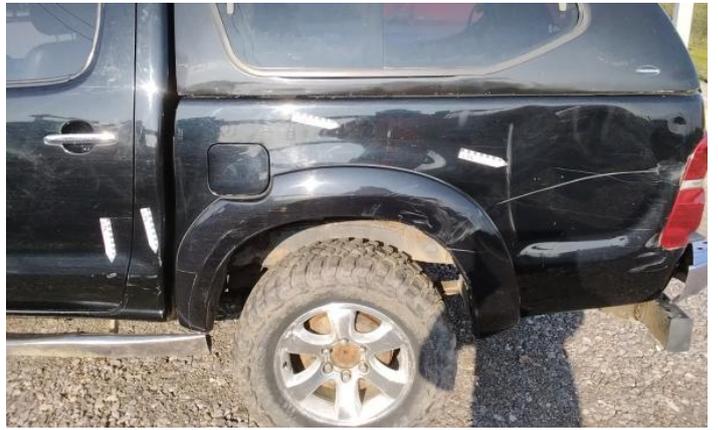
10: Qtr Panel nsr
Dented
With Paint Damage

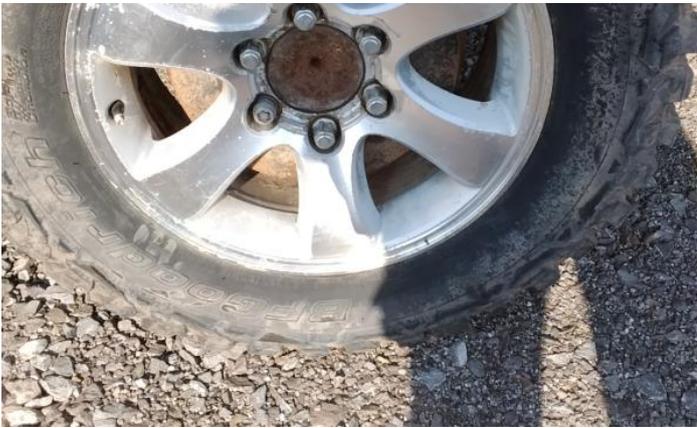
11: Wheel nsr
Damaged
Replace

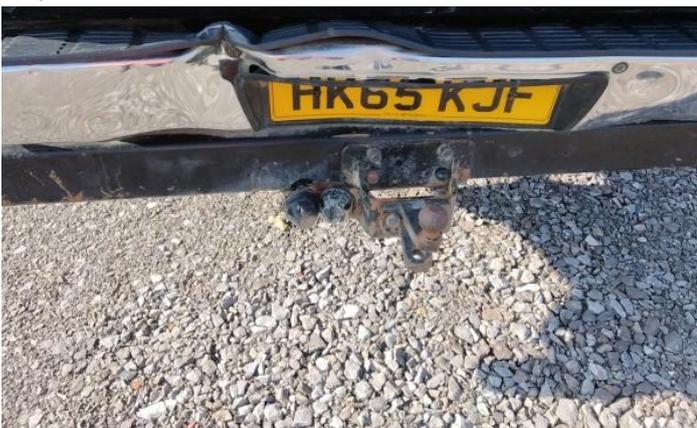
13: Bumper Rear
Dented
Over 30% Of Panel

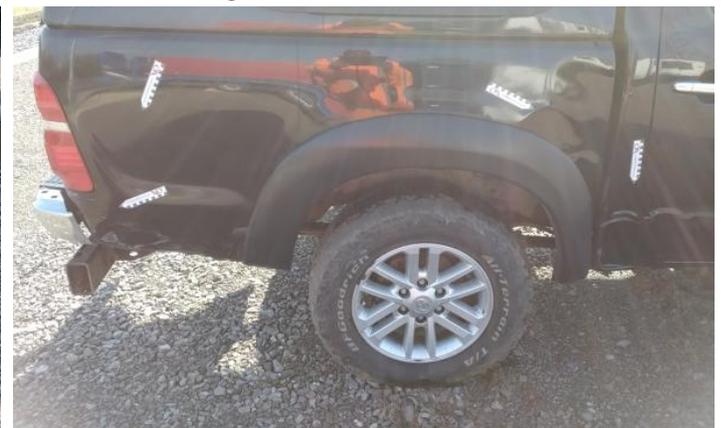
14: Qtr Panel osr
Poor Previous Repair
Rippled Over 30%

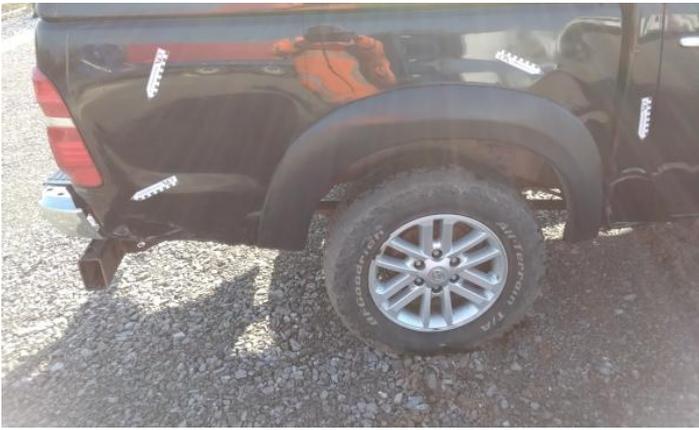
15: Qtr Panel osr
Dented
With Paint Damage

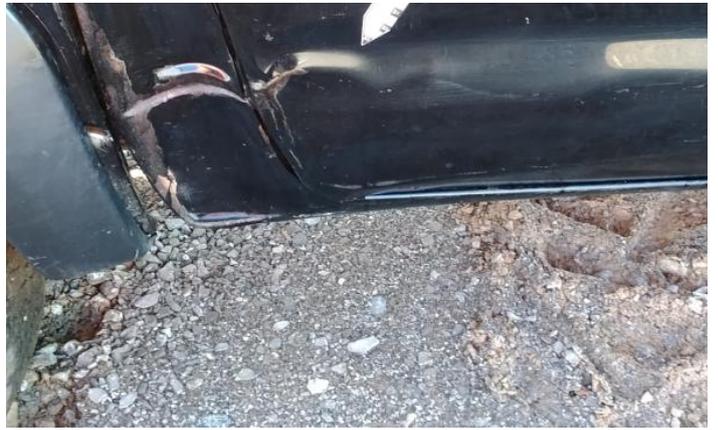
16: Door osr
Dented
With Paint Damage

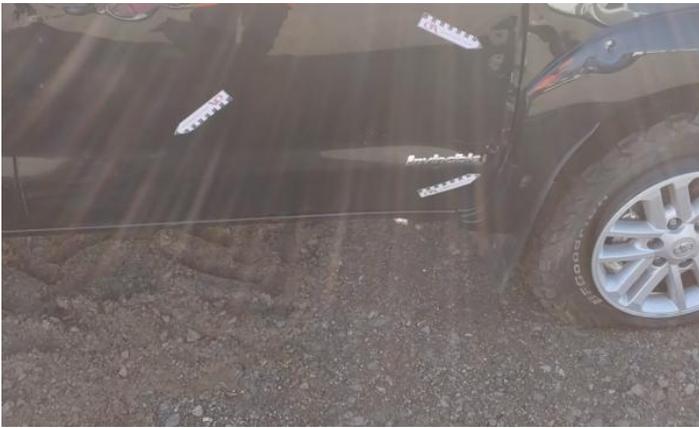
17: Door osf
Dented
With Paint Damage

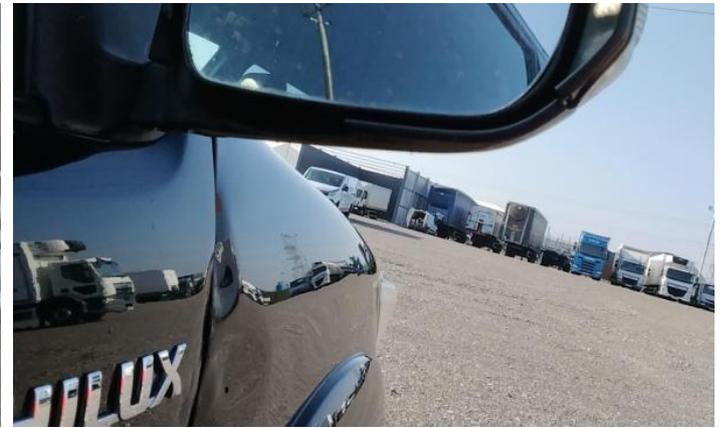
18: Door Mirror Assy osf
Broken
Replace

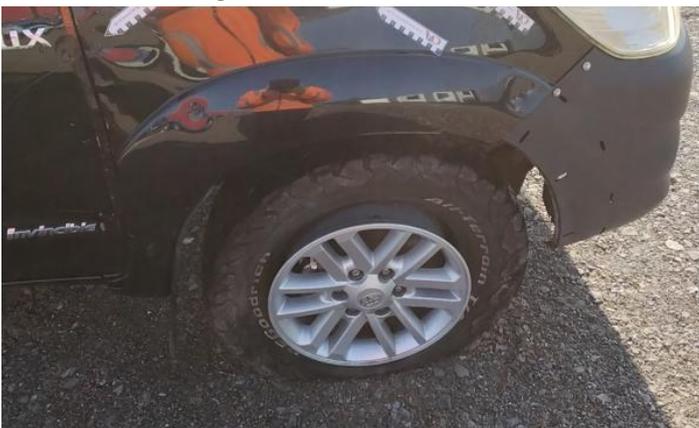
19: Wing osf
Dented
With Paint Damage

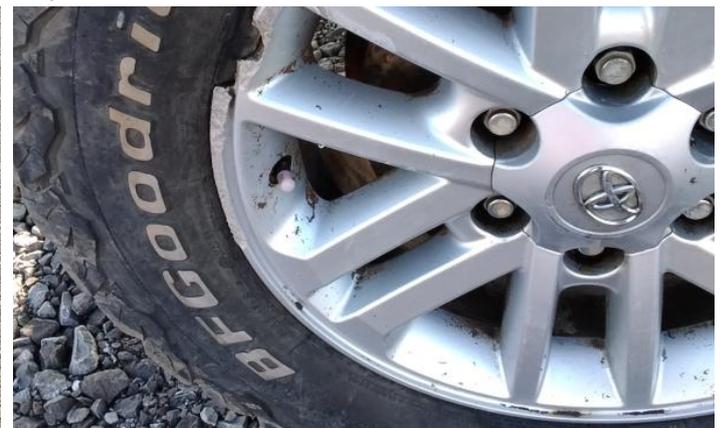
20: Wheel osr
Damaged
Replace

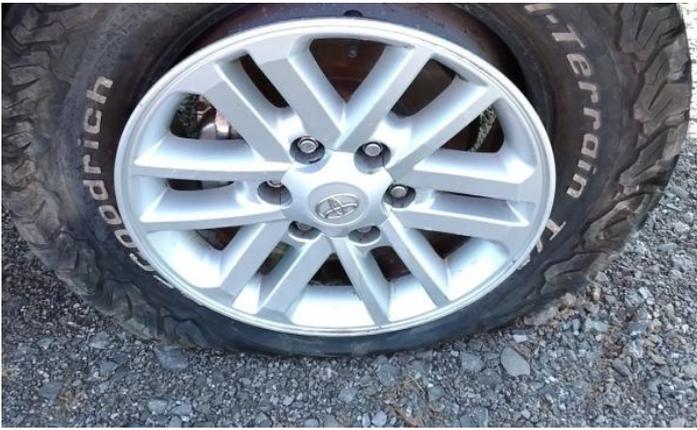
21: Wheel of
Damaged
Replace

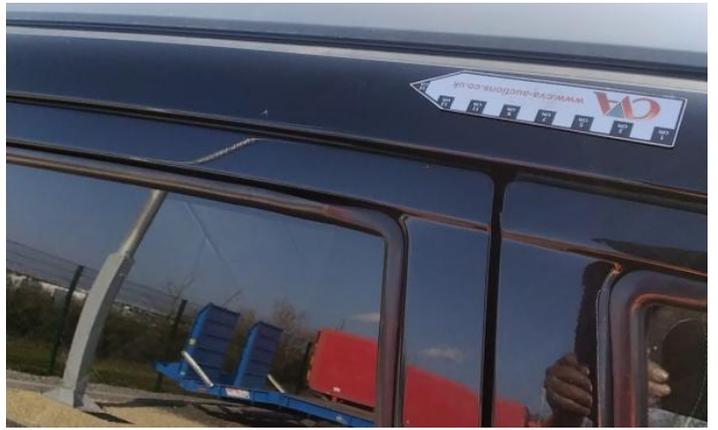
22: B Post of
Dented
Over 30mm

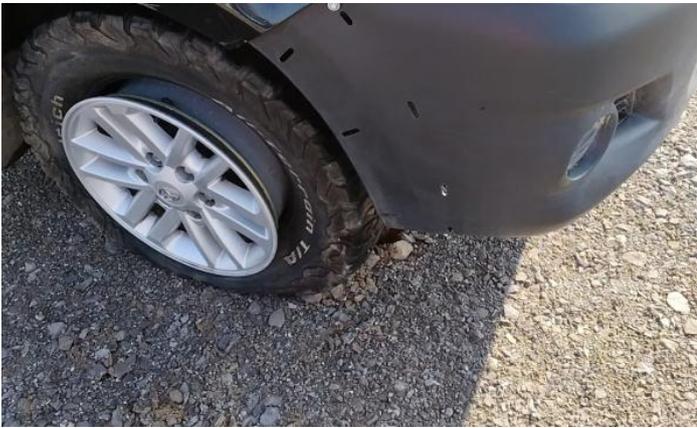
23: Moulding of Wing
Broken
Replace

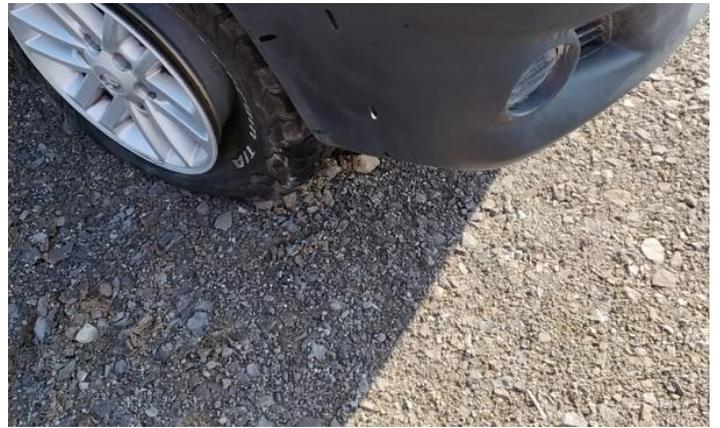
24: Bumper Front
Hole
Over 25mm

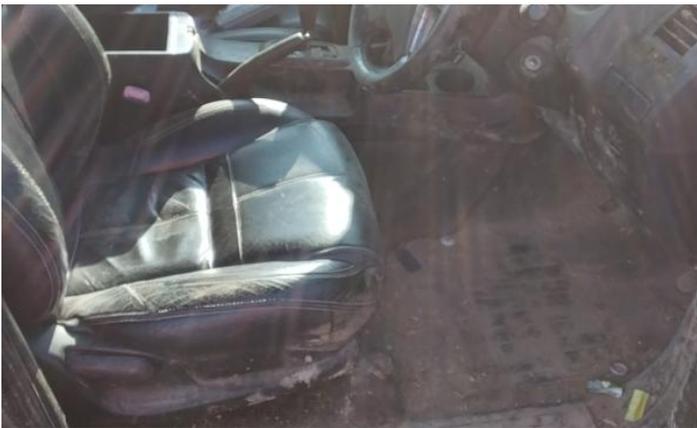
25: General Interior
Soiled
Light

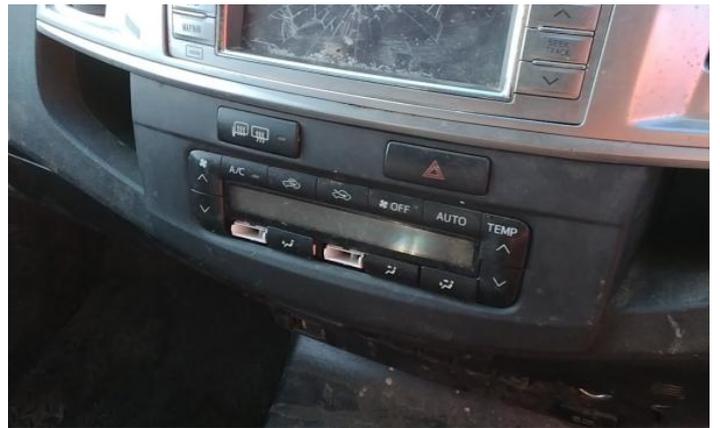
26: In Car Entertainment
Broken
Replace
